PILATUS AIRCRAFT LTD. STANS, S	SWITZERLAND		
Service Bulletin No:	32-002	Ref No:	62
Modification No:	INSPECTION	ATA Chapter:	32

LANDING GEAR - MAIN GEAR AND DOORS **INSPECTION OF THE MAIN-GEAR SUPPORT STRUT**

Service Bulletin No:32-002Rev. No.1Date:Aug 27/09

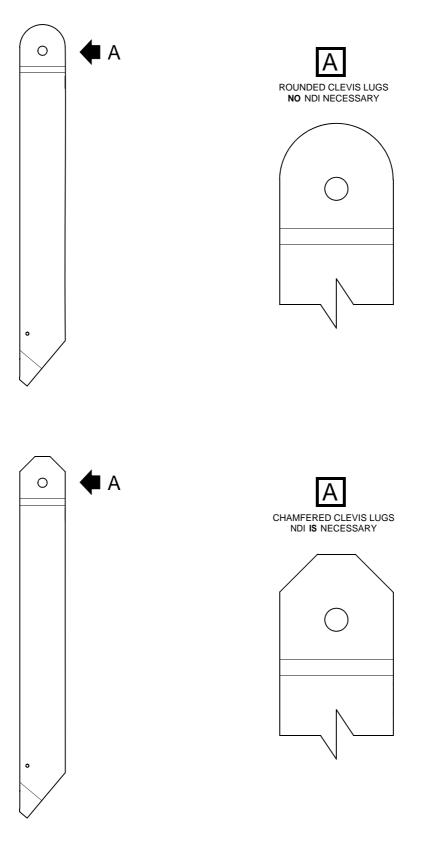
Type of Main-Gear Support Struts Figure 1

Cracks have occurred in the main-gear support struts on some aircraft. All the main-gear support struts that had cracks were made from material AA2024-T351. This material has a lower resistance to stress corrosion cracking.

The cause of the cracks is stress corrosion.

- (1) Do a visual examination of the left and right main-gear support struts installed on the aircraft:
 - If the main-gear support struts has rounded clevis lugs, they are made of material with an increased resistance to stress corrosion cracking. Continue the Service Bulletin from Step 3.E.
 - If the main-gear support struts has chamfered clevis lugs, they are made of material which has a lower resistance to stress corrosion cracking. Continue the Service Bulletin from Step 3.B.

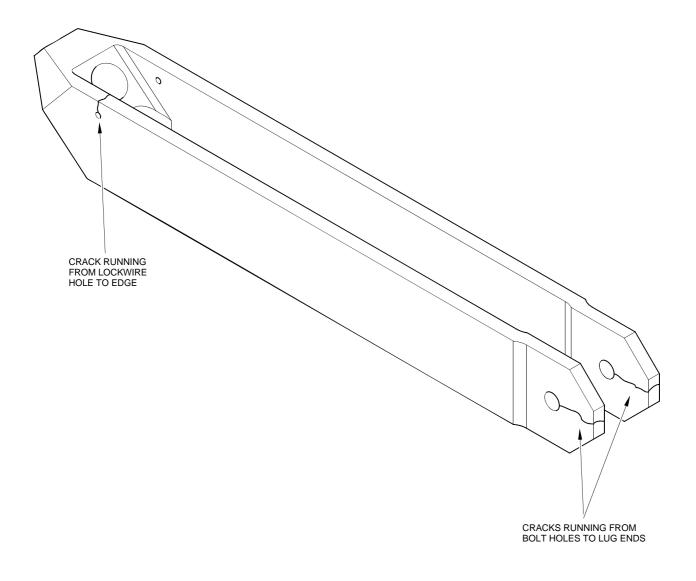
Position of Possible Cracks Figure 3

- (4) Examine the area around the hole, for the bolt (4), on the aft surface with a 90° shielded probe.
- (5) Examine the area around the hole, for the bolt (4), on the forward surface with a 90° shielded probe.

- (6) Examine the area adjacent to the lockwire holes with the 90° shielded probe.
- (7) Do steps 3.C.(1) to 3.C.(6) for the right main-gear support strut.

- (8) If you find cracks (Ref. Fig. 4):
 - (a) Use the report and record the length and position of the crack(s). Send the report to:

- (b) Do Service Bulletin 32-003 to replace the main-gear support strut.
- (9) If you do not find cracks (Ref. Fig. 2):
 - (a) Put the bush (2) in position in the actuator (3).
 - (b) Put the actuator (3) in the correct position between the lugs of the left and/or right folding strut lever (1).
