Service Bulletin No: 52-005

ATA Chapter: 52

**CANOPY - GENERAL
INSPECTION FOR CORRECT INSTALLATION OF THE HINGE ATTACHMENT RIVNUTS****1. Planning Information****A. Effectivity**

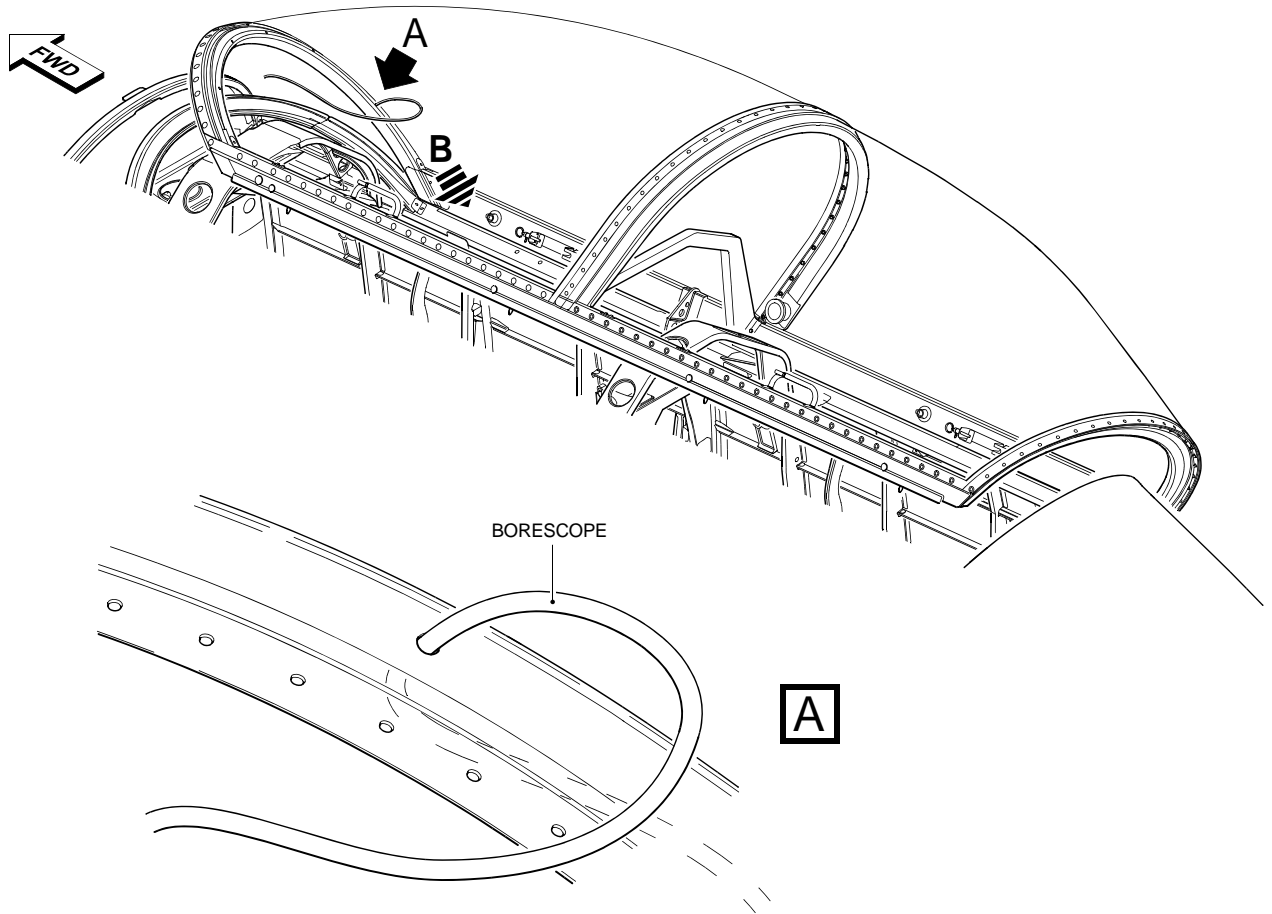
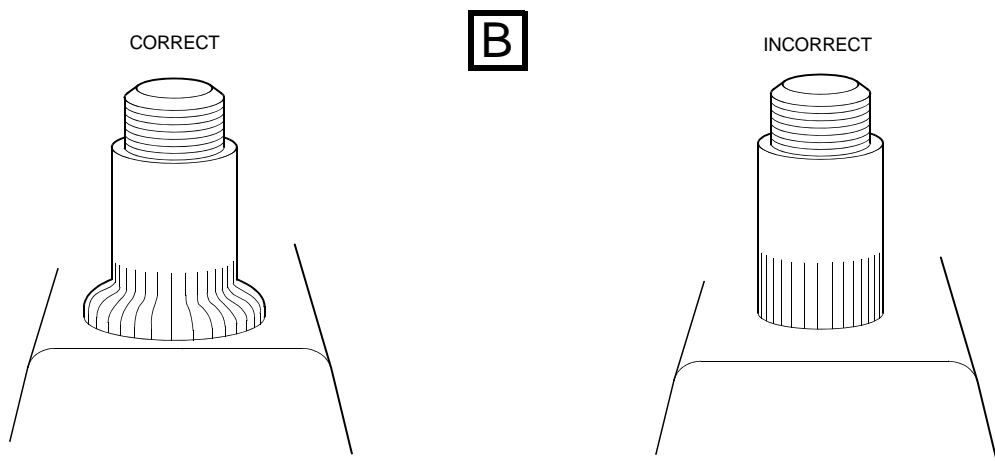
Rivnuts - Inspection
Figure 1

- (1) Put the flexible borescope through the tooling hole in the right side of the front frame of the canopy.
- (2) Push the flexible borescope into the right side frame until you can see the rivnuts.
- (3) Examine the first four hinge attachment-screw rivnuts (minimum).
- (4) If the rivnuts have a bulge they are correctly installed. Remove the borescope and do the re-identification procedure (Ref. Para. F.).
- (5) If the rivnuts are cylindrical with no bulge they are not correctly installed. Continue with the rivnut installation procedures.
