# SERVICE BULLETIN

SERVICE BULLETIN NO: 53-008

ATA CHAPTER: 53

## FUSELAGE ENGINE MOUNTING-FRAME ATTACHMENT-FITTINGS - INSPECTION

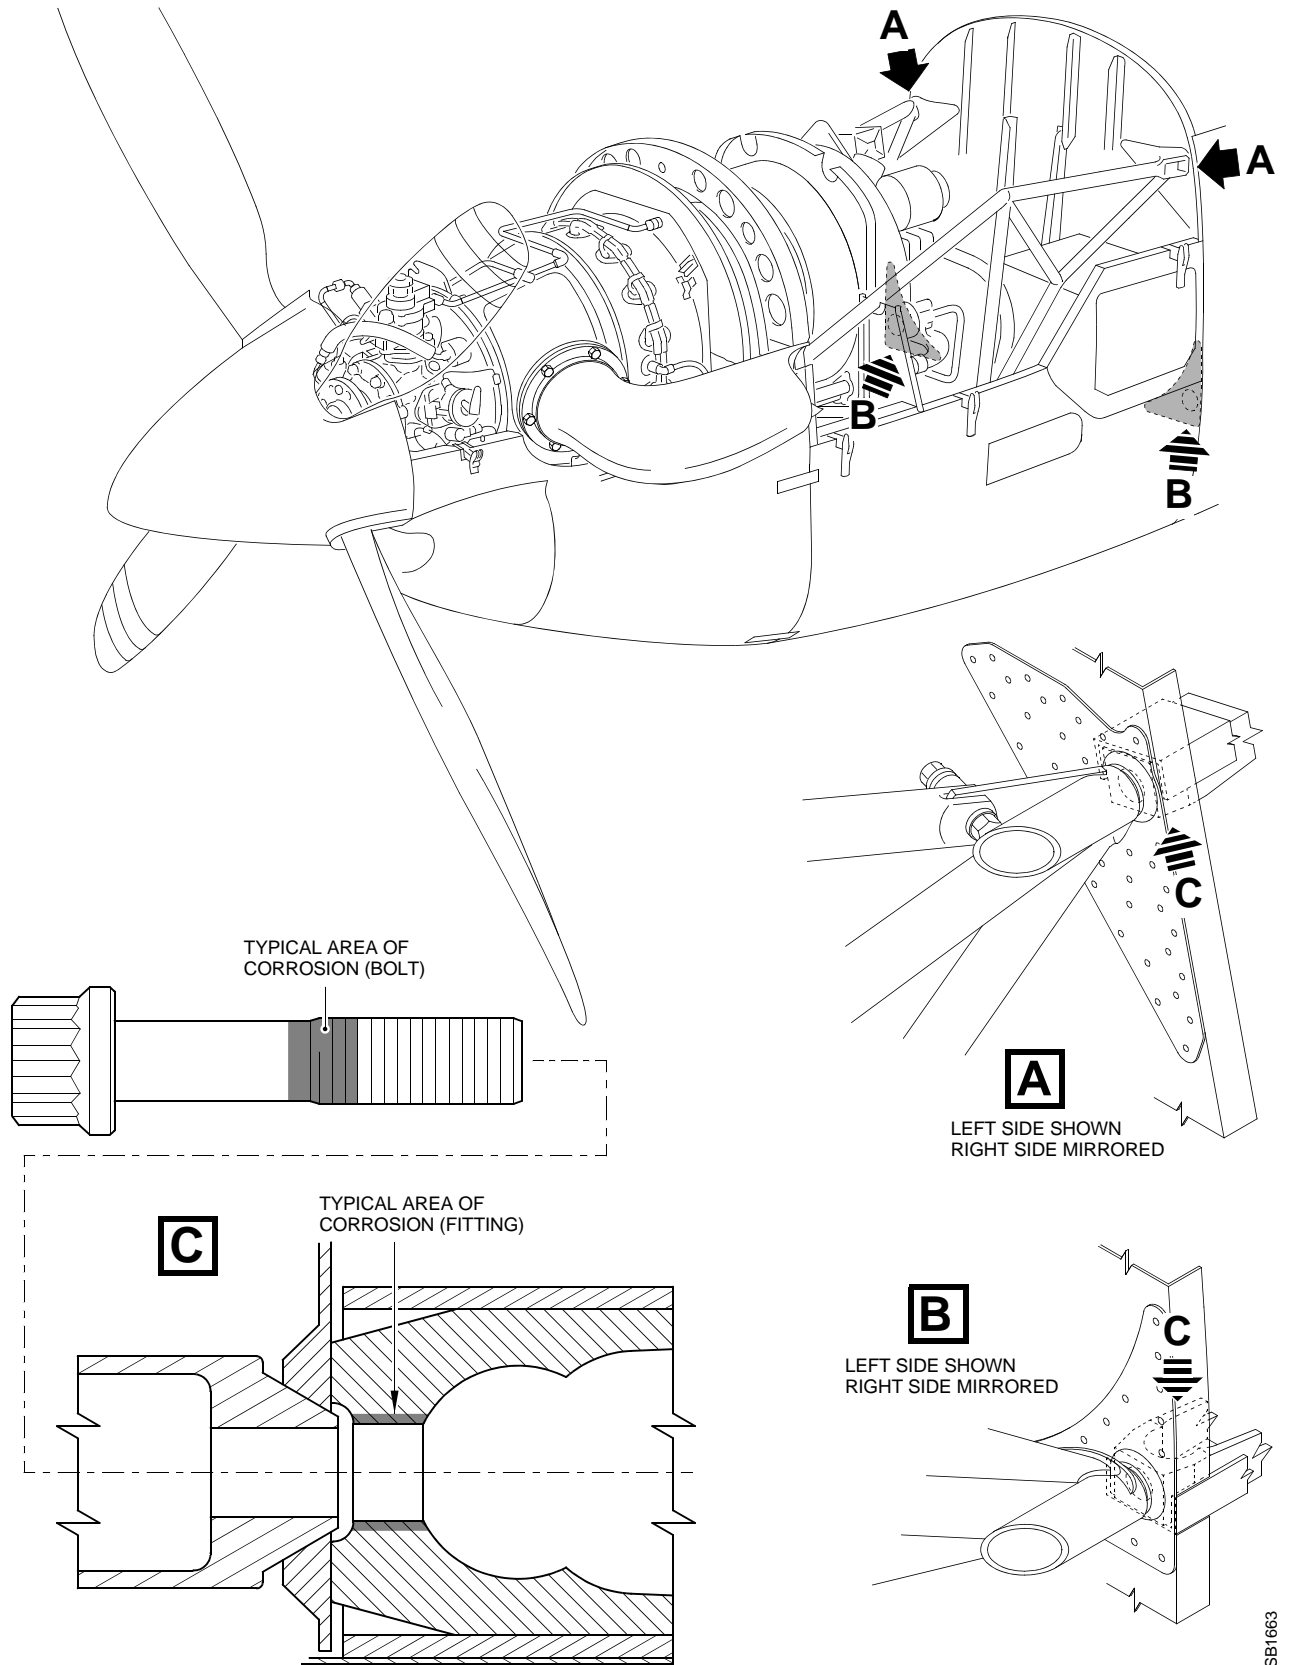
Engine Mount Attachment Fittings - Inspection/Repair  
Figure 1

Corrosion has been found on the bolts and in the bores of the attachment fittings for the engine mounting frame.

Damage to the cadmium plating of the bolt, or to the surface finish of the attachment fitting, can cause corrosion. The damage is caused when the bolts are removed and installed.

- (1) Remove the bolt and washer from one of the four engine mounting-frame attachment points (Ref. AMM 71-20-01, Page Block 401).
- (2) Do a visual inspection for corrosion on the removed bolt.
- (3) Do a visual inspection for corrosion in the bore of the attachment fitting. Do this with a boroscope. If you find corrosion, do the subsequent steps:

- (a) Use aluminum wool (Material No. P02-002) to remove surface corrosion.
- (b) If you cannot remove all of the corrosion contact Pilatus for repair information.

- (c) Clean the bore and the threads of the barrel nut with solvent (Material No. P01-008) and absorbent paper (Material No. P02-031).
- (d) Remove all swarf and debris from the attachment fitting. If necessary, you must remove the barrel nut and/or the engine mounting frame to do this. Make sure there is no swarf and debris in the joints between:

- The attachment fitting and the barrel nut
  - The attachment fitting and the engine mounting frame.
- (e) Apply a layer of CCC solution (Material No. P07-001) to the bore.

- (f) If necessary, install the barrel nut and/or the engine mounting frame.
- (4) Install the new bolt (P/N 571.20.09.031) and the washer (P/N 938.75.11.105) (Ref. AMM 71-20-01, Page Block 401).
