**Service Bulletin No:** 53-011  
**Modification No:** EC-09-0594

**FUSELAGE - GENERAL  
INSPECTION FOR GALVANIC CORROSION ON THE UPPER LEFT LONGERON AND REPLACEMENT  
OF THE CHAFING PLATES**

PC-7 MkII aircraft MSN 010, MSNs 101 thru 160, MSNs 601 thru 604, MSNs 608 thru 616 and MSNs 675 thru 684.

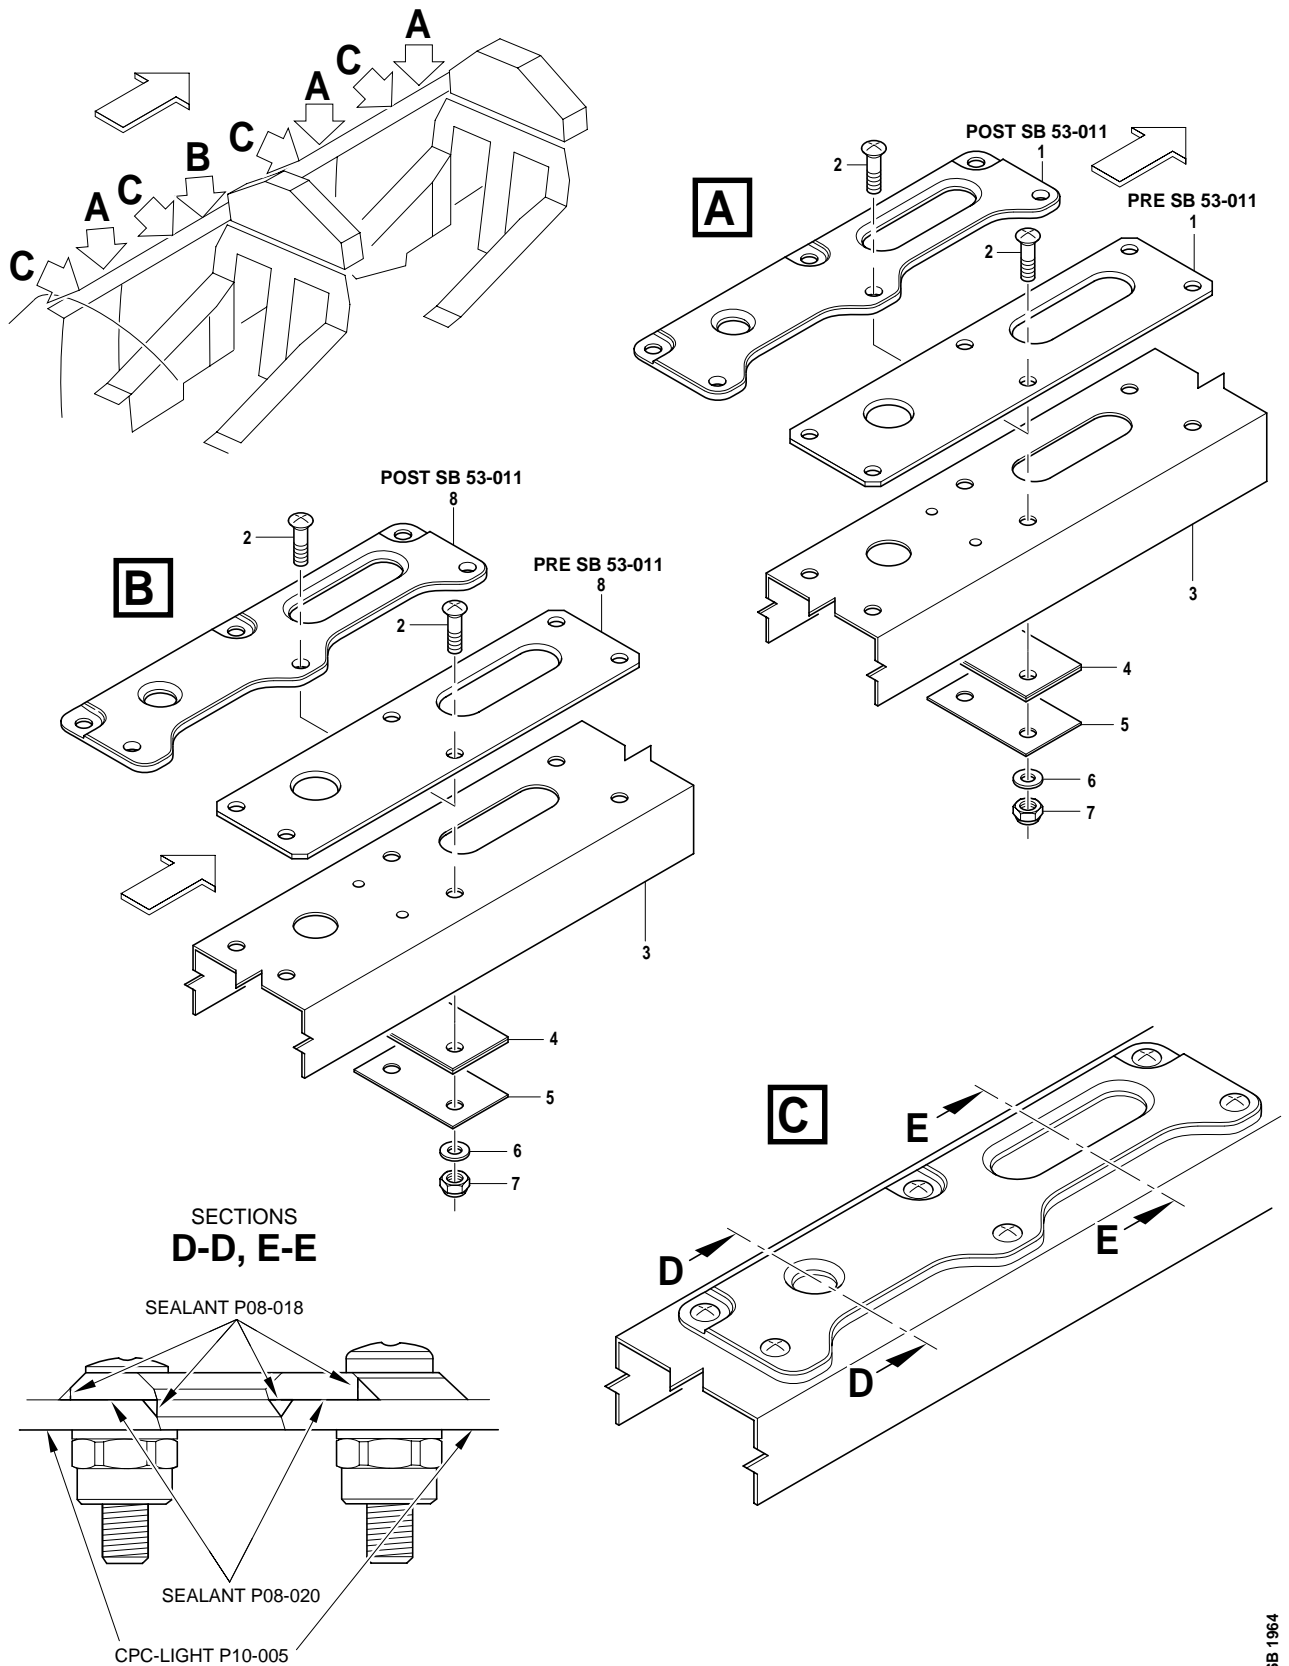
Canopy-lock Chafing Plates - Removal and Installation  
Figure 1

Corrosion has been reported on the upper left longeron underneath the chafing plates for the canopy door latches.

- The use of liquid shim
- Excessive latch chafing that damages and causes removal of the sealant and nucleation of further galvanic corrosion
- Poor application of sealant or finishes such as Alodine to the blended aluminium
- The use of chemical paint stripper.

Do an inspection of the longeron in the specified areas and, if necessary, remove the corrosion. Apply to Pilatus for a repair scheme if the removal of corrosion decreases the metal thickness to less than the specified limits. Install new, more robust, chafing plates.

- (c) Use a X 10 magnifier and look for signs of corrosion in the areas of the chafing plates (1 and 8) on the upper and lower surfaces of the longeron (3) (Ref. SRM, 51-10-01).
- (d) If you find corrosion in Para. 3.B.(2)(c), obey the evaluation and assessment instructions (Ref. SRM, 51-10-02).
- (e) Remove the corrosion (Ref. SRM, 51-10-02) from the longeron (3).
- (f) After you have removed the corrosion in Para. 3.B.(2)(e), measure and record the thickness of the metal in the bare metal areas of the longeron (3). Make an entry in the Aircraft Logbook to record these values.

- (g) If the thickness of the remaining metal is less than:
- 1,8 mm (0.071 in.) at the FWD chafing plate (1) in the front cockpit
  - 2,3 mm (0.091 in.) at the AFT chafing plate (1) in the front cockpit
  - 2,1 mm (0.083 in.) at the FWD chafing plate (8) in the rear cockpit
  - 1,8 mm (0.071 in.) at the AFT chafing plate (1) in the rear cockpit,

- (k) Put the new chafing plates (1) (P/N 553.20.09.326) and (8) (P/N 553.20.09.327) in position on the longeron (3).
  - (l) Put the locking plate assemblies (5) and shim packs (4) in their recorded locations on the longeron (3) (Ref. Para 3.B.(1)).

- The chafing plates (1)
    - The chafing plate (8)
- As shown in Detail C and Section D-D and E-E.
- (q) Apply a layer of the CPC-Light (Material No. P10-005) to the lower surface of the longeron (3) in the areas of the chafing plates (1) and the chafing plate (8).
