Service Bulletin No: 53-012
Modification No: EC-09-0734

**FUSELAGE - GENERAL
INSPECTION OF THE FORWARD ELECTRICAL BONDING POINTS**

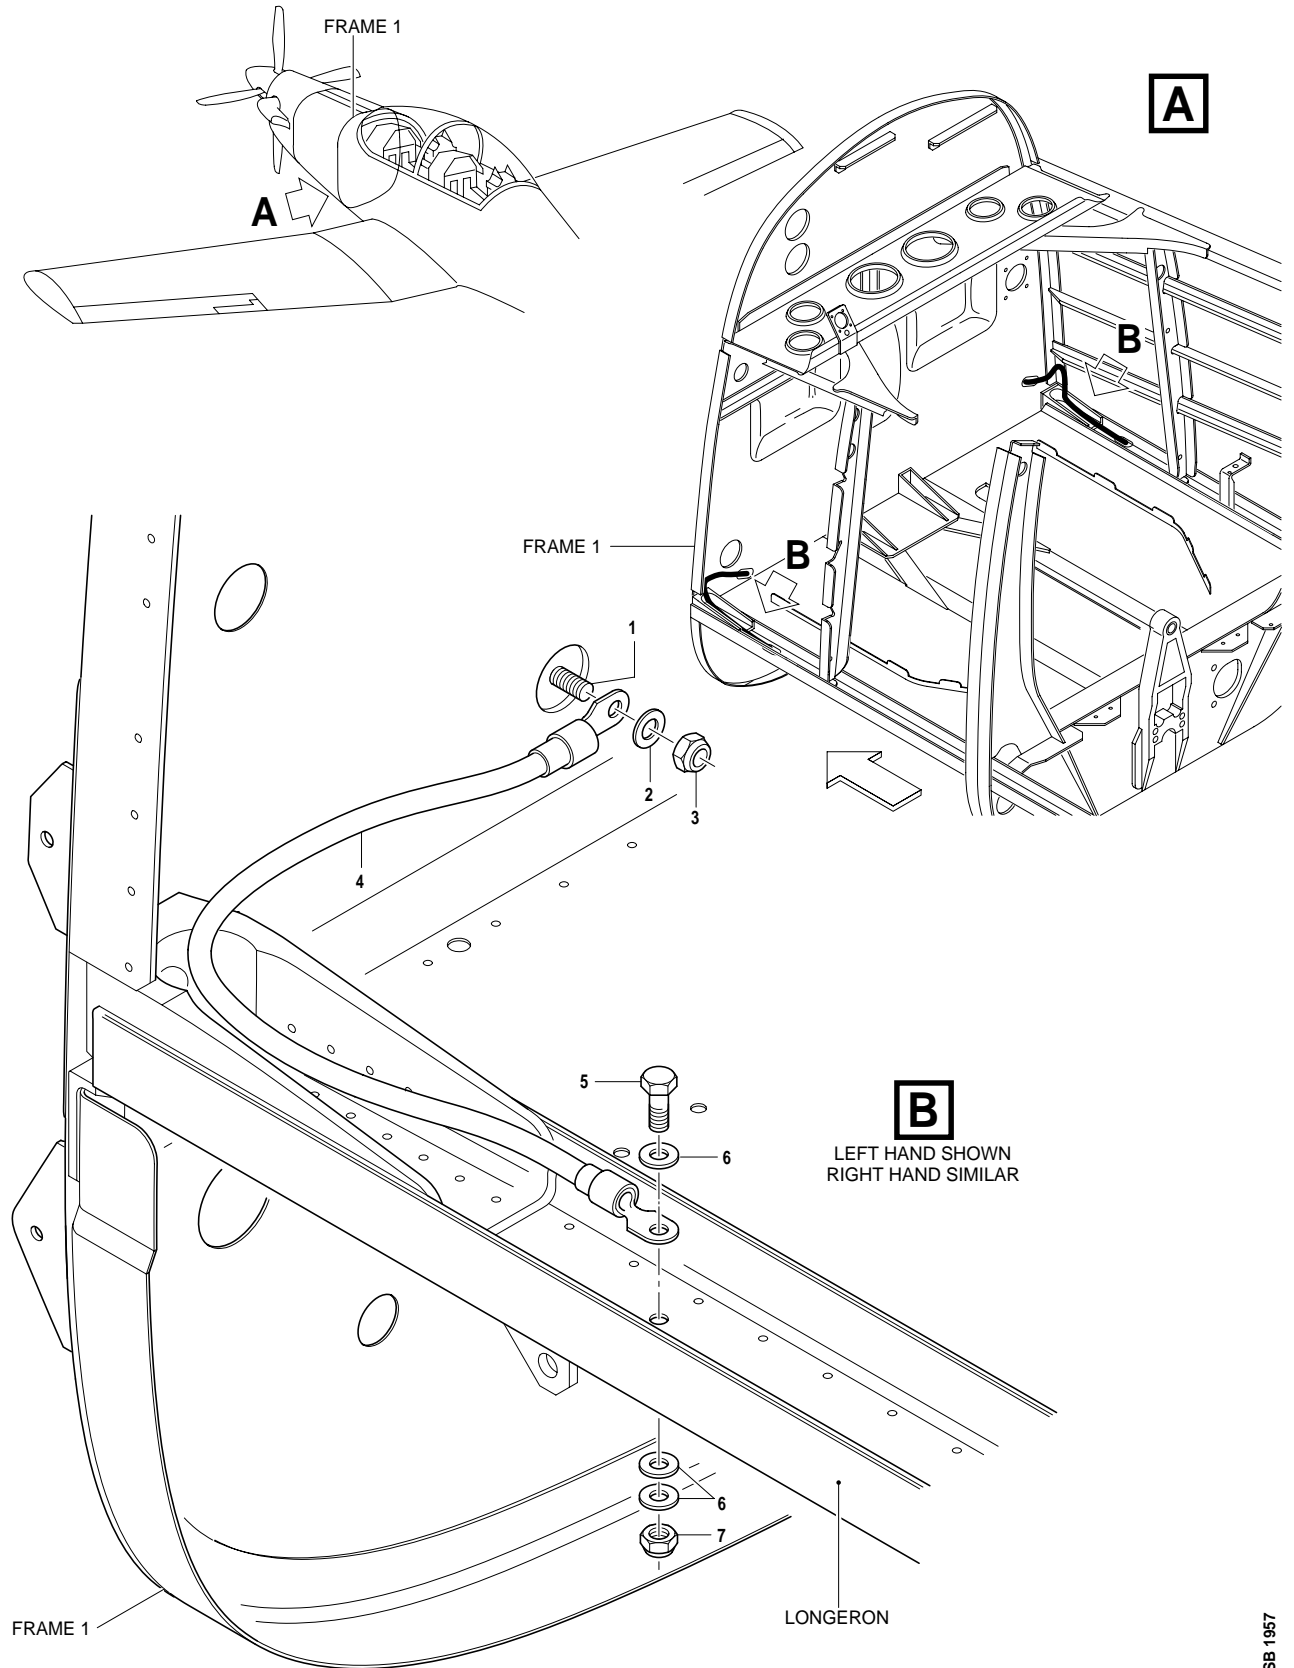
Bonding Strap - Removal/Installation
Figure 1

Corrosion has been reported at the bonding strap connections on the left and right lower longerons between fuselage frames 1 and 1A.

The contact faces of the longeron and bonding strap are susceptible to corrosion. The possibility of corrosion is increased because of the high electrical current flow between the tinned copper terminal lug of the bonding strap and the aluminum longeron.

- (1) If the bonding connection is oversealed, use a non-metallic scraper and solvent (Material No. P01-008) to remove the sealant.
- (2) Remove the nut (7) and the washers (6).

- (3) Remove the bolt (5) and washer (6) to disconnect the terminal lug of the bonding strap (4) from the longeron.

1 Connect the bonding strap (4) to the longeron with the bolt (5) the washers (6) and the nut (7).

(e) Torque tighten the nut (7) to the measured run-down torque plus between 11 and 16 Nm (100 and 140 lb in.).

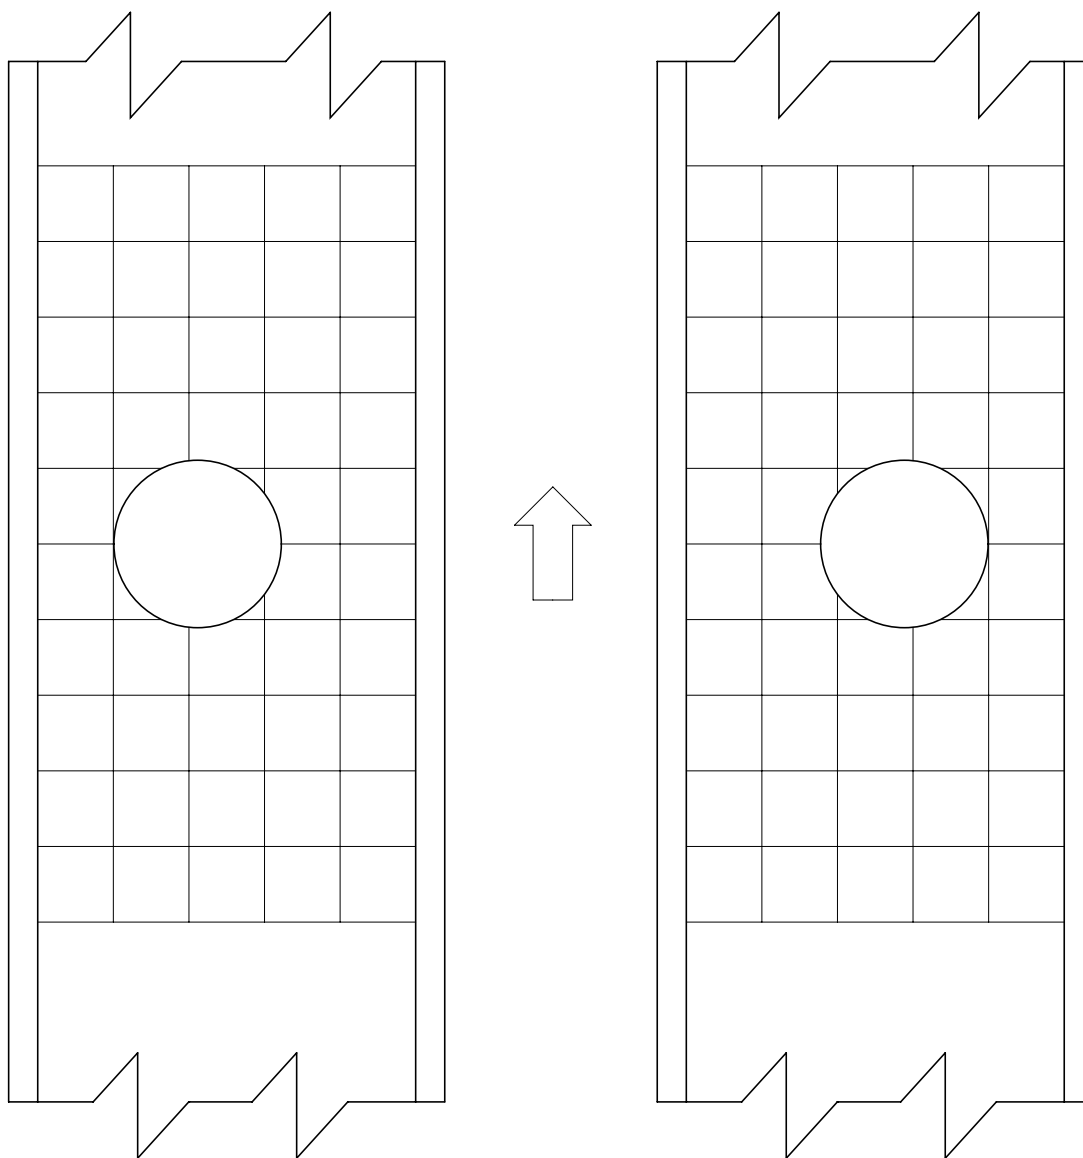
Report Form
Figure 2

- (9) Measure (with the ultrasonic thickness gage) and record this data on a copy of the Report Form (Fig. 2):
 - The minimum thickness of the metal in the repaired area(s). Use the grid on the Report Form to record the position of the measurement(s)

- The shape and area(s) where you removed corrosion
- (10) If the thickness of the longeron at any position is less than 1,9 mm, stop the procedure and contact Pilatus for more repair information:
