Service Bulletin No: 57-011

ATA Chapter: 57

**WINGS - OUTER WING
INSPECTION OF THE LEFT AND RIGHT OUTBOARD AILERON BEARING-BRACKETS****1. Planning Information****A. Effectivity**

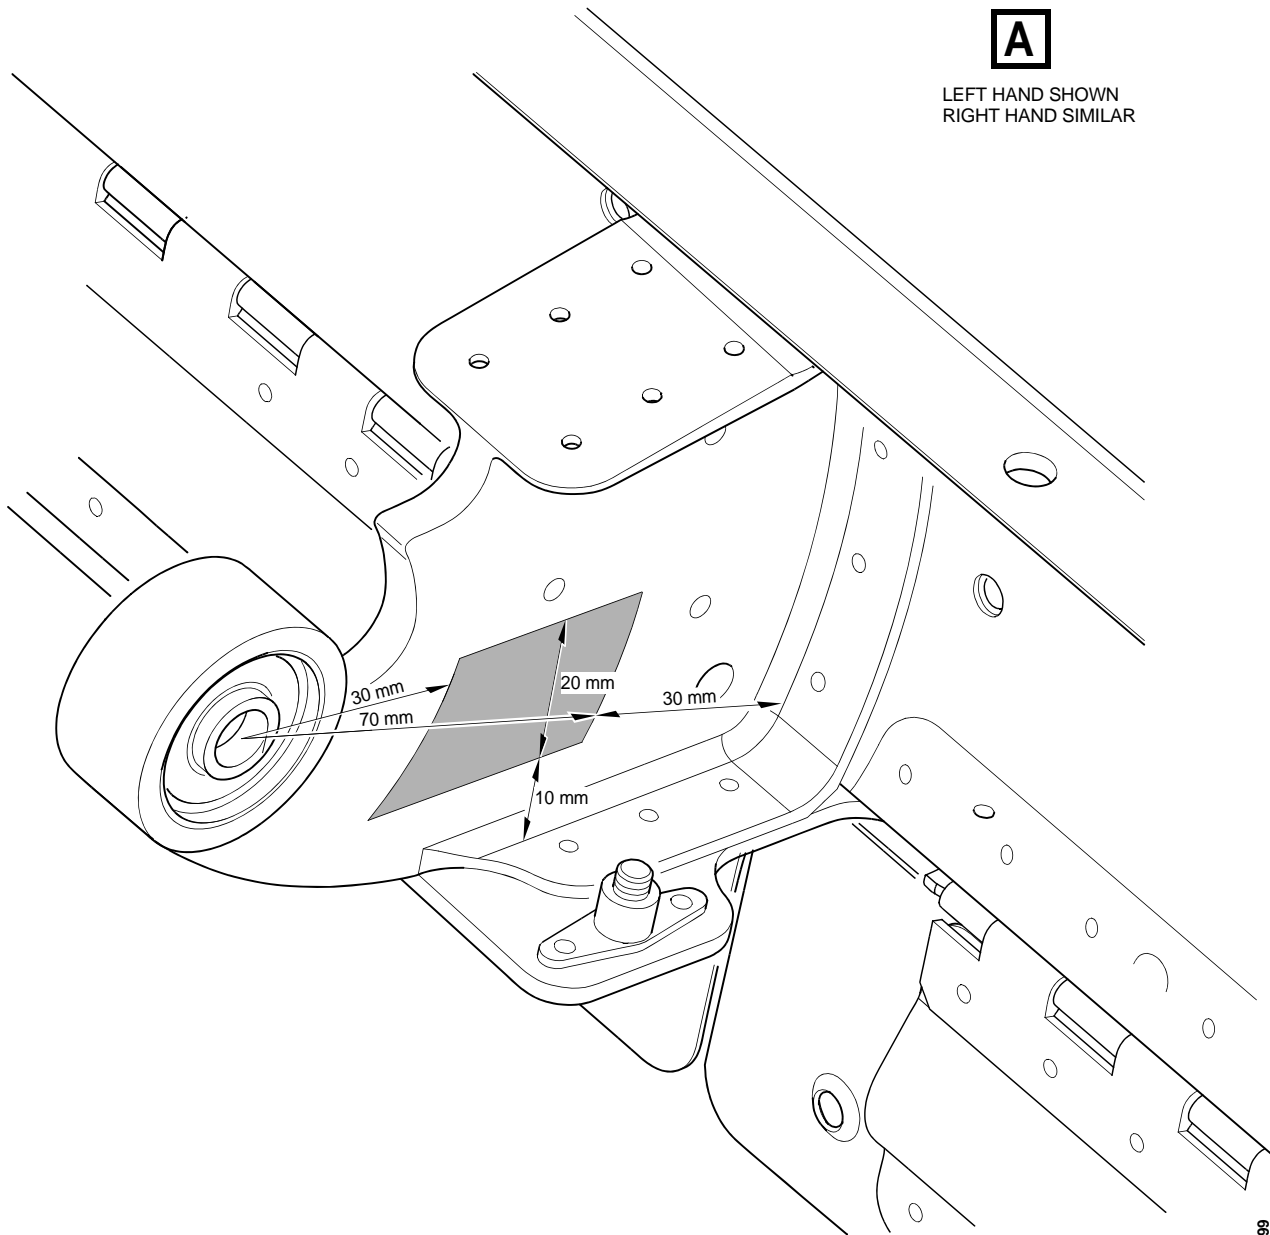
Inspection to Find the Type of Material
Figure 1

An Operator has found cracks in the outboard aileron bearing-bracket (bracket), P/N 557.22.09.281 (LH) and P/N 557.22.09.282 (RH) installed on some of his aircraft. If the rivets in the affected location come out, they could cause the aileron to become jammed or lost in flight.

The cause of the cracks is stress corrosion.

It is possible for stress corrosion cracks to occur in brackets, P/N 557.22.09.281 (LH) and P/N 557.22.09.282 (RH) made of aluminium alloy 2024-T351. These cracks would occur in the areas around the attachment fasteners.

- 1 Put the eddy current probe in position in the test area (shown shaded in the Fig 1).
- 2 Record the value shown on the test equipment.
- 3 Put the eddy current probe on:
 - The AA2024-T351 test piece (P/N 513.57.09.149) and record the value
 - The AA2124-T851 test piece (P/N 513.57.09.150) and record the value.
- 4 Do a comparison of the values recorded on the eddy-current conductivity measurement-equipment for:
 - The left bracket assembly (P/N 557.22.09.279)
 - The AA2024-T351 test piece (P/N 513.57.09.149)
 - The AA2124-T851 test piece (P/N 513.57.09.150).

Do an eddy-current conductivity measurement-test to identify the material specification of the brackets, P/N 557.22.09.281 (LH) and P/N 557.22.09.282 (RH). If the brackets, P/N 557.22.09.281 (LH) and P/N 557.22.09.282 (RH) are made of aluminium alloy 2024-T351 and not replaced (Ref. Service Bulletin 57-012), do an eddy-current inspection in the areas around the attachment fasteners.

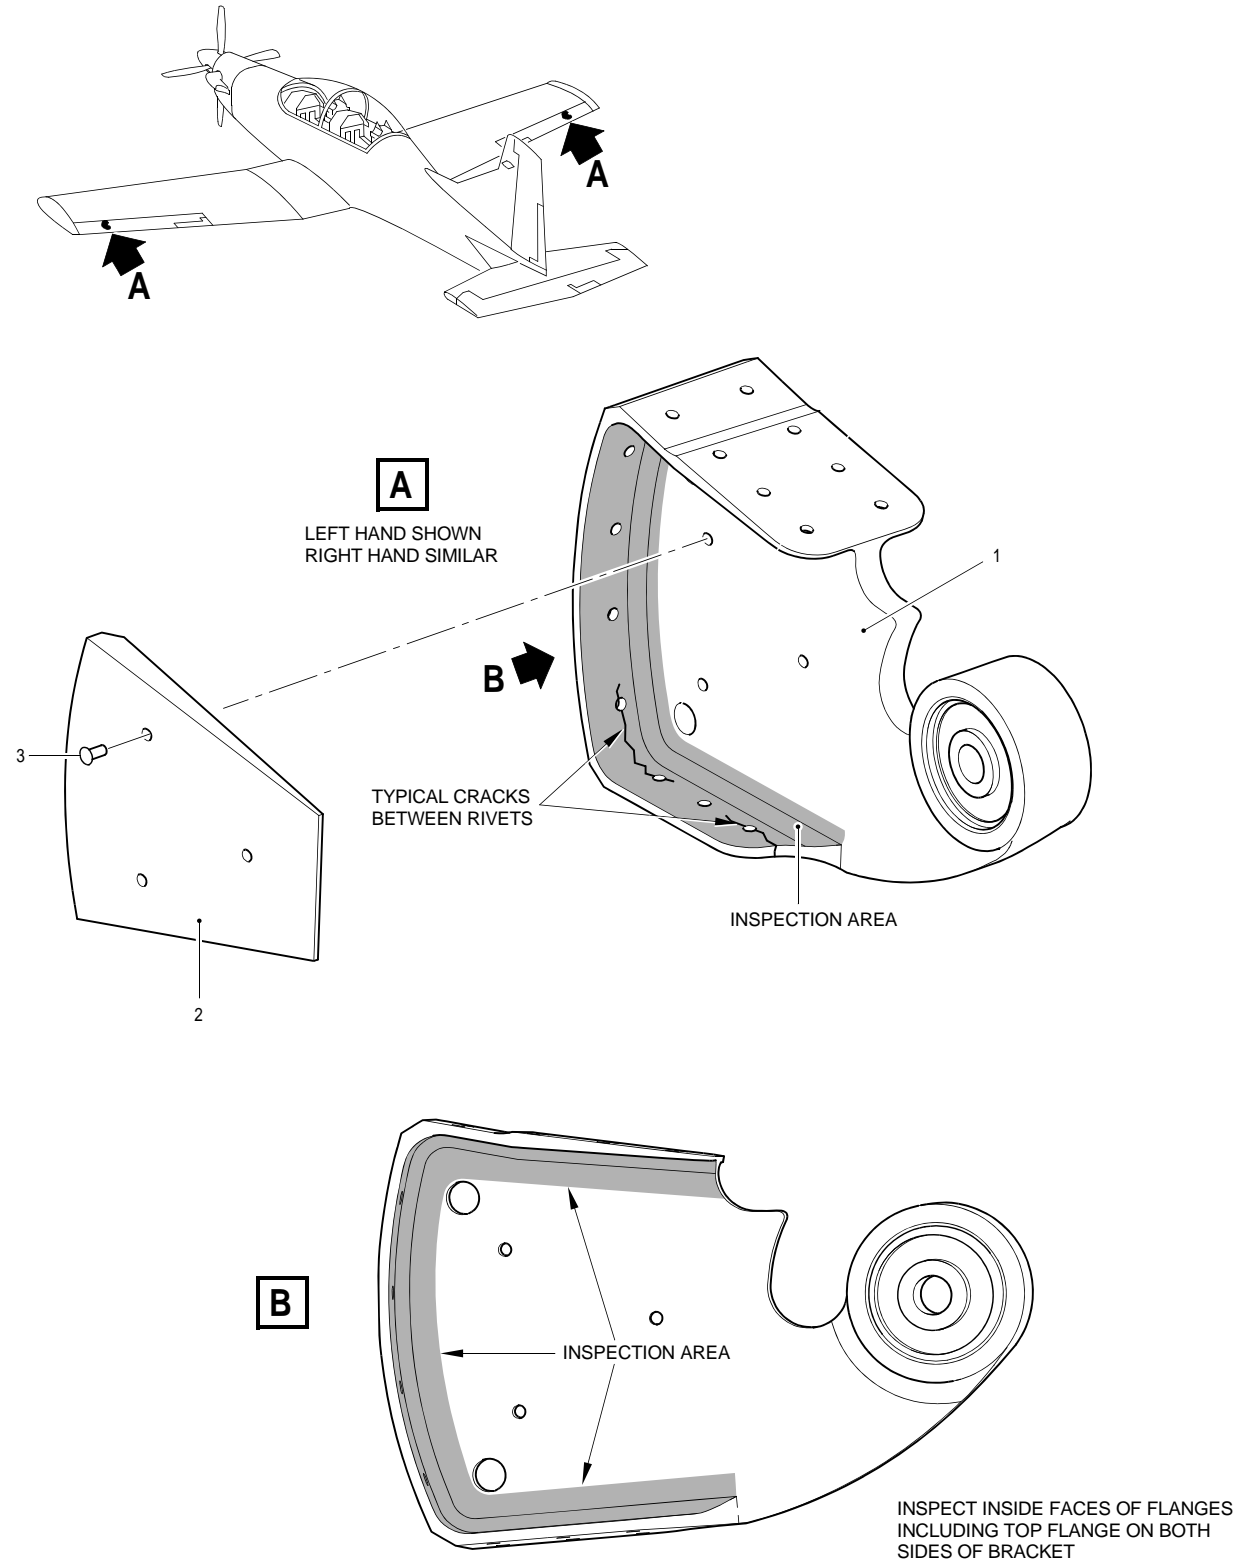
Inspection to find Cracks
Figure 2

- (4) Obey the manufacturer's operating instructions and calibrate the eddy-current crack-detection equipment.
- (5) Move the probe of the eddy-current crack-detection equipment over the areas shown in Fig. 2.
- (6) If you find cracks:
 - Continue with this Service Bulletin from Step 3.C(12)
 - Do Service Bulletin 57-012 before the next flight.

NOTE: If you find a crack in one of the bearing brackets, P/N 557.22.09.281 (LH) or P/N 557.22.09.282 (RH) made of aluminium alloy 2024-T351, you must replace the left and right brackets (Ref. Service Bulletin 57-012) before the next flight.
