Service Bulletin No: 57-012

**WINGS - OUTER WING
REPLACEMENT OF THE LEFT AND RIGHT OUTBOARD AILERON BEARING-BRACKETS****1. Planning Information****A. Effectivity**

PC-7 MkII aircraft MSN 010, MSN 101 thru MSN 160, MSN 601 thru MSN 604, MSN 608 thru MSN 616 and MSN 675 thru MSN 684.

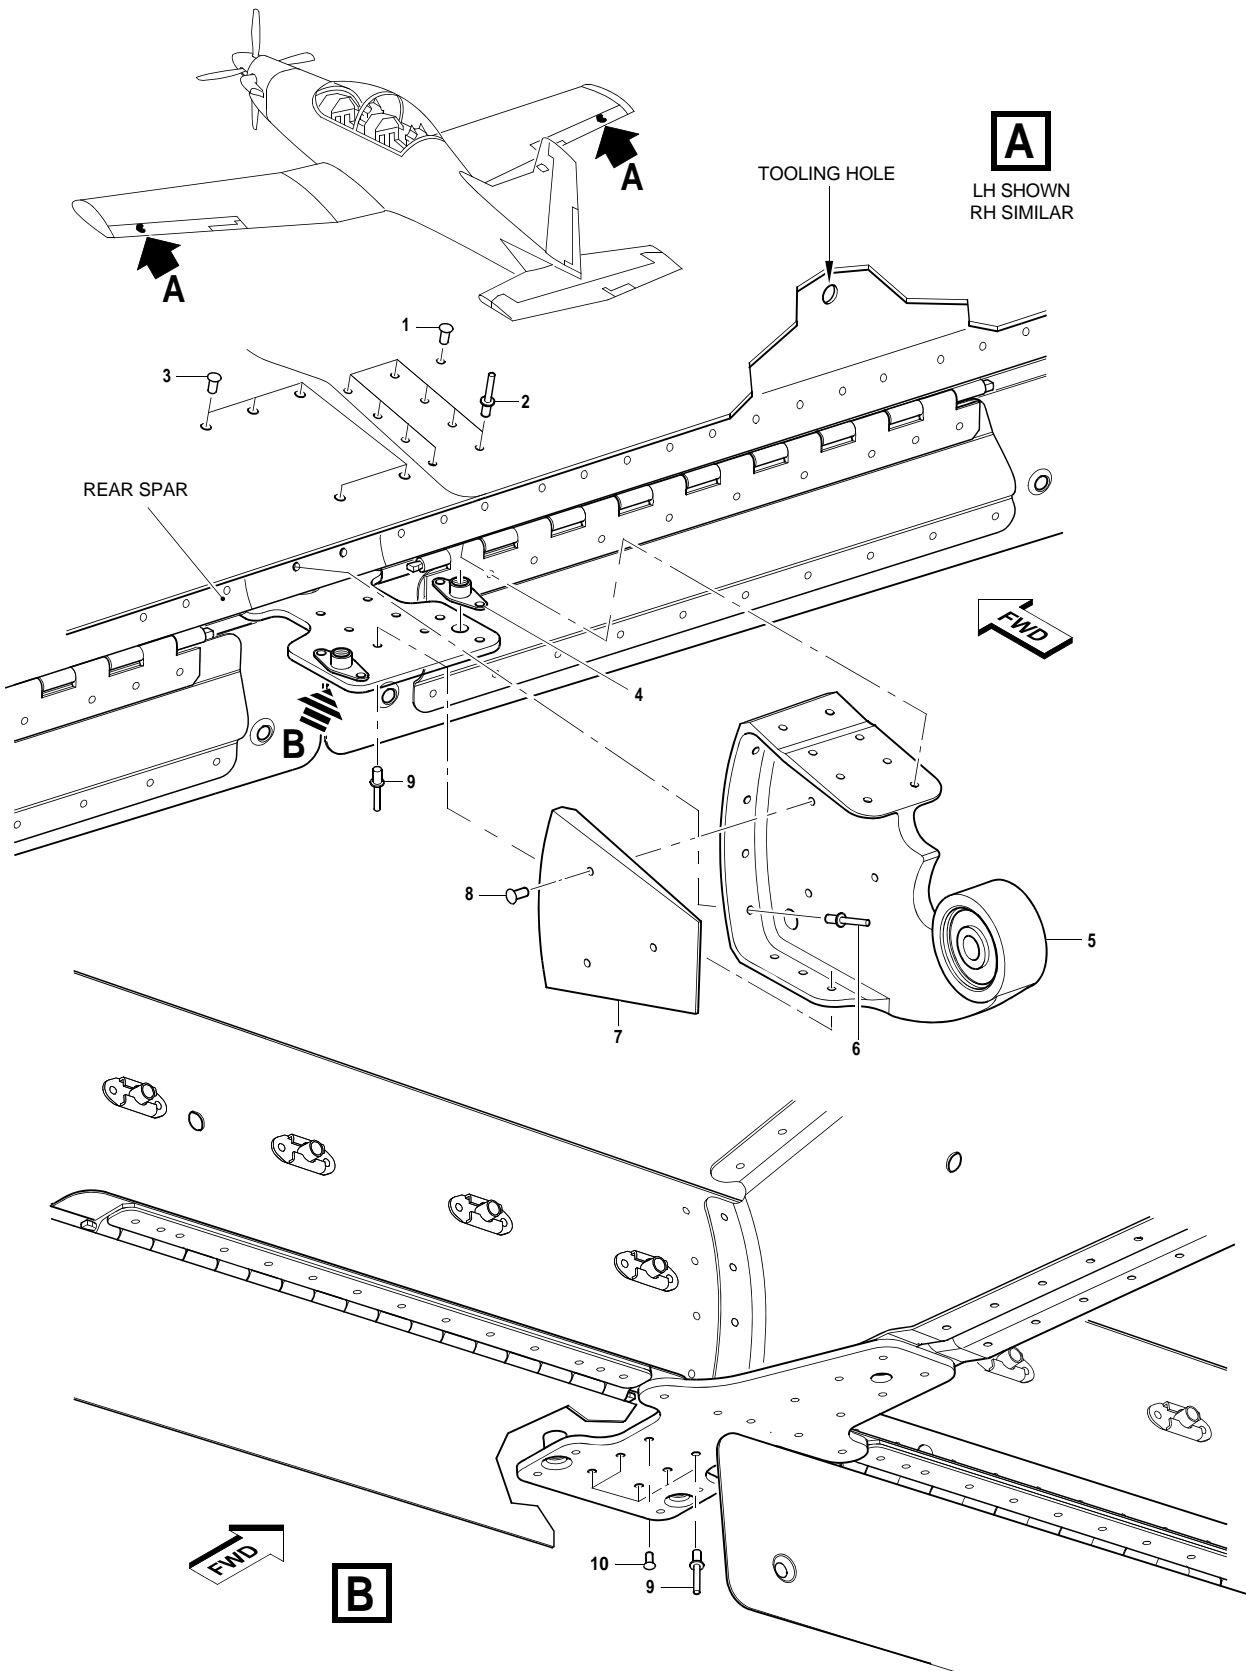
Removal / Installation of the Shim and Bracket
Figure 1

A Operator has found cracks in the aileron outboard bearing-bracket (bracket), P/N 557.22.09.281 (LH) and P/N 557.22.09.282 (RH) installed on some of his aircraft. If the rivets in the affected location come out, they could cause the aileron to become jammed or lost in flight.

The cause of the cracks is stress corrosion.

- (1) If installed, make a note of the position of the shim (7) on the applicable bracket (5).
- (2) If installed, use the applicable sized drill and remove the three rivets (8) that attach the shim (7) to the applicable bracket (5).
- (3) Remove and keep the shim (7).
- (4) Remove the five rivets (3) from the top skin, outboard of the bracket (5).

- (1) Measure and record the height of the tail of the inboard forward rivet (10) that attaches the flange of the bracket (5) to the lower skin.
- (2) Remove the six rivets (9 and 10) that attach the flange of the bracket (5) to the lower skin.
- (3) Remove the eight rivets (2) that attach the flange of the bracket (5) to the upper skin.
- (4) Remove the rivet (1) from the upper skin.

- (6) Remove the remaining four inboard rivets (6) that attach the flange of the bracket (5) to the wing rear spar.
- (7) Remove the bracket (5).
- (8) Remove, and keep, the spherical bearing from the bracket (5).

- (4) Apply a layer of the sealant (Material No, P08-020) to the new bracket (Fig. 1, Item 5) (P/N 557.22.09.547, LH or P/N 557.22.09.548, RH).
- (5) Put the new bracket (Fig. 1, Item 5) (P/N 557.22.09.547, LH or P/N 557.22.09.548, RH) in position on the wing.

- (12) Install the rivet (Fig. 1, Item 10) (P/N NAS1097AD4 or MS20426AD4) in the forward inboard hole in the location shown.
- (13) Make sure the tail of the rivet (Fig. 1, Item 10) (P/N NAS1097AD4 or MS20426AD4) is the same dimension as recorded at Step 3.D.(1). The minimum height is 0.5 mm. If necessary, remove material from the tail.
- (14) Install the remaining rivets (Fig. 1, Item 9) (P/N CR3224-4 or CR3222-4) in the other five positions.
