SERVICE BULLETIN NO: 57-004

WINGS - CENTER WING NOSE SKIN - INSPECTION FOR CRACK DAMAGE

PILATUS
PC-7 MK II
SERVICE BULLETIN

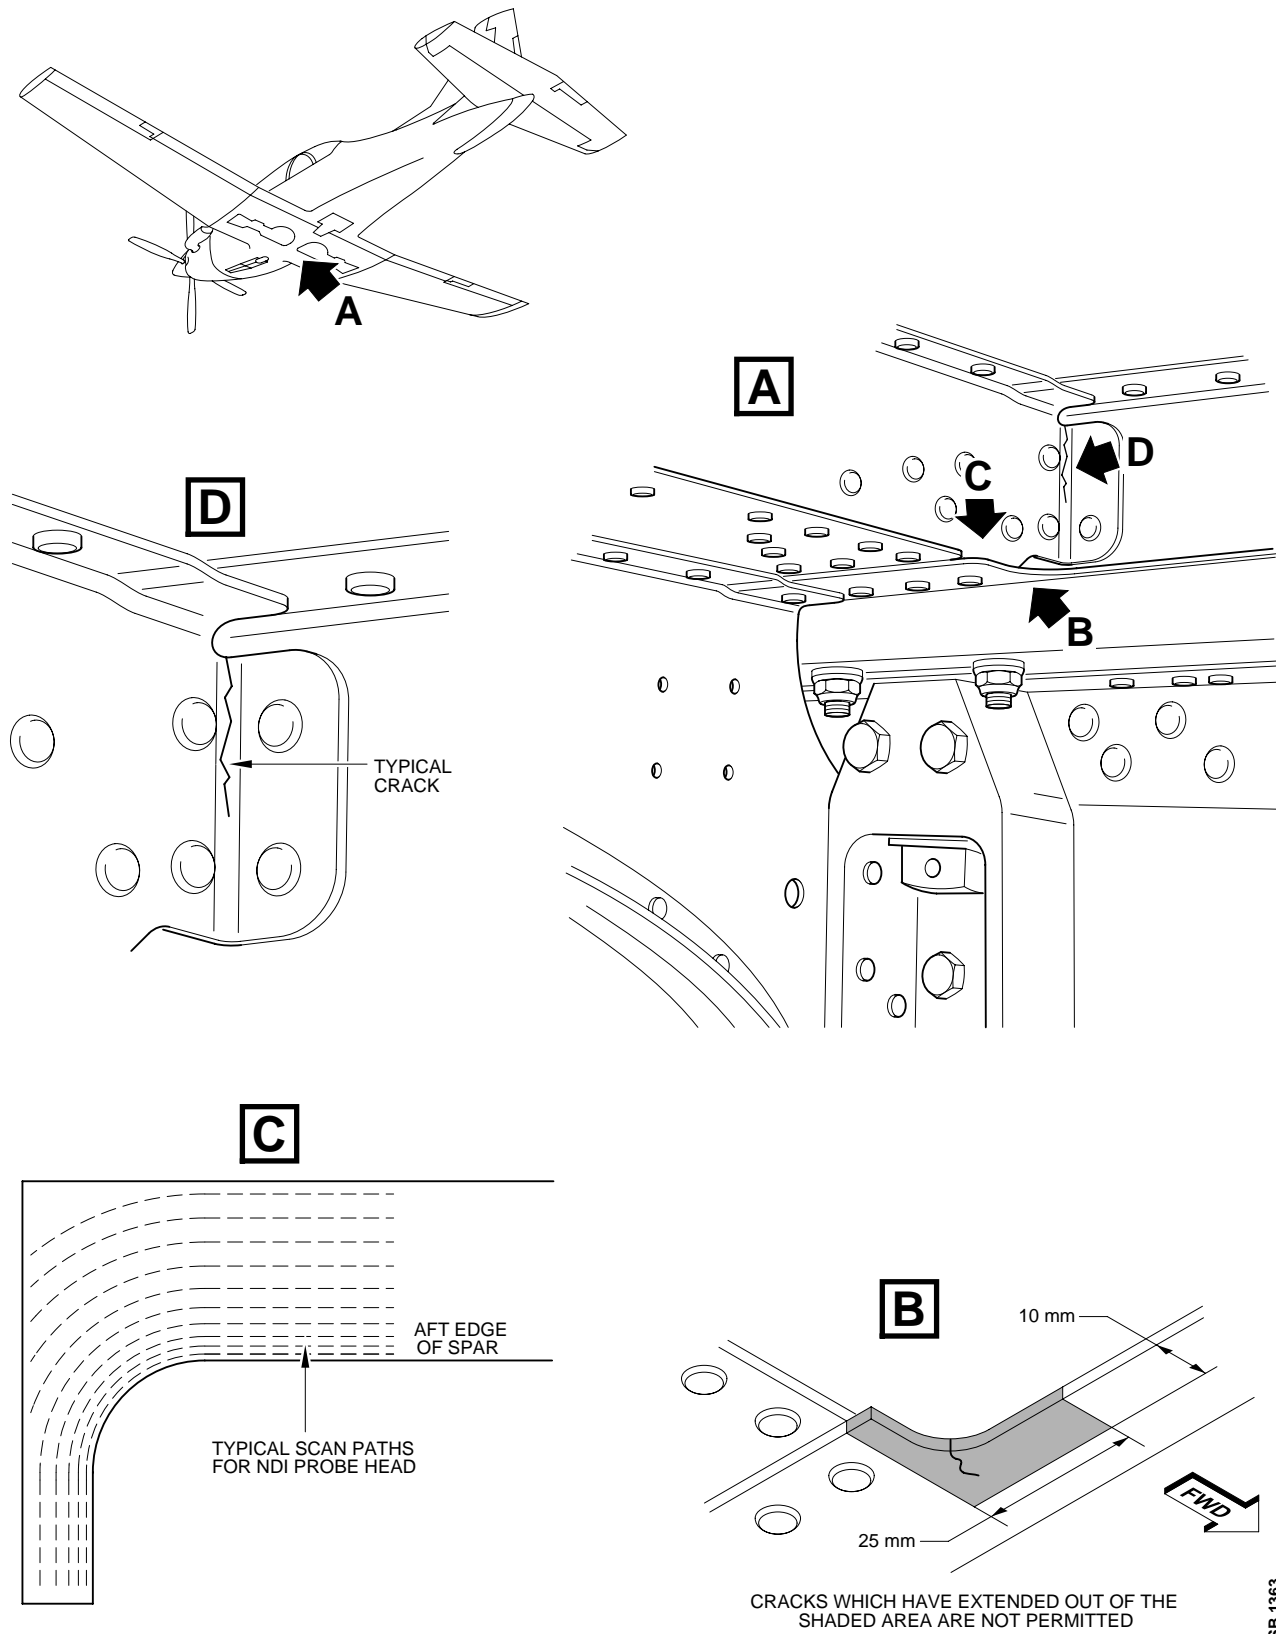
Nose Skin - Inspection
Figure 1

Crack damage can occur in the radii at the rear edge of the nose skin P/N: 557.31.09.120. The radii are adjacent to the left and right corners at the forward edge of the floor panel P/N: 557.31.09.027. Crack damage can also occur in the forward support structure of the floor panel adjacent to the skin panel.

Fatigue damage caused by stresses which occur normally during operation of the aircraft.

- (1) Use a source of bright light and a X10 magnifier and do an inspection of the forward area of the floor panel and the related structure at the locations shown (Ref. View D). Crack damage is not permitted. Apply to PILATUS for instructions if crack damage has occurred.
- (2) Do an NDI of the nose skin (Ref. Sect 4 and Views B and C). Cracks that have not extended out of the limit areas shown are permitted. Instructions to do subsequent inspections will be given in AMM, 05-10-20. The lengths of permitted cracks must also be monitored at the subsequent inspections.

Cracks that have extended out of the limit areas shown are not permitted. Apply to PILATUS for instructions before the next flight if such cracks have occurred.

- (1) Put the probe in position on the top of the skin in the inspection scan area.
- (2) Train the equipment.
- (3) Check train.
- (4) Zero the equipment.
- (5) Do a line scan on the nose skin as near to the edge as possible. Make sure you scan the full radius length (Ref. Fig. 1, Views B and C).
- (6) Do Step (5) again as many times as necessary to fully scan the inspection area shown. Make each line scan approximately 1,0 mm (0.04 in.) apart.
- (7) Do Steps (1) thru (5) again on the lower surface of the nose skin.
- (8) Do Steps (1) thru (7) again on the right inspection areas.
