SERVICE BULLETIN

SERVICE BULLETIN NO: 28-008

FUEL - DISTRIBUTION ENGINE DRIVEN PUMP - TORQUE CHECK OF RELIEF-VALVE-BODY SCREWS

≡PILATUS≡
PC-7
SERVICE BULLETIN

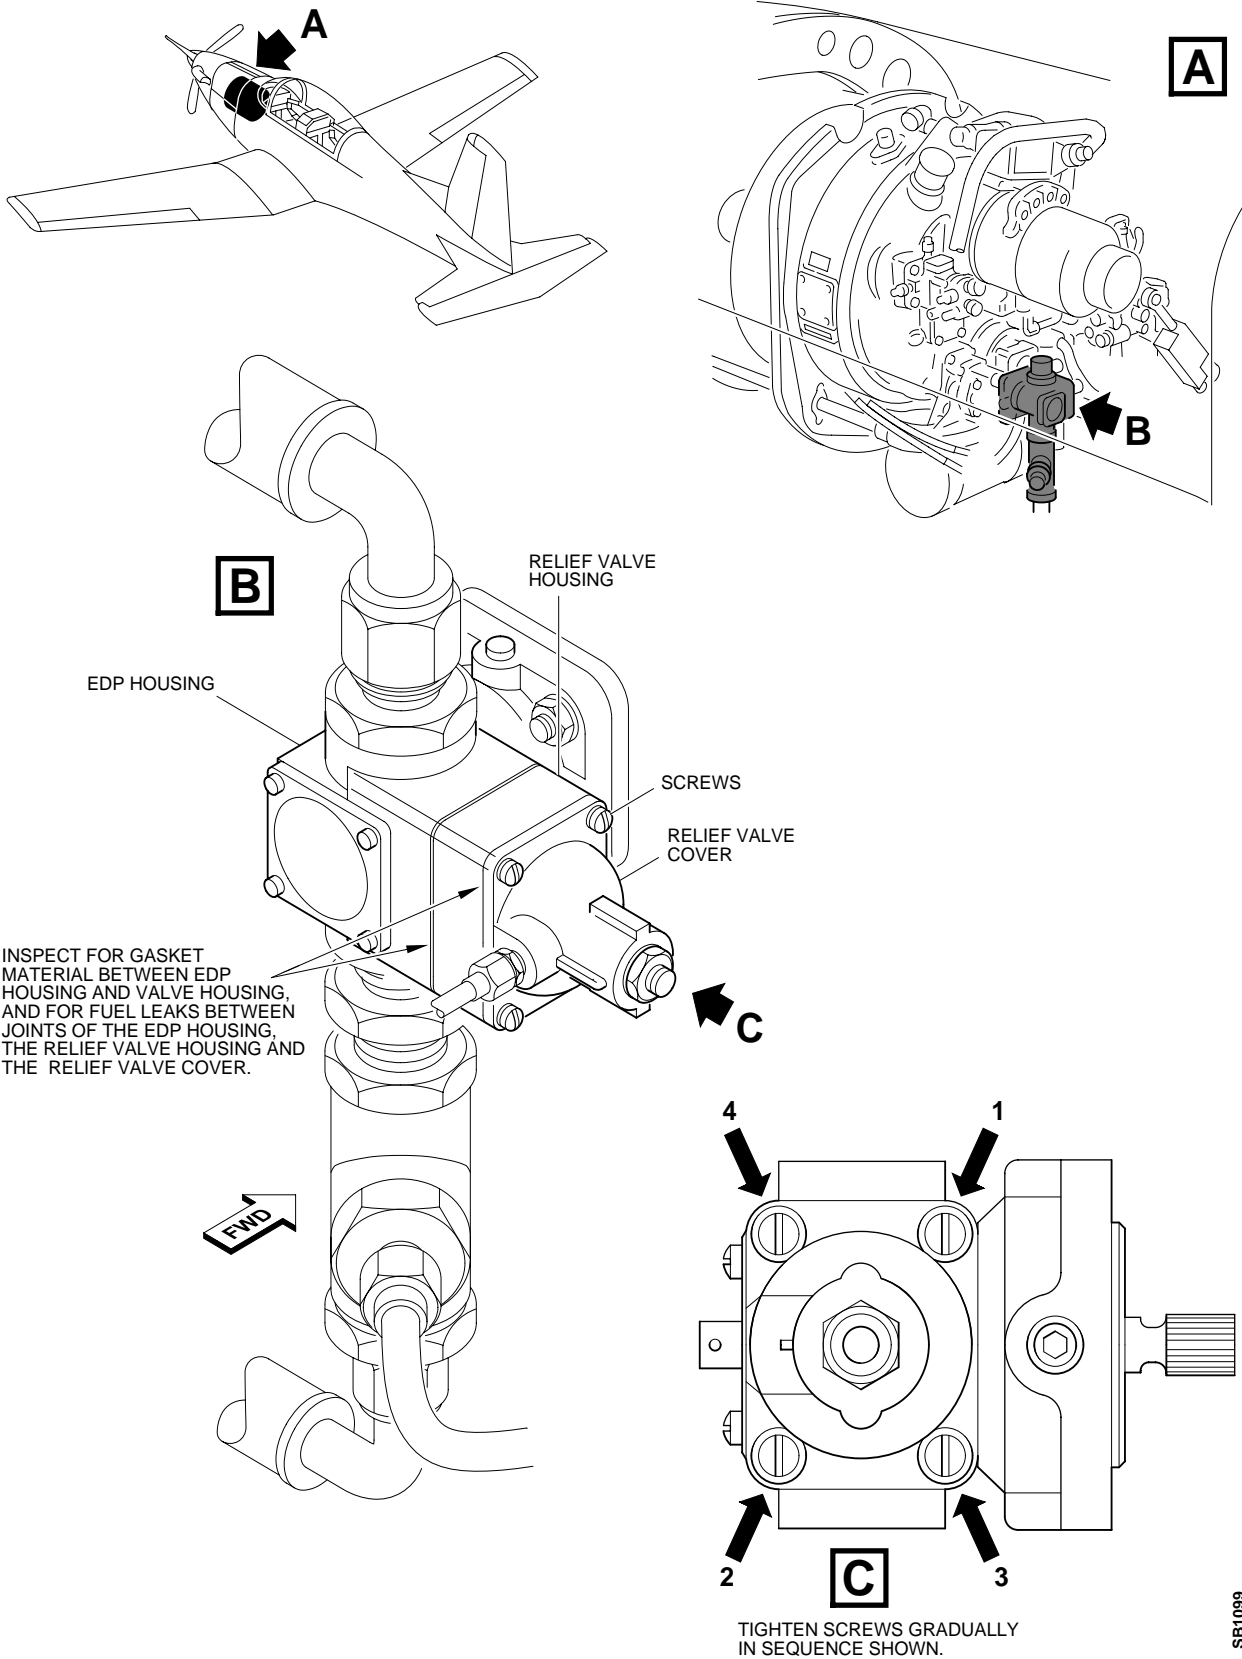
Torque Check and Fuel Leak Inspection of the EDP
Figure 1

Fuel leakage through the gasket of the EDP relief valve.

It is possible the torque of the screws that attach the EDP relief-valve cover to the relief valve housing is not correct. It is also possible that the gasket between the EDP relief-valve housing and the EDP housing has been pushed out.

- (1) Visually inspect the joints between the EDP housing, relief valve housing and the relief valve cover for:

- Fuel leakage
- Gasket material pushed out

- (2) If the EDP shows signs of fuel leakage or the gasket between the EDP housing and the relief valve housing has been pushed out, replace the EDP (Ref. AMM, 28-20-09, Page Block 401).

- (3) Use a torque screwdriver to do a check of the torque value of the relief-valve-cover screws. Do the check clockwise only. The minimum torque must be 23 lbf in. (2,6 Nm).

- (5) If the relief-valve-cover screws are loose, or the torque found at Step (3) is less than 23 lbf in. (2,6 Nm), do as follows:

- (b) Torque the screws gradually to between 23 and 25 lbf in. (2,6 and 2,83 Nm). Do this in the sequence shown in Figure 1, Detail B.

TIGHTEN SCREWS GRADUALLY
 IN SEQUENCE SHOWN.
