SERVICE BULLETIN

SERVICE BULLETIN NO: 57-006

WINGS - CENTER WING - INSPECTION AND MODIFICATION OF THE MAIN-SPAR DIHEDRAL FITTINGS

PILATUS
PC-7
SERVICE BULLETIN

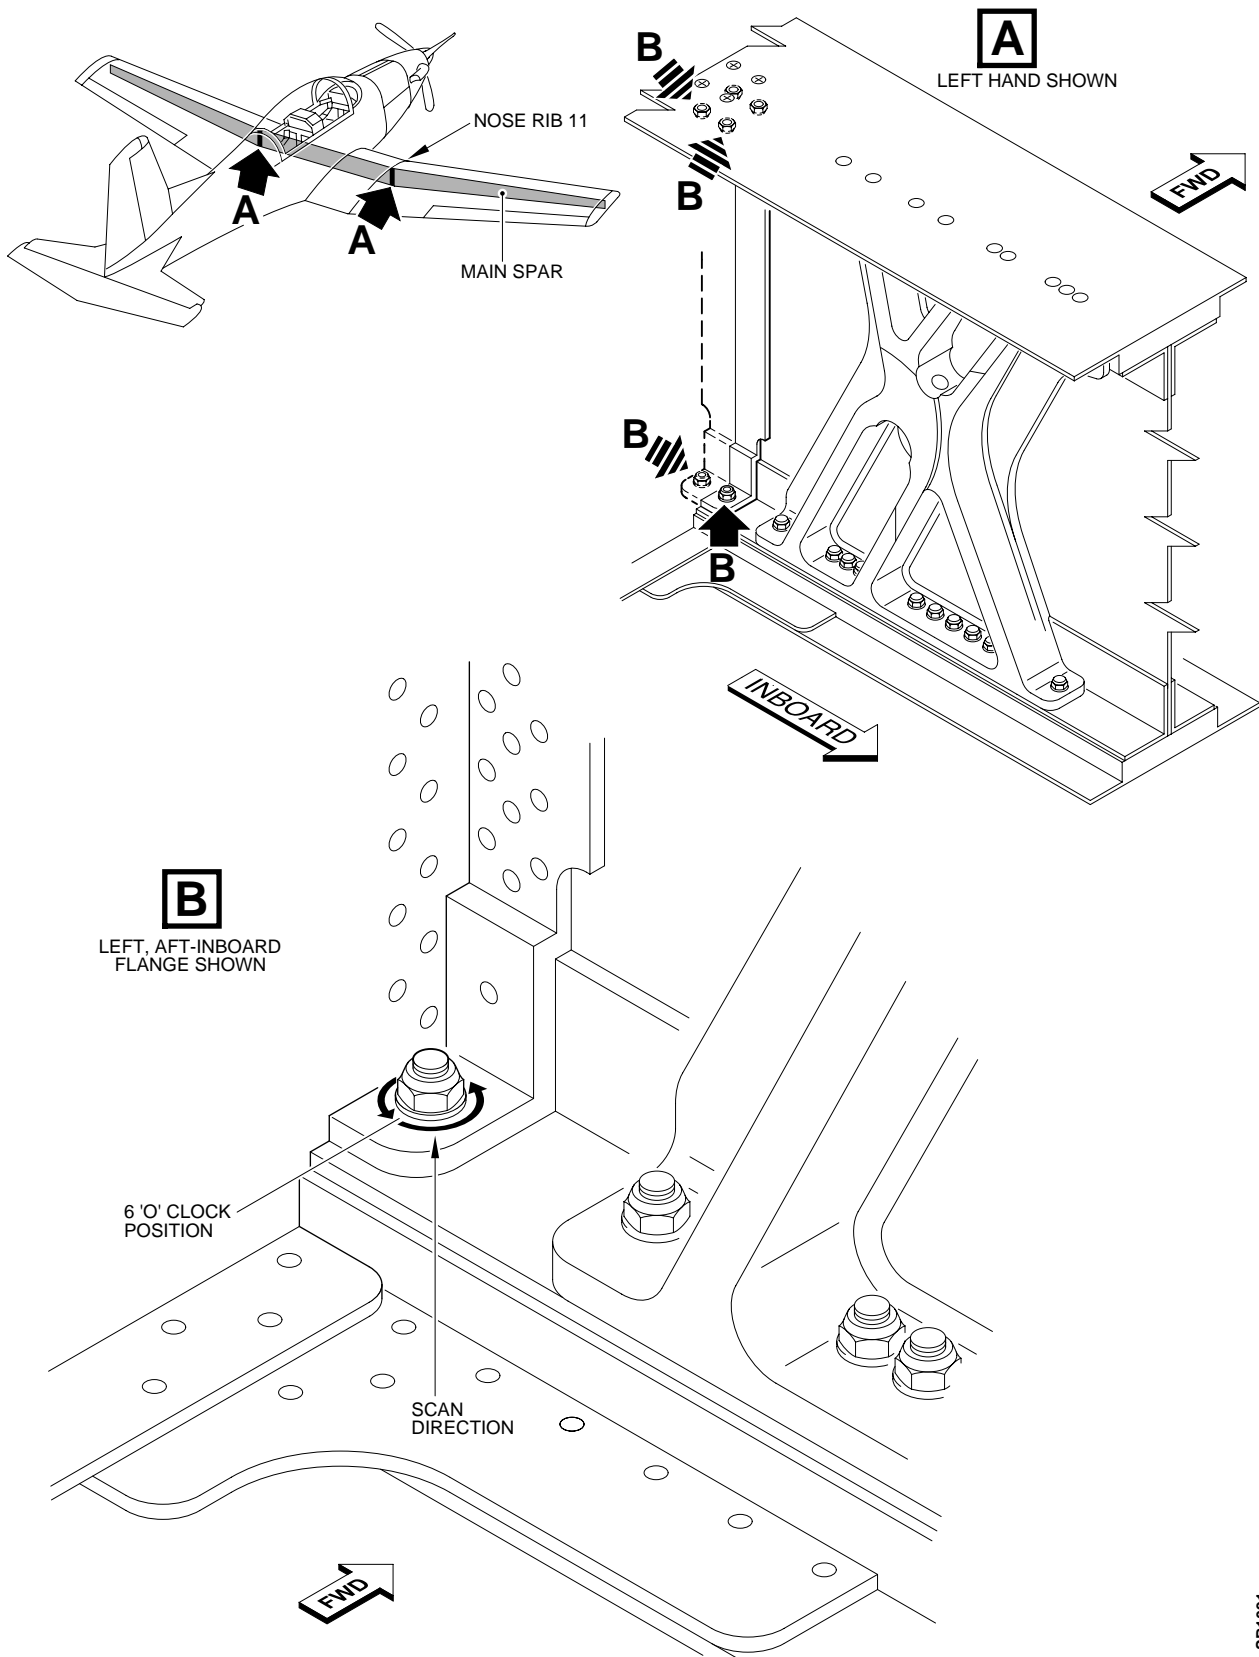
Eddy Current Inspection of the Wing Aft-Dihedral Fittings - Surface and Scan Path Data
 Figure 1

B. Eddy Current Inspection of the Aft Dihedral Fitting Flanges (8 Locations) (Ref. Fig. 1)

- (1) Calibrate the Eddy Current Instrument as follows:
 - (a) Initial gain 35 Db.
 - (b) Frequency 500 KHz.
 - (c) Alarm low OFF.
 - (d) Alarm high 50%.
 - (e) Probe selection Absolute.
- (2) Refer to the manufacturer's handbook and calibrate the instrument for an 80% upscale deflection from the 0.5 mm EDM slot of the calibration standard.
- (3) Put the probe on the inspection surface of the lower inboard flange of the left aft dihedral-fitting. Put the probe so that it touches the washer of the fastener at the 6 o'clock position (Ref. Fig 1, Detail B).
- (4) Do the balance procedure as given in the manufacturer's handbook.
- (5) From the 6 o'clock position, do a scan around the fastener of the bottom flange. Use the washer as guide. Defect indications will show as a fast upscale movement of the indicator.
- (6) Record the results of the inspection (Ref. Para. C).

- (7) Do Steps (3) thru (6) again for a scan of the:
- top inboard flange of the left aft dihedral-fitting
 - upper and lower outboard flanges of the left aft dihedral-fitting.
 - upper and lower, inboard and outboard flanges of the right aft dihedral-fitting.

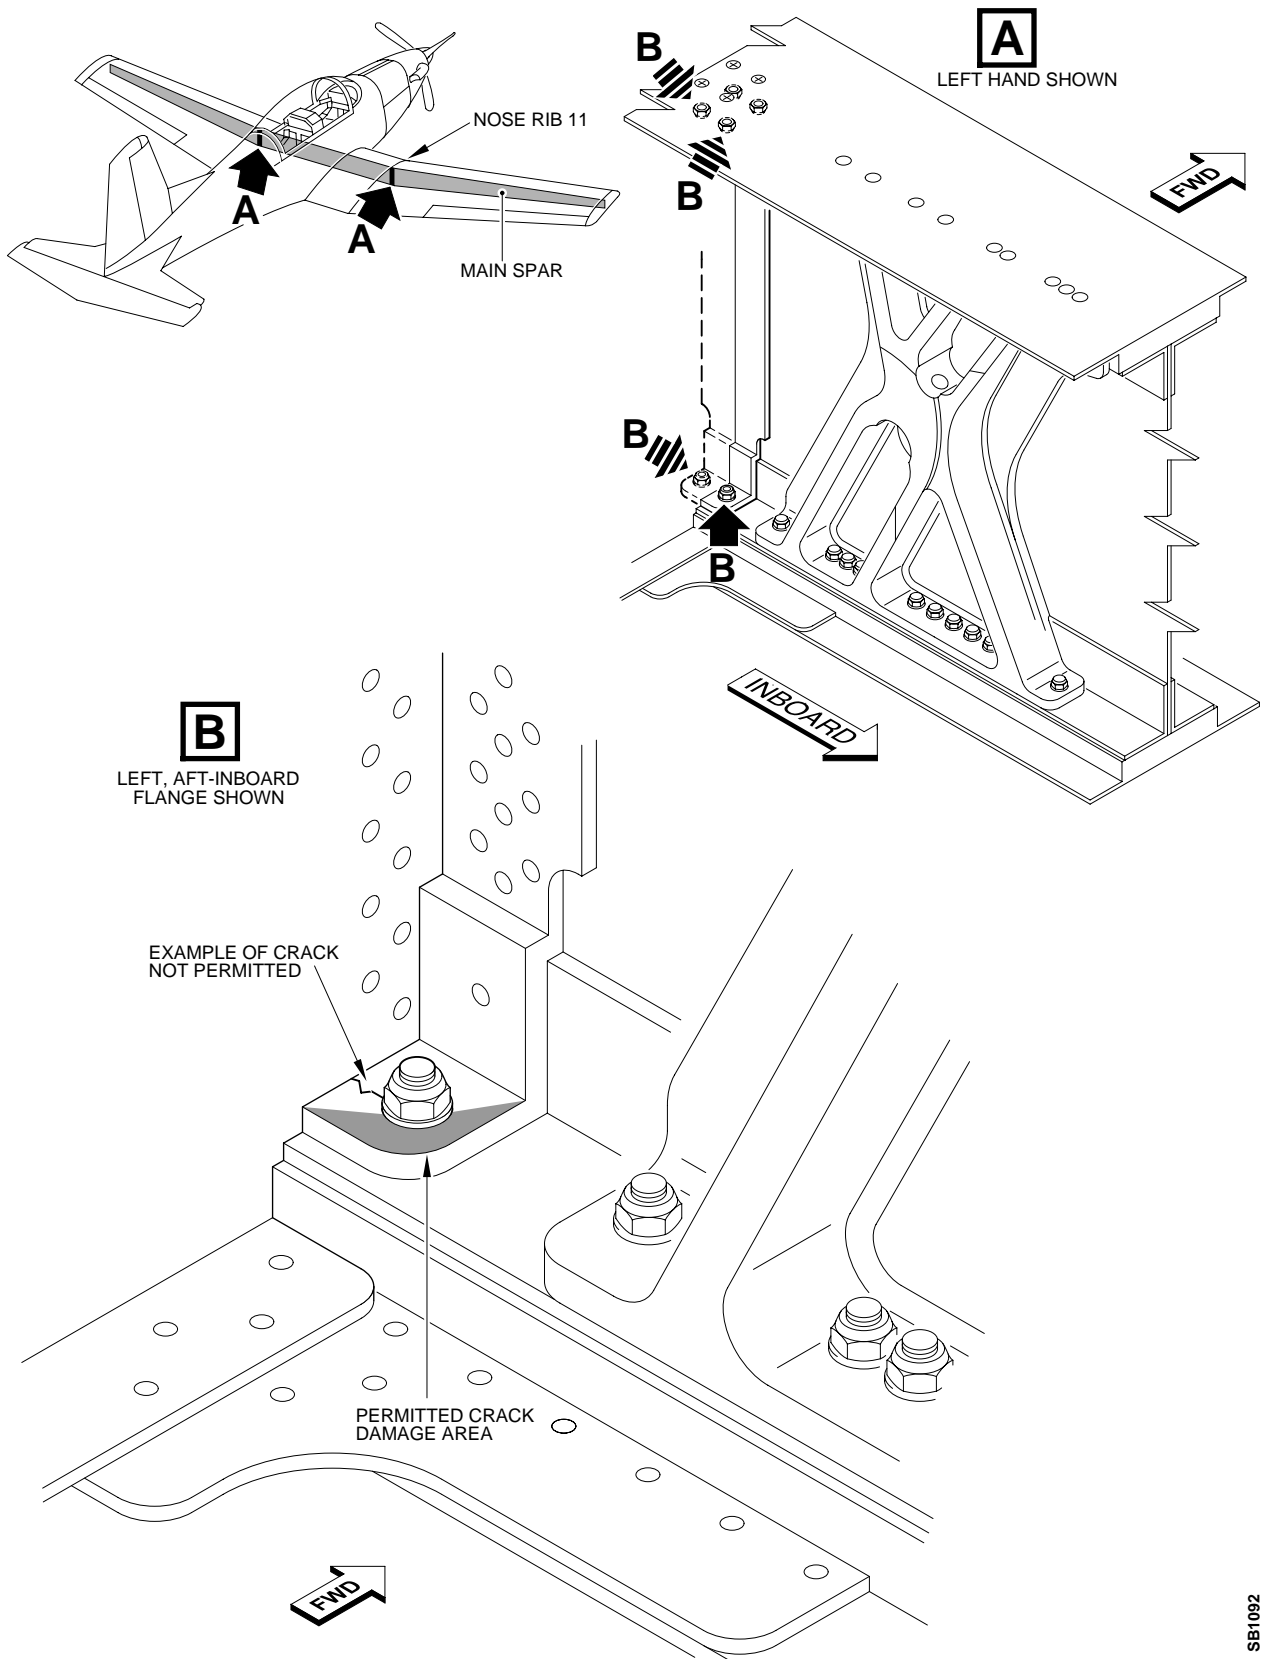
Eddy Current Inspection of the Wing Aft-Dihedral Fittings - Permitted Crack Damage Area
Figure 2

C. Defect Data for Eddy Current Inspection of the Aft Dihedral Flanges (Ref. Fig. 1 and 2)

- (1) A defect indication in a fitting that can be repeated and is not caused by edge effect or part geometry and is not in the permitted-crack-damage area is not permitted.

- (2) If the inspection shows no defects or defect(s) only in the permitted crack-damage area of the aft fittings:
- (a) Make an entry in the Aircraft Logbook that the brackets have had an Impedance-Plane Eddy-Current Inspection.
 - (b) Repeat inspections of the bolt holes are necessary (Ref. AMM 05-10-00, Page Block 1).
- (3) If the inspection shows no defects in all four bolt holes, the aft dihedral-fitting bolt-holes must be modified at the earliest servicing opportunity (Para. D). This modification will prevent the start of stress corrosion cracks. It is not necessary to do repeat inspections of the bolt holes after modification.
- (4) Use the Inspection Report Form (Figure 3) to tell the result of the inspection to PILATUS (Ref. Para.I).

Do not fly the aircraft until PILATUS has made an analysis of the results. PILATUS will make a decision on the repair, replacement or inspection frequency necessary for each aircraft.

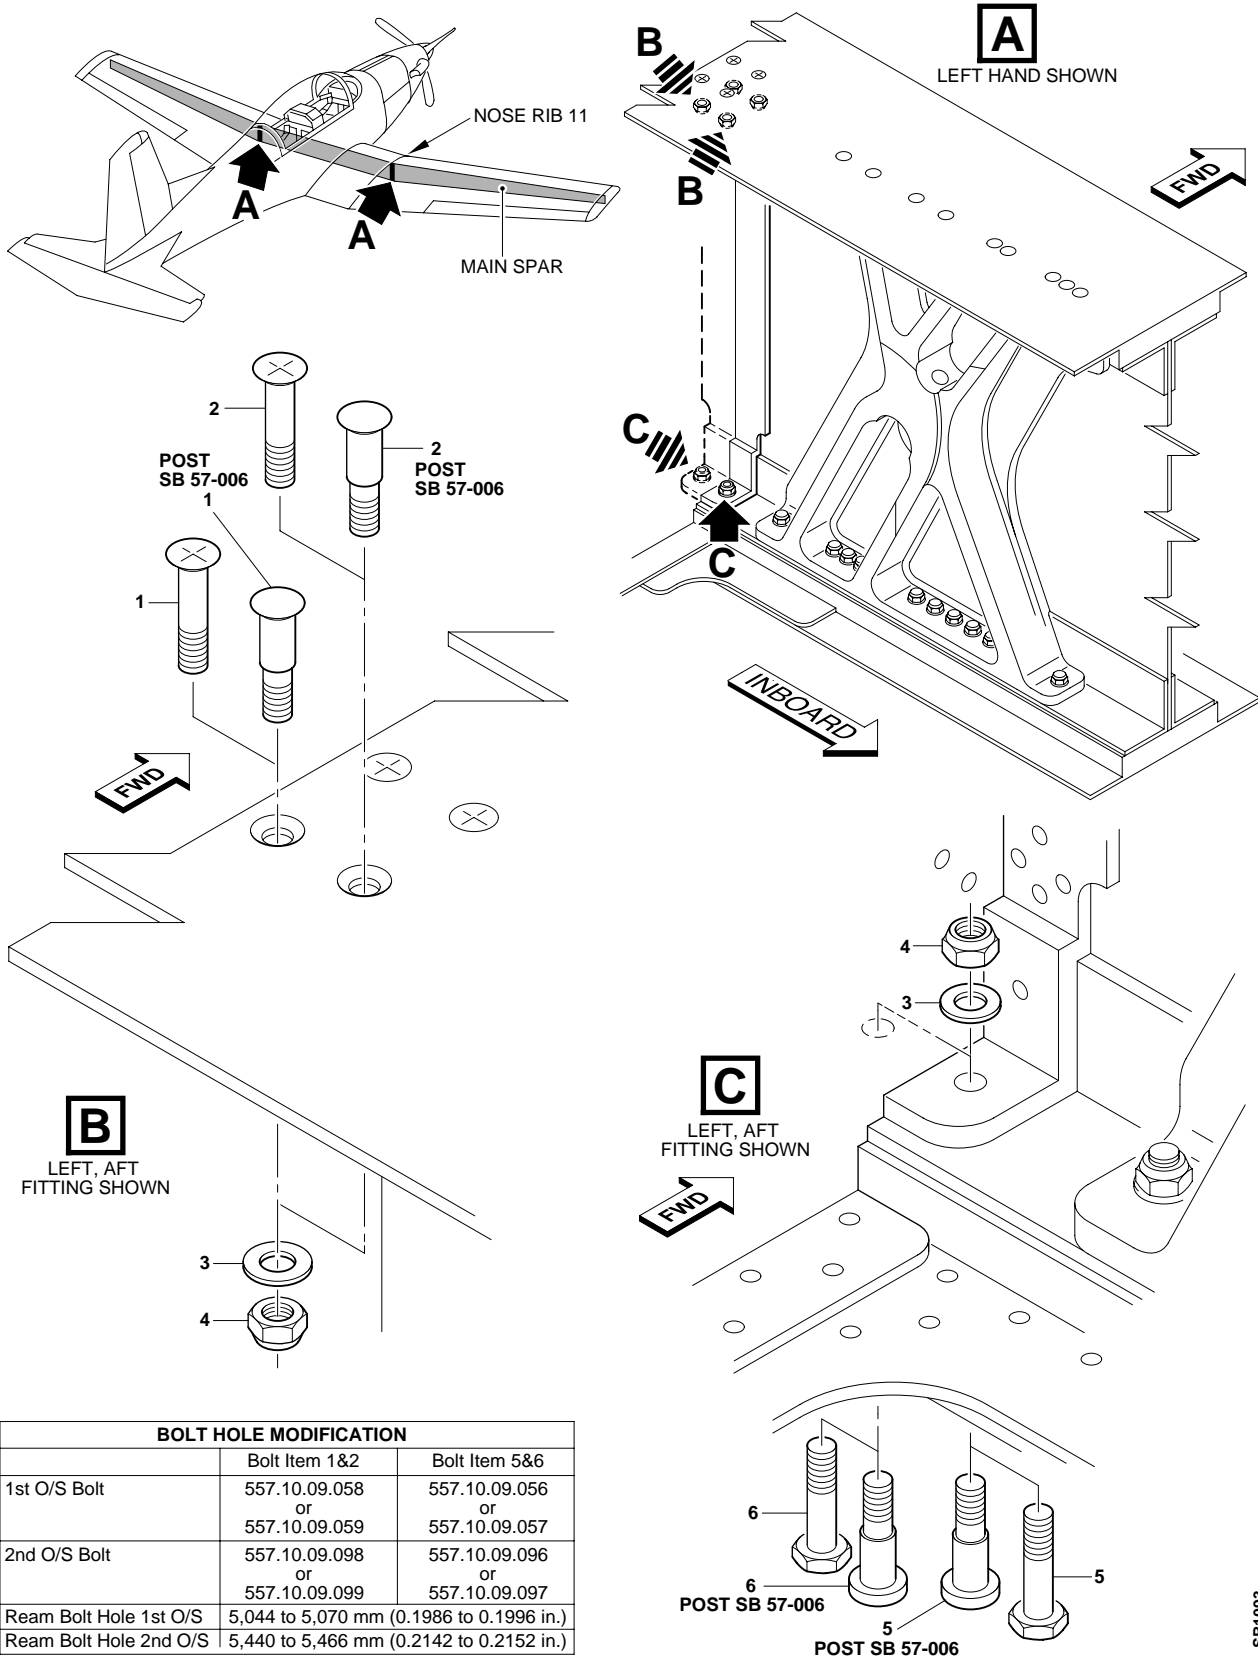
Aft Dihedral Fittings - Modification
Figure 5

D. Modification of the Aft Dihedral Fitting and Spar-Cap Bolt Holes (Ref. Fig. 5)

Only do this modification to aft dihedral fittings at locations which have no cracks in the flanges. The modification removes high remaining stress from around the bolt holes so that stress corrosion will not start.

This procedure is only applicable to a left and right aft-dihedral fitting in which all four bolt holes (two upper and two lower) have no cracks.

- (1) Remove and discard the nuts (4) and washers (3).

- (c) Use an applicable drift and carefully punch the bolts through the spar and the flange of the dihedral fitting.
- (4) Use the reamer (P/N: 513.57.09.086) to increase the diameter of the bolt holes to between 5,044 and 5,070 mm (0.1986 and 0.1996 in.).

- (7) Measure the grip length of the aft fitting lower-bolt-holes to find which replacement bolt to install
- (a) If the grip length is equal to or greater than 25,2 mm, use bolt P/N: 557.10.09.056.

- (b) If the grip length is less than 25,2 mm, use bolt is P/N: 557.10.09.057.
- (8) If the aft fitting lower-bolt-hole is damaged, install the next oversize bolt

- (11) Obey the manufacturer's instructions and apply corrosion preventative (Item No. P04-012) to the shanks of the new bolts (1), (2), (5) and (6).
- (12) Install the new bolts (1), (2), (5) and (6).

- (13) Install the new washers (3) and nuts (4). Torque the nuts (4) to between 4,0 and 5,0 Nm (35 to 45 lbf in.).
- (14) Clean unwanted sealant from the bolt head, nut and washer.

- (15) Repair the surface finish (clean, then apply primer and top coat) as necessary at the heads of the bolts (Ref. SRM, 51-10-02).
- (16) Apply Dinitrol AV 30 (Item No. P10-005C, liquid or spray) to the nuts (4) and washers (3) and to the upper and lower flanges of the aft dihedral fittings.

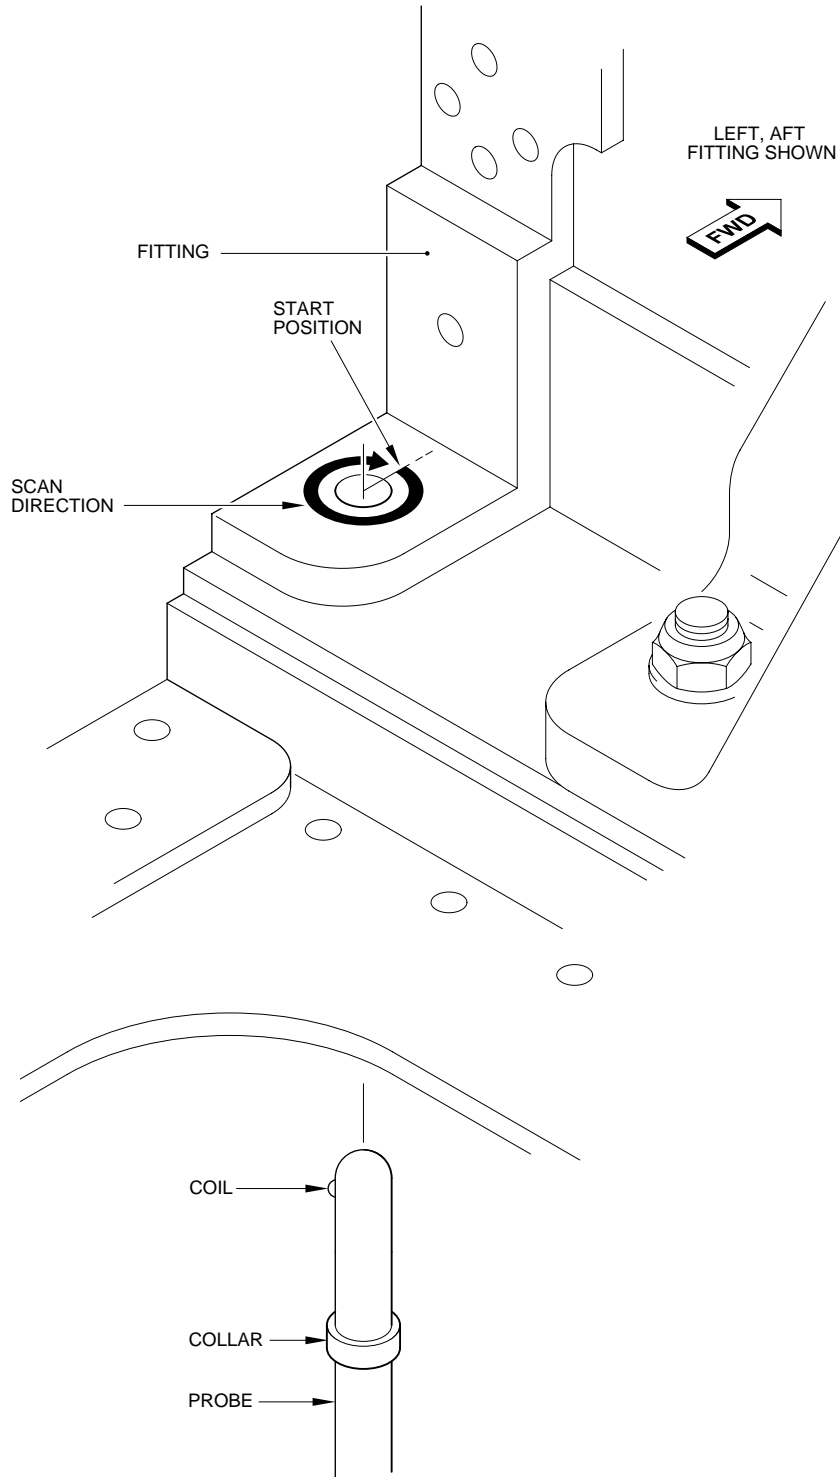
Eddy Current Inspection of the Wing Aft-Dihedral-Fitting Bolt-Holes - Scan Path Data
Figure 6

E. Eddy Current Inspection of the Aft-Dihedral-Fitting Bolt Holes (Ref. Fig. 6)

This procedure is applicable to the 4 bolt holes in each fitting, which were reamed out in Para. D.

- (3) Put the probe inside one of the holes in the aft flange of the dihedral fitting.
- (4) Point the coil of the probe forward. Push the probe slowly down the hole and monitor for defect indications. A defect indication will be given at each material interface.

- (10) Carefully turn the probe in the hole. Make sure the probe stays normal to the aircraft wing surface and do a scan around the bolt hole. Defect indications will show as a fast upscale movement of the indicator. Defect indications will normally be across the wing span.

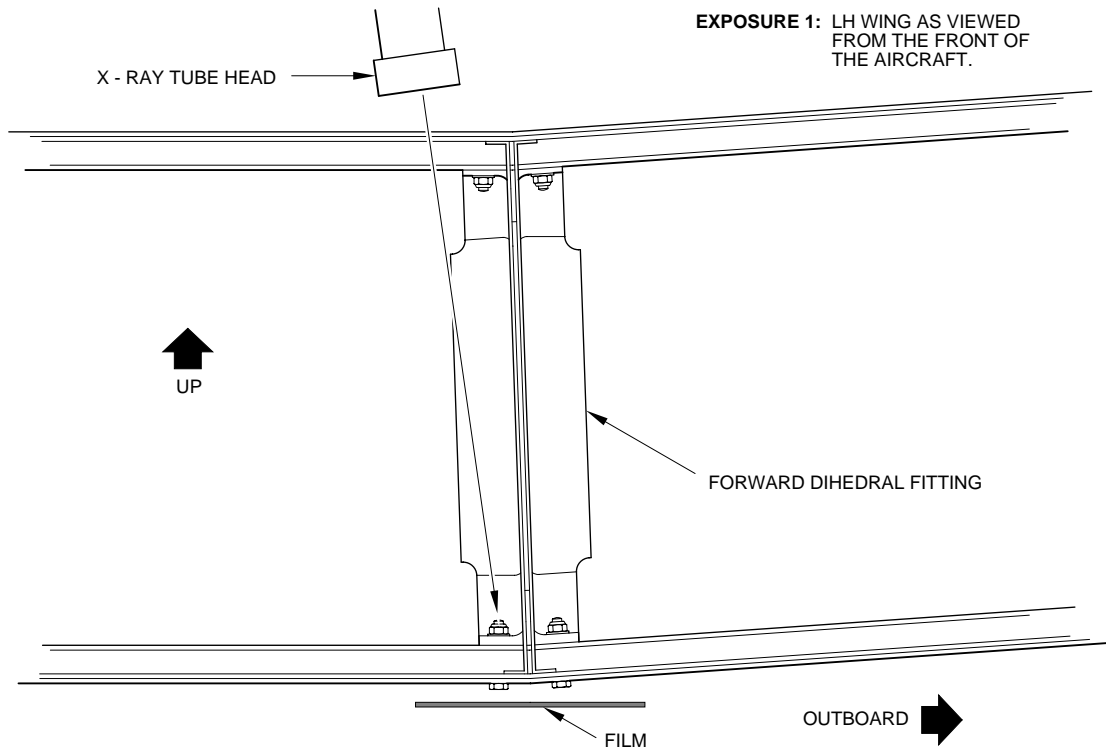
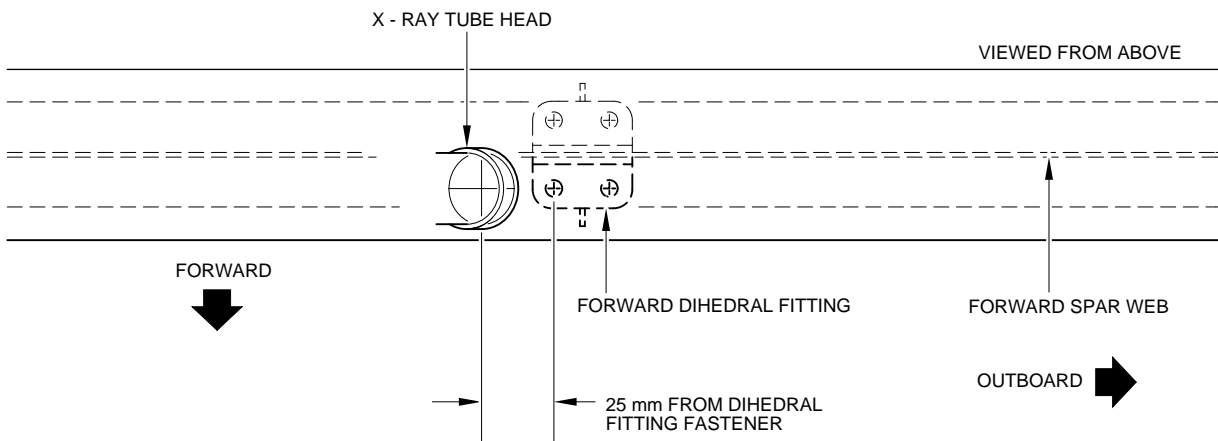
Forward dihedral Fitting - X-ray Inspection Areas and Beam Position
 Figure 7

G. Radiographic Inspection of the Forward Dihedral Fittings (Ref. Fig. 7)

- (1) Set the safety barriers around the aircraft (Refer to Manufacturers Instructions and local instructions).
- (2) Put the X-ray equipment in position on the aircraft. Align the X-ray tubehead against the wing, so that it is 25 mm from the forward-dihedral-bracket fastener in the direction of the span.
- (3) Make sure there are no personnel in the radiographic danger area.
- (4) Use the Exposure Table 1 to expose the films, to get a density of between 1.5 and 2.5 adjacent to the fastener to be inspected.
