PILATUS AIRCRAFT LTD. STANS, SWITZERLAND

PC-7

FILATUS AIRCRAFT LTD. STANS, S	WIZERLAND		-
Service Bulletin No:	21-012	Ref No:	165
Modification No:	EC-14-0359	ATA Chapter:	21

AIR CONDITIONING - COOLING INSTALL A COVER ASSEMBLY TO THE COMPRESSOR TO PROTECT TO THE ENGINE OIL HOSE

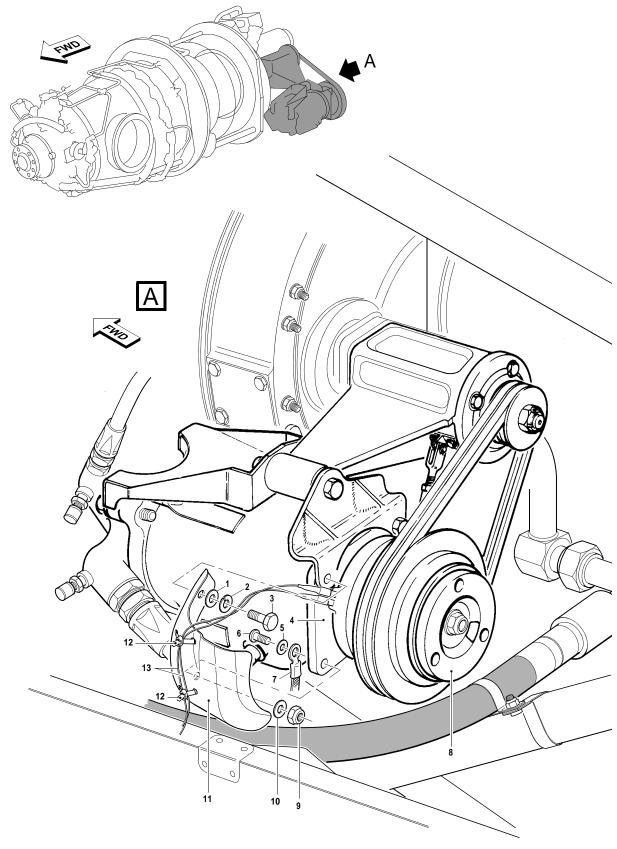
Installation of the Cover Assy Figure 1

On PC-7 aircraft that are pre Service Bulletin 21-006, the oil cooler inlet-hose is routed close to the air conditioning compressor clutch plate. If a spring on the compressor clutch plate shears, the oil hose can become damaged and the engine oil can spill into the engine bay.

- **NOTE:** On Pre Service Bulletin installations, the ground lead (7) is installed on the aft face of the plate (4) (opposite to that shown in Figure 1). The washer (5) is not installed.

NOTE: On Post Service Bulletin installations, the ground lead (7) is installed on the forward face of the plate (4) (as shown in Figure 1).

Install a cover assy which will be mounted on the attachment points of the compressor. This will provide a barrier between the compressor clutch plate and the oil hose. The shield can be mounted on the compressor support bracket with the current bolts.

B. Installation of the Cover Assy (Ref. Fig. 1)

- (1) Remove, and keep, the bolt (3), the spring washer (2) and, if installed, the washer (1).
- (2) Remove, and keep, the nut (9), the washer (10), the ground lead (7) and the screw (6).

- (3) Prepare the plate (4) for the new position of the ground lead (7):
 - (a) Make a circular mark on the forward face of the plate around the lower attachment hole, approximately 10 mm from the edge of the hole.

- (b) Use the abrasive cloth (Material No. P02-013 and P02-014) to remove the paint and primer to get bare metal in the area you marked.
 - (c) Clean the bare metal area with the solvent (Material No. P01-010) and absorbent paper (Material No. P02-031).

- (d) Apply layers of the Alodine 1132 (Material No. P07-021) on the bare metal area and allow to dry.
- (4) Put the cable ties (12) through the holes in the cover assy (11) (P/N 521.50.07.022).

- (5) Put the cover assy (11) (P/N 521.50.07.022) in position on the aft face of the plate (4) and around the pulleys (8).
- (6) Put the spring washer (2) and, if necessary, the new washer (1) (P/N 938.75.11.311) on the bolt (3).

- (7) Loosely install the bolt (3), complete with the spring washer (2) and the washer (1).
- (8) Put the ground lead (7) and the washer (5) (P/N 938.77.11.110) on the screw (6).

- (9) Install the screw (6), complete with the ground lead (7) and the washer (5) (P/N 938.77.11.110), the washer (10) and the nut (9).
- (10) Tighten the bolt (3).
- (11) Make sure there is no interference between the pulleys (8) and the new cover assy (11) (P/N 521.50.07.022).
- (12) Use the cable ties (12) to attach the cables (13) to the cover assy (11) (P/N 521.50.07.022).
- (13) Apply a layer of Dinitrol AV40 (Material No. P10-013) to completely cover:
 - The screw (6)
 - The washer (5) (P/N 938.77.11.110)
 - The ground lead (7)
 - The bare metal of the plate (4)
 - The washer (10)
 - The nut (9).
