SERVICE BULLETIN NO: 53-006

53

FUSELAGE

ENGINE MOUNTING-FRAME ATTACHMENT-FITTINGS - INSPECTION

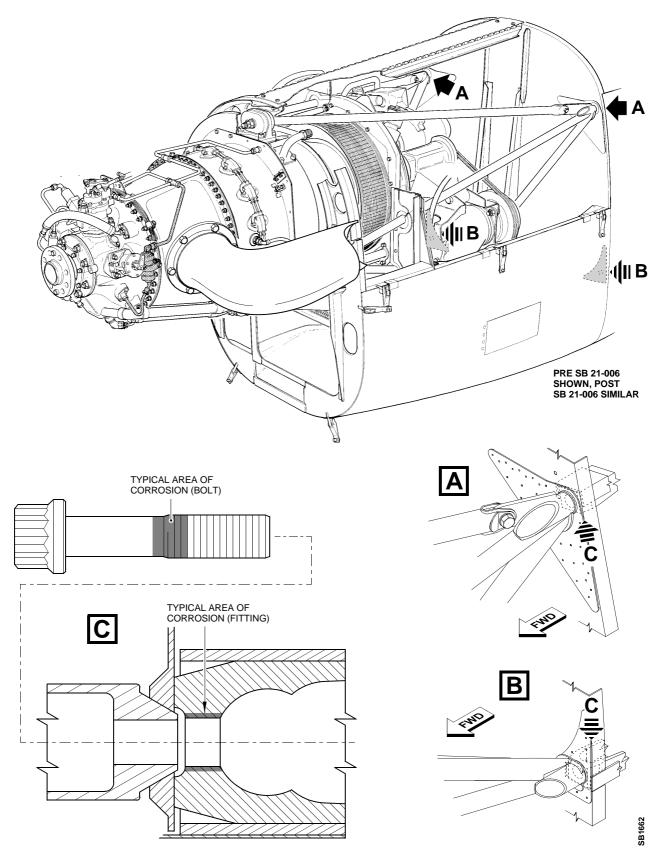
Engine Mount Attachment Fittings - Inspection/Repair Figure 1

Corrosion has been found on the bolts and in the bores of the attachment fittings for the engine mounting frame.

Damage to the cadmium plating of the bolt, or to the surface finish of the attachment fitting, can cause corrosion. The damage is caused when the bolts are removed and installed.

- NOTE: It is not necessary to remove the barrel nut to do the inspection.
- (1) Remove the bolt and washer from one of the four engine mounting-frame attachment points (Ref. AMM 71-20-01, Page Block 401).

- (2) Do a visual inspection for corrosion on the removed bolt.
- (3) Do a visual inspection for corrosion in the bore of the attachment fitting. Do this with a boroscope. If you find corrosion, do the subsequent steps:

- (a) Use aluminum wool (Material No. P02-002) to remove surface corrosion.
 - (b) If you cannot remove all of the corrosion contact Pilatus for repair information.

- (c) Clean the bore and the threads of the barrel nut with solvent (Material No. P01-008) and absorbent paper (Material No. P02-031).
 - (d) Remove all swarf and debris from the attachment fitting. If necessary, you must remove the barrel nut and/or the engine mounting frame to do this. Make sure there is no swarf and debris in the joints between:

- The attachment fitting and the barrel nut
 - The attachment fitting and the engine mounting frame.
 - (e) Apply a layer of CCC solution (Material No. P07-001) to the bore.

- (f) If necessary, install the barrel nut and/or the engine mounting frame.
- (4) Install the new bolt (P/N 115.45.07.047) and the washer (P/N 938.75.11.104) (Ref. AMM 71-20-01, Page Block 401).
