**Service Bulletin No:** 53-007  
**Modification No:** EC-09-0734

**FUSELAGE - GENERAL  
INSPECTION OF THE FORWARD ELECTRICAL BONDING POINTS**

PC-7 aircraft MSN 101 thru MSN 618.

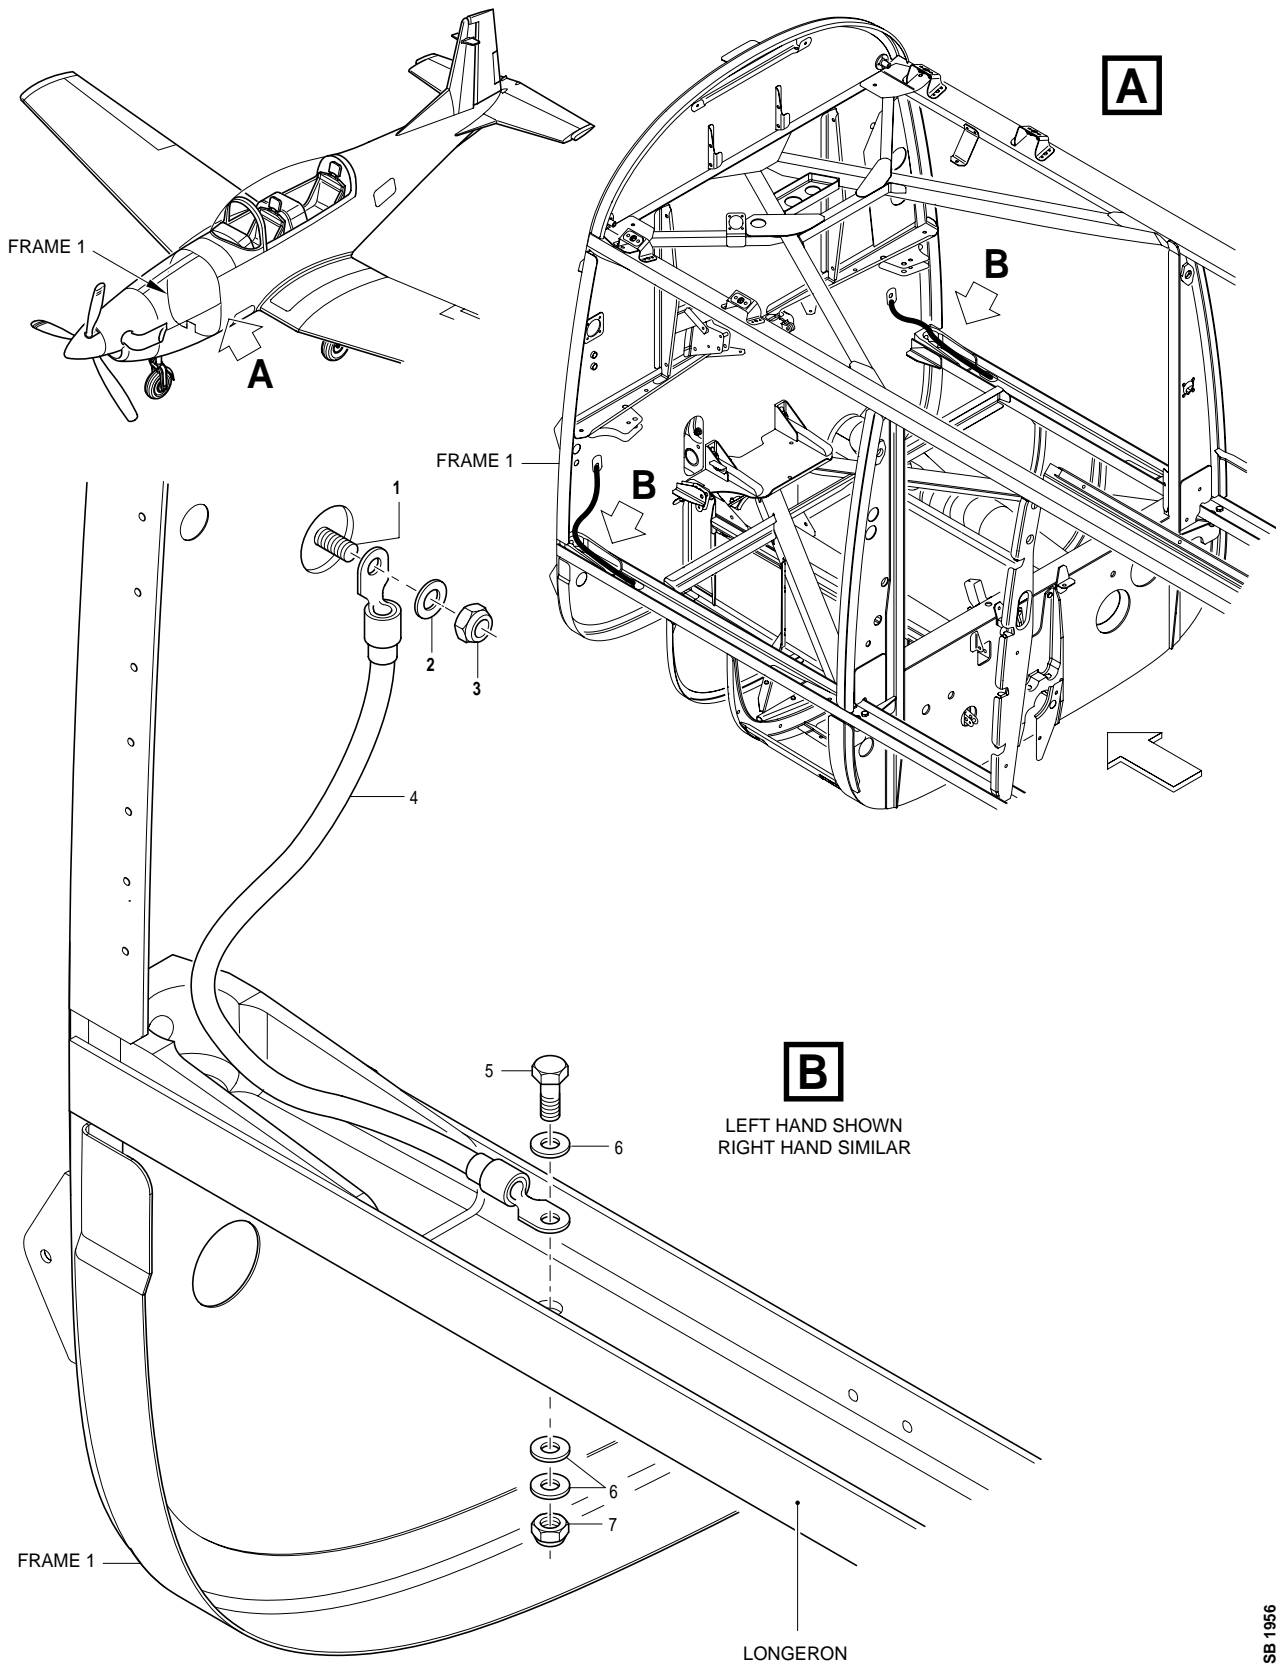
Bonding Strap - Removal/Installation  
Figure 1

Corrosion has been reported at the bonding strap connections on the left and right lower longerons between fuselage frames 1 and 1A.

The contact faces of the longeron and bonding strap are susceptible to corrosion. The possibility of corrosion is increased because of the high electrical current flow between the tinned copper terminal lug of the bonding strap and the aluminum longeron.

(b) Do a visual inspection for corrosion in the bore of the bolt hole and the area around the bolt hole. If necessary, use a borescope to do this.

(c) If you find corrosion, do the Repair (Ref. Para. D.).

- (3) If you found corrosion on the surface of the longeron:
- (a) Use abrasive cloth (Material No. P02-009) to remove the corrosion.
  - (b) Use abrasive cloth (Material No. P02-011) to make the area smooth.

- (b) If you did not enlarge the bolt hole or discard corroded parts:
- 1 Connect the bonding strap (4) to the longeron with the bolt (5) the washers (6) and the nut (7).

- (d) Measure the run-down torque of the nut (7).
  - (e) Torque tighten the nut (7) to the measured run-down torque plus between 11 and 16 Nm (100 and 140 lb in.).
- (2) If you install a new bonding strap (4):
