SERVICE BULLETIN

SERVICE BULLETIN NO: 28-004

FUEL - DISTRIBUTION ENGINE DRIVEN PUMP - TORQUE CHECK OF RELIEF-VALVE-BODY SCREWS

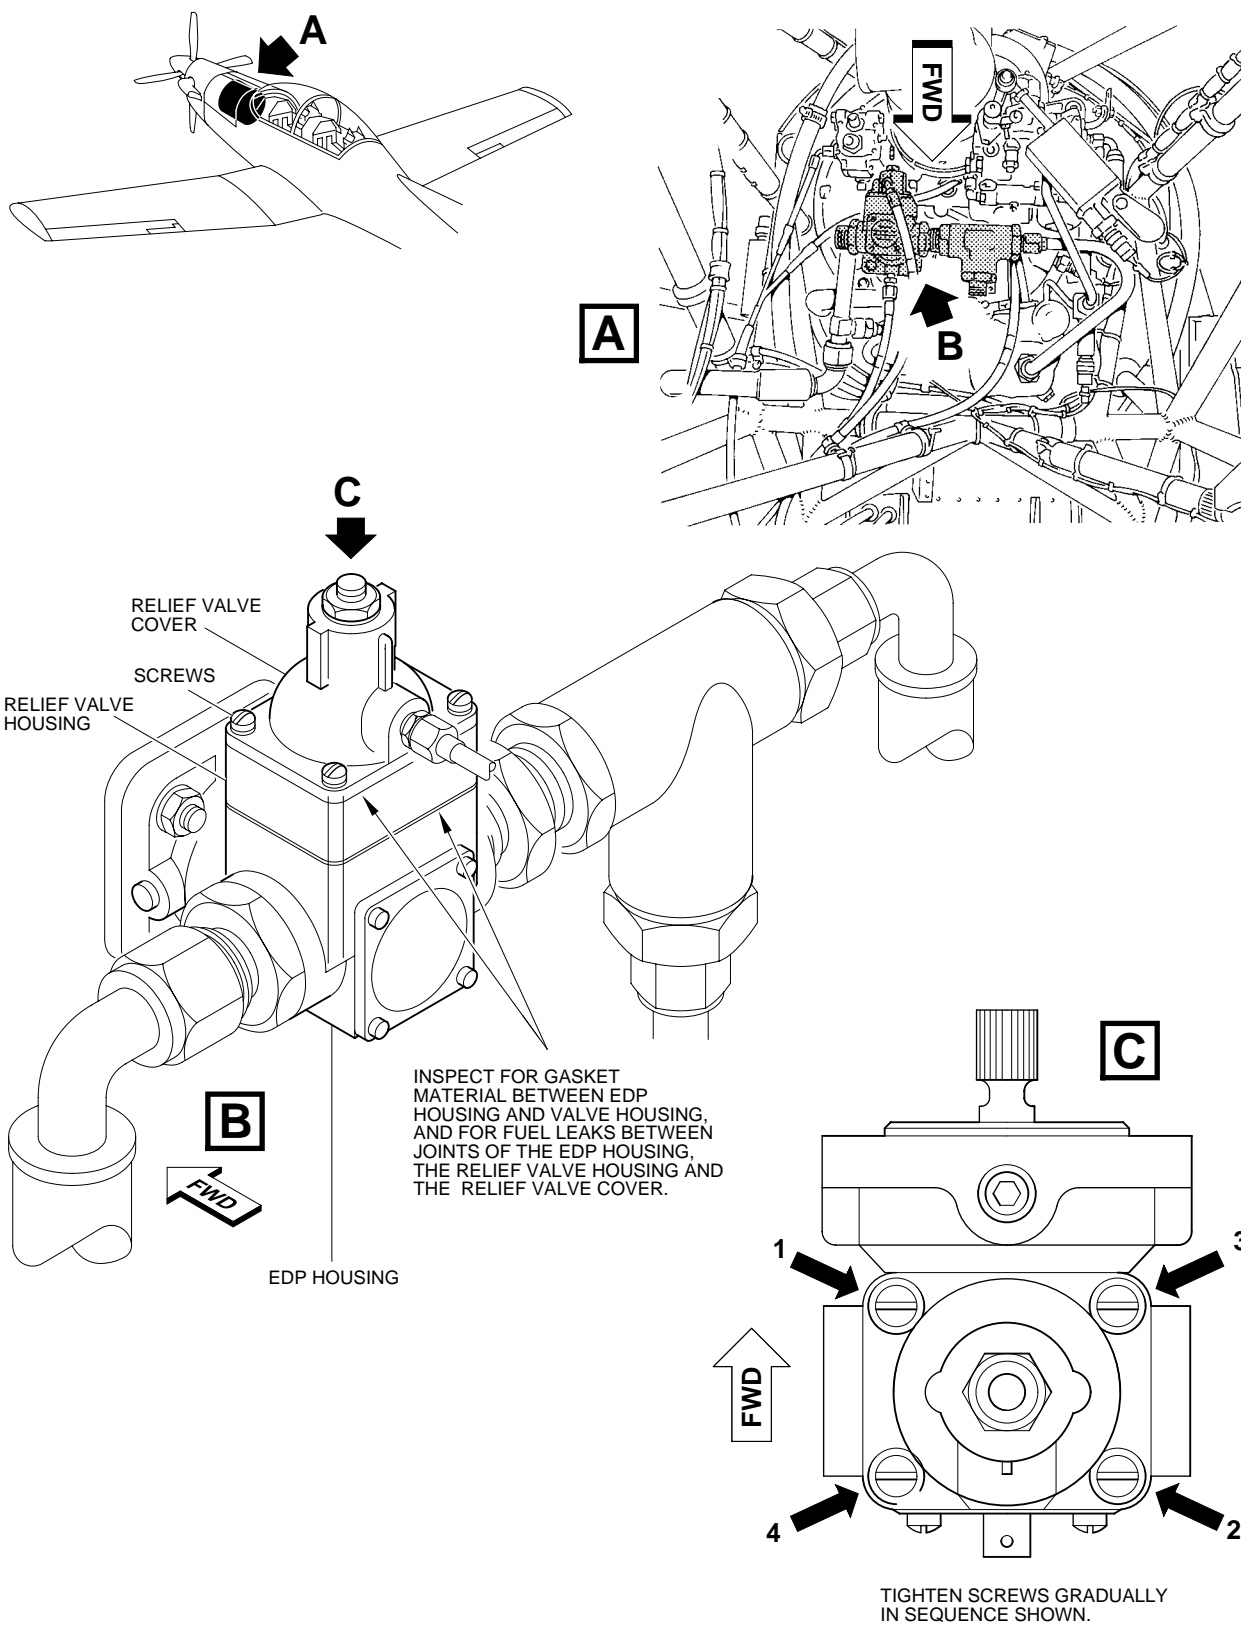
Torque Check and Fuel Leak Inspection of the EDP
Figure 1

Fuel leakage through the gasket of the EDP relief valve.

It is possible the torque of the screws that attach the EDP relief-valve cover to the relief valve housing is not correct. It is also possible that the gasket between the EDP relief-valve housing and the EDP housing has been pushed out.

- (1) Visually inspect the joints between the EDP housing, relief valve housing and the relief valve cover for:

- Fuel leakage
- Gasket material pushed out

- (2) If the EDP shows signs of fuel leakage or the gasket between the EDP housing and the relief valve housing has been pushed out, replace the EDP (Ref. AMM, 28-20-10, Page Block 401).

- (3) Use a torque screwdriver to do a check of the torque value of the relief-valve-cover screws. Do the check clockwise only. The minimum torque must be 23 lbf in. (2,6 Nm).

- (5) If the relief-valve-cover screws are loose, or the torque found at Step (3) is less than 23 lbf in. (2,6 Nm), do as follows:

- (b) Torque the screws gradually to between 23 and 25 lbf in. (2,6 and 2,83 Nm). Do this in the sequence shown in Figure 1, Detail B.

- (c) Safety the screws with lockwire (Material Item P02-001).
