SERVICE BULLETIN NO: 53-005

ATA CHAPTER: 53

## FUSELAGE - FUSELAGE STRUCTURE INSPECTION FOR CORROSION IN FRAMES 3C AND REPLACEMENT OF WING ATTACHMENT BOLTS

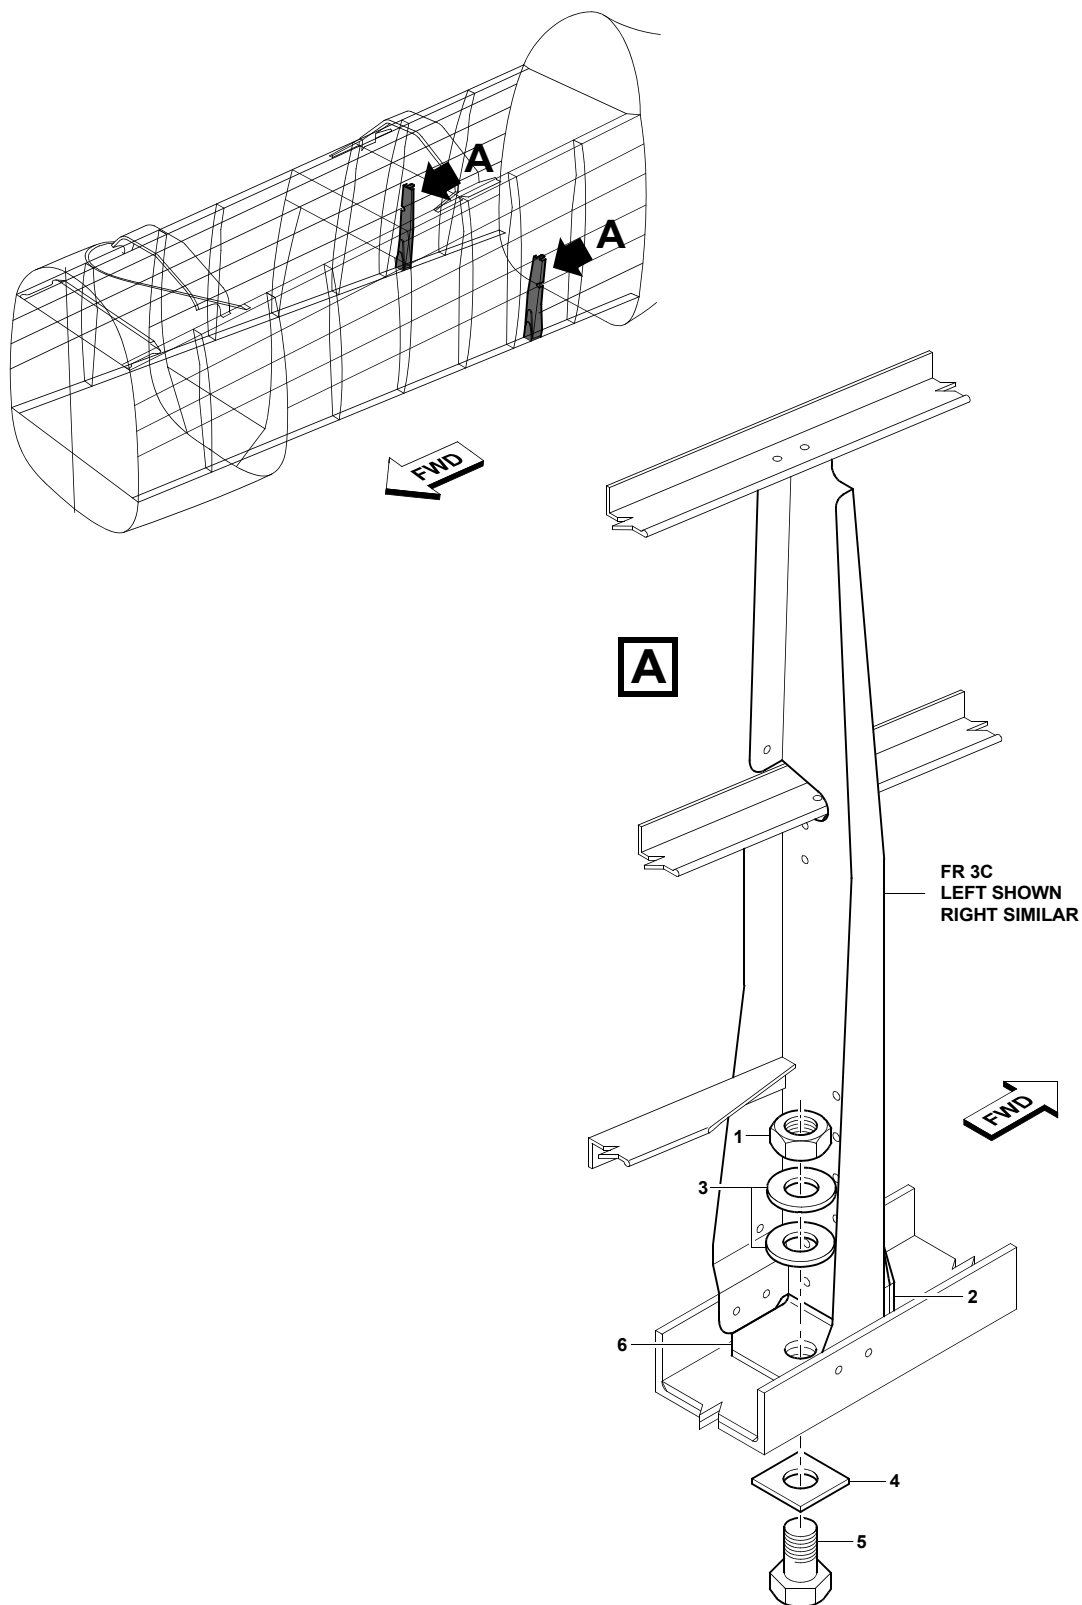
FR 3C Assembly - Inspection and Replacement of Bolt Assembly  
Figure 1

Corrosion has occurred in the pick-up brackets (brackets) (553.20.09.039) of Frame (FR) 3C in some aircraft. The brackets connect FRs 3C to the bottom, left and right longerons. They are also the locations for the wing bolts (bolts) (932.19.60.337).

Electrolytic action between the dissimilar metals of the bolts (932.19.60.337) and the brackets (553.20.09.039) has caused the corrosion.

Corrosion is not permitted in the bolt holes. Surface corrosion on the bracket, shear plate or FR 3C assembly is permitted if in limits (Ref. SRM, 53-20-00, Page Block 101). All other types of corrosion in the bracket, shear plate, FR 3C or the adjacent structure is not permitted. You must:

- (1) Remove and discard the left nut (1), washers (3) & (4) and bolt (5).
- (2) Obey the manufacturers instructions and use the solvent (Material Item No. P01-008 or approved alternative) to clean the surfaces of hole for the bolt (1).
- (3) Use a source of bright light and a X 10 magnifier to do an inspection for signs of corrosion:
  - In the hole for the bolt (1)
  - On the bracket (6), shear plate (2), FR 3C and the adjacent structure.

- Remove surface corrosion (Ref. Step 4)
  - Replace the bracket, shear plate and FR 3C assembly together if you find corrosion in one or more of them (Ref. SRM, 53-20-00, Page Block 201):
  - Apply to PILATUS for instructions if you find corrosion in the skin or structure adjacent to FR 3C.
- (4) If necessary remove the surface corrosion (Ref. SRM, 51-10-02, Page Block 1). You must replace the bracket, shear plate and FR 3C assembly (together) if it is not possible to remove the surface corrosion and stay in limits.
  - (5) Obey the manufacturers instructions and apply layers of the corrosion preventative (Material Item No. P04-012) on the faying surfaces of the new bolt (5), washers (3) & (4) and the bolt hole.
  - (6) Assemble the bolt (5) and washer (4), put the bolt in position and install the washers (3) and nut (1).

- (7) Torque the nut (1) to between 26 and 28 Nm (230 to 248 lbf in.).
- (8) Obey the manufacturers instructions and use the solvent (Material Item No. P01-008 or approved alternative) to remove unwanted corrosion preventative.
- (9) Apply layers of the corrosion preventative (Material Item No. P10-015) on the FR 3C assembly and adjacent skin and structure.
- (10) Do Steps (1) thru (9) again to:
  - Do an inspection for corrosion in the right bolt hole, bracket (5), shear plate (6), FR 3C and the adjacent structure.
  - Replace the right bolt assembly
