SERVICE BULLETIN NO: 55-002

STABILIZERS - HORIZONTAL STABILIZER ELEVATOR - INSPECTION AND REPAIR TO PREVENT SKIN DISTORTION

PILATUS
MODULAR TRAINER
SERVICE BULLETIN

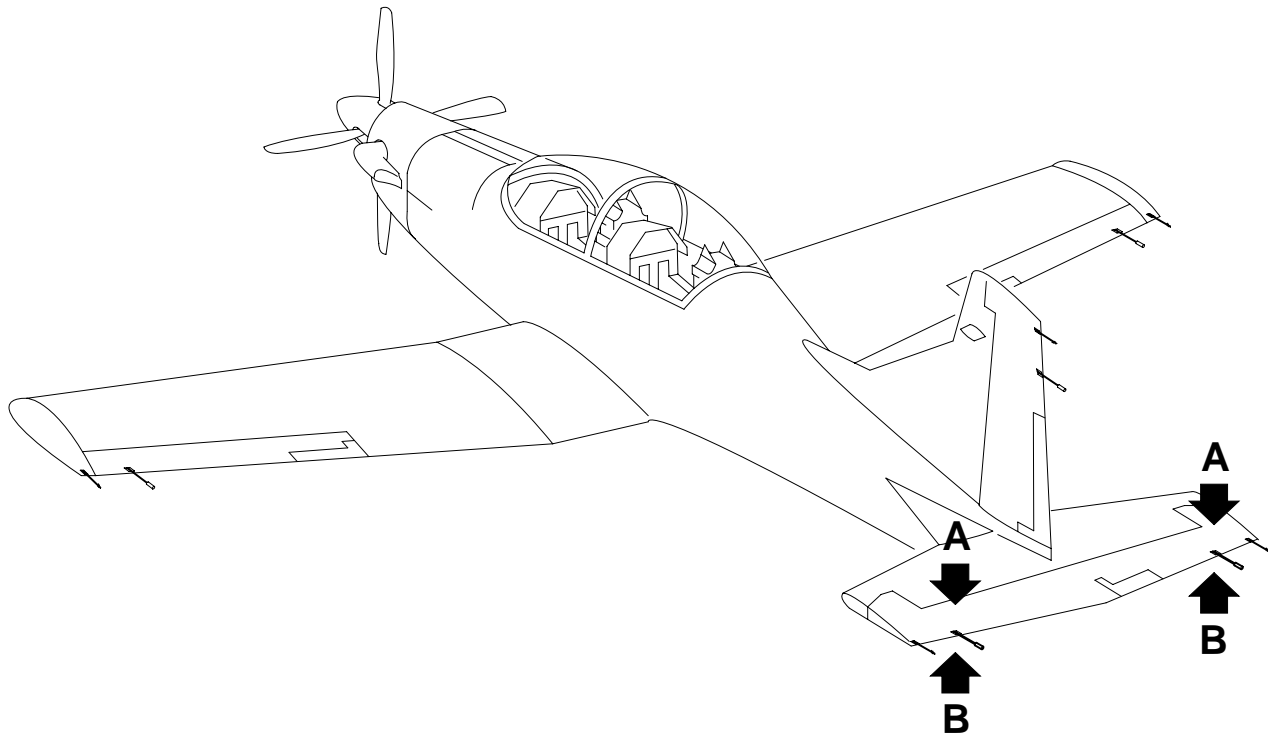
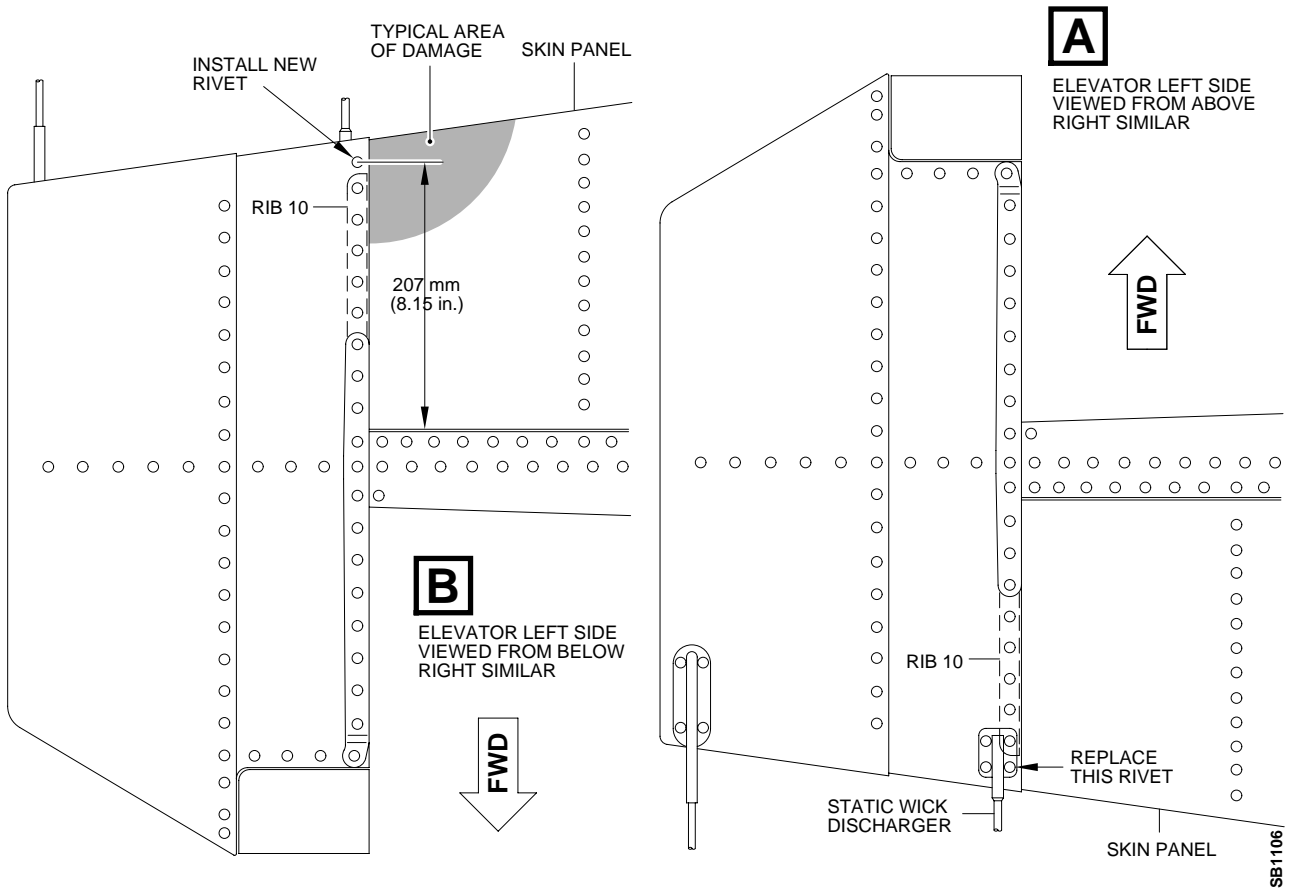
Elevator - Inspection and Repair
Figure 1

It is possible for damage to occur in the bottom skin panels of the elevator during some flight conditions. The areas at risk of damage are adjacent to the trailing edges, immediately inboard of left and right rib 10.

There are no fasteners (rivets) to hold the skin panels in the areas between the last rivets at the rear ends of ribs 10 and the trailing edges of elevator. Thus, during unusually high aerodynamic loads, unwanted movement and separation of the skin from the internal structure can occur.

- (1) Do an inspection of the elevator for signs of buckling and crack damage in the bottom skin panels. Do this in the areas immediately inboard of the left and right ribs 10 and adjacent to the trailing edge.
- (2) Do an inspection of the elevator trailing edges for signs of distortion and crack damage.
- (3) Replace the elevator assembly if you find buckling, distortion or crack damage in the inspection areas (Ref. AMM, 27-30-01, Page Block 401). Send the unserviceable elevator to PILATUS for repair.

- (1) Make marks to show the new rivet locations on the bottom skin panels.
 - (a) Make a mark to show the centerline of the rivets which attach the bottom skin panel to the left rib 10. Make sure the centerline continues to the trailing edge.
 - (b) Make a mark to show an intersection of the rivet centerline at 207 mm (8.15 in.) from the front edge of the skin panel. The intersection of the marks shows the location of the rivet.
 - (c) Do Steps (a) and (b) again to show the new rivet location on the right side of the elevator.
- (2) Use a 3.2 mm (1/8 in.) diameter drill to remove the rear, inboard rivets from the bases of the static wick dischargers. These are on the top surface of the elevator at the rear of the left and right ribs 10.

- (3) Install the rivets in the bottom skin panels.
 - (a) Use a 2.5 mm (3/32 in.) and a 3.3 mm (1/8 in.(clearance)) diameter drills in sequence to make the rivet hole at the intersection of the marks on the left skin panel.
 - (b) De-burr the rivet hole.
