PILATUS AIRCRAFT LTD. STANS, SWITZERLAND

SERVICE BULLETIN

PC-9 M

AIRCRAFT STRUCTURE - GENERAL DO A CHECK OF THE MATERIAL SPECIFICATION USED DURING MANUFACTURE AND, IF NECESSARY, DO A CHECK FOR CRACKS OR REPLACE THE PART

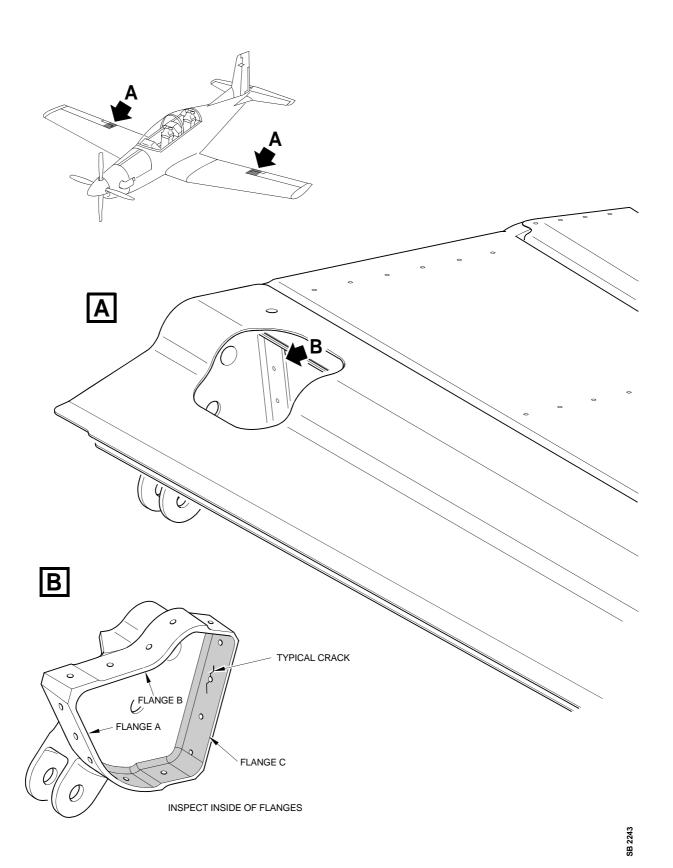
Nose Rib 1 - Inspection (If Necessary) Figure 3

- 2 Use a bright light source and a mirror to examine the inspection areas of the left-aileron nose-rib 1 for cracks.
- 3 If you find cracks:
 - You must contact Pilatus Customer Support before next flight. The address is:

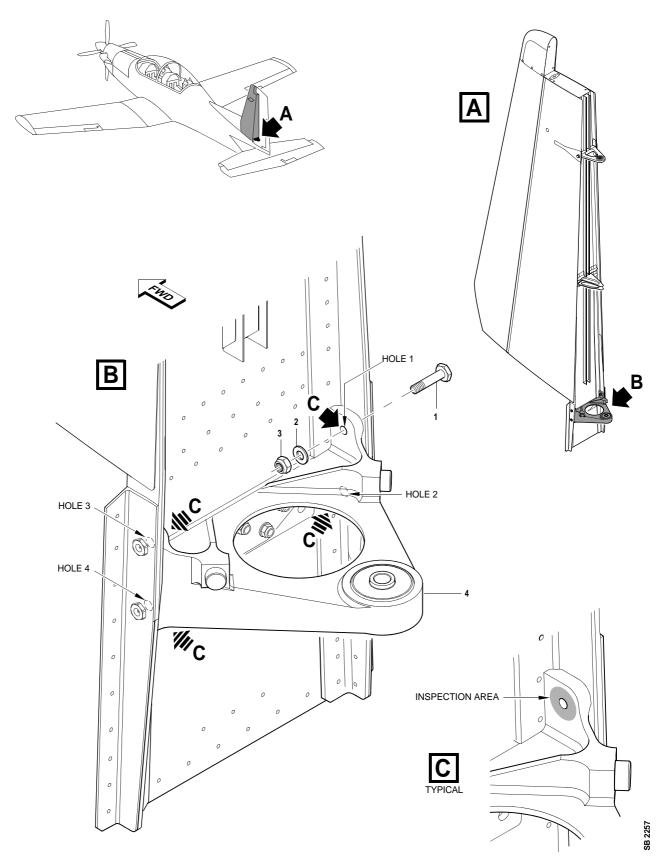
Lower Rudder Bracket - Inspection (If Necessary) Figure 5

(d) Do an eddy-current Non-Destructive-Inspection (NDI) for cracks (Ref. Fig. 5):

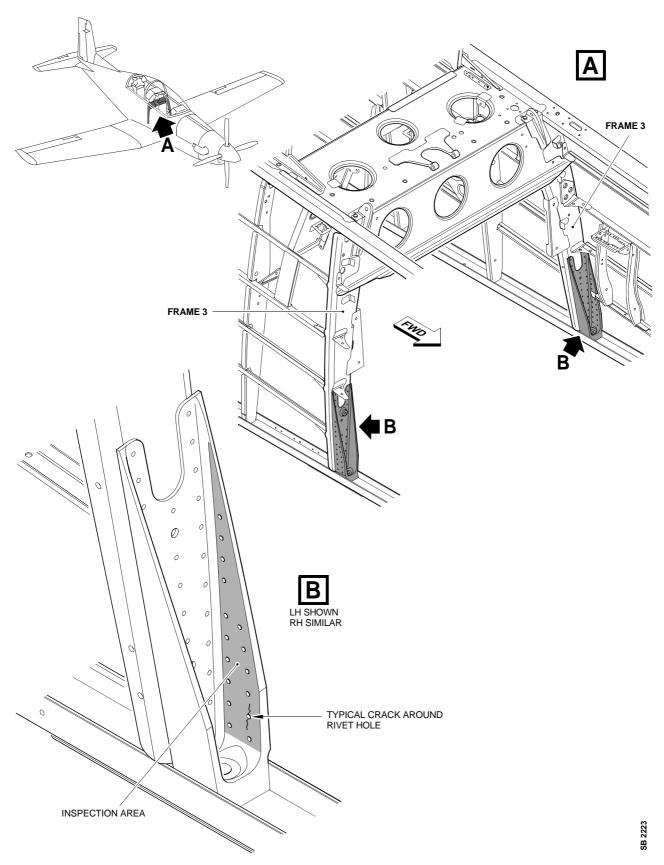
Frame 3 Pick-Up Brackets - Inspection (If Necessary) Figure 7

- Obey the manufacturer's instructions and use a boroscope to examine the inspection areas of the left frame 3 pick-up bracket for cracks.
- 3 If you find cracks:
 - <u>a</u> You must contact Pilatus Customer Support before next flight. The address is:

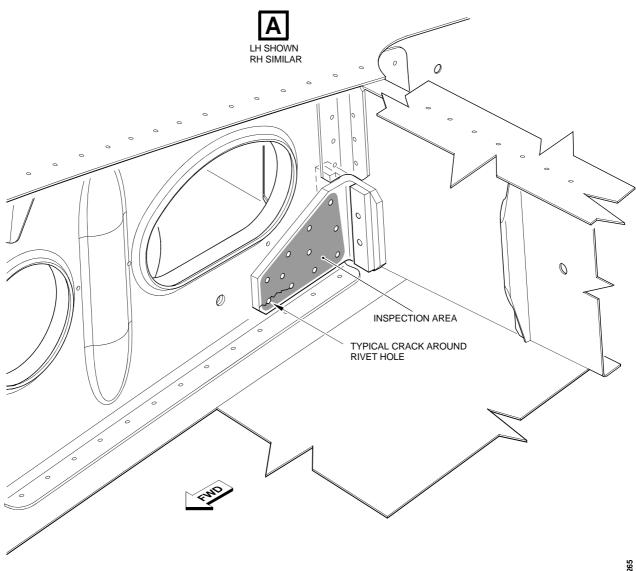
Left and Right Flap Bearing Support-Bracket - Inspection (If Necessary) Figure 9

- 2 Obey the manufacturer's instructions and use a boroscope to examine the inspection areas of the left flap bearing support-bracket for cracks.
- 3 If you find cracks:
 - You must contact Pilatus Customer Support before next flight. The address is:

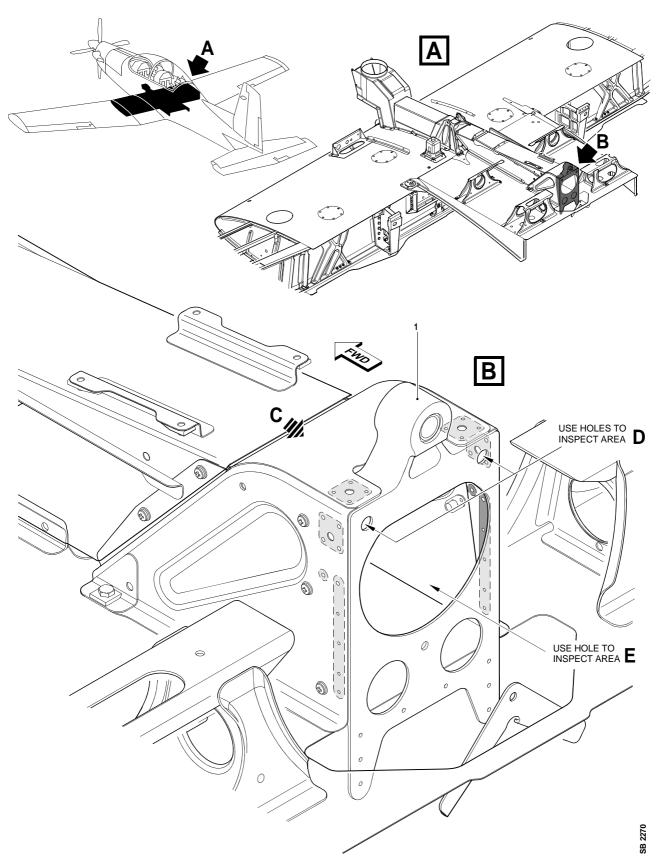
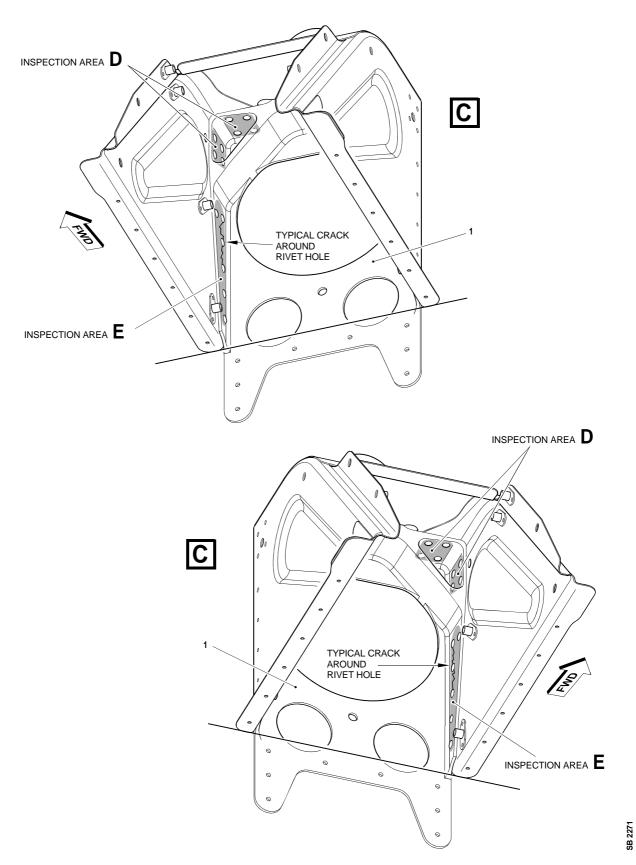
Rear Control-Column Support-Bearing Bracket - Inspection (If Necessary) Figure 11, Sheet 1 of 2

- Obey the manufacturer's instructions and use a boroscope to examine the inspection areas of the rear control-column support-bearing bracket (1) for cracks.
- 3 If you find cracks:
 - You must contact Pilatus Customer Support before next flight. The address is:

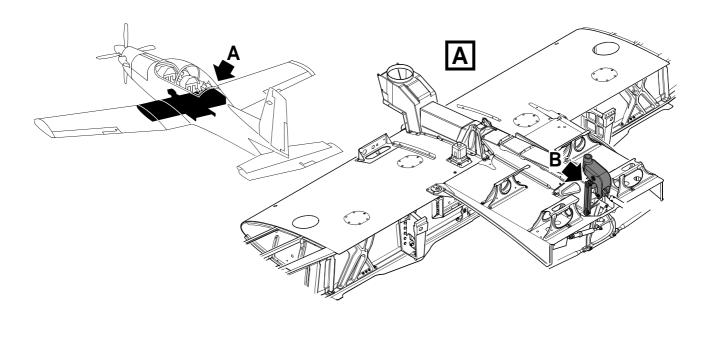
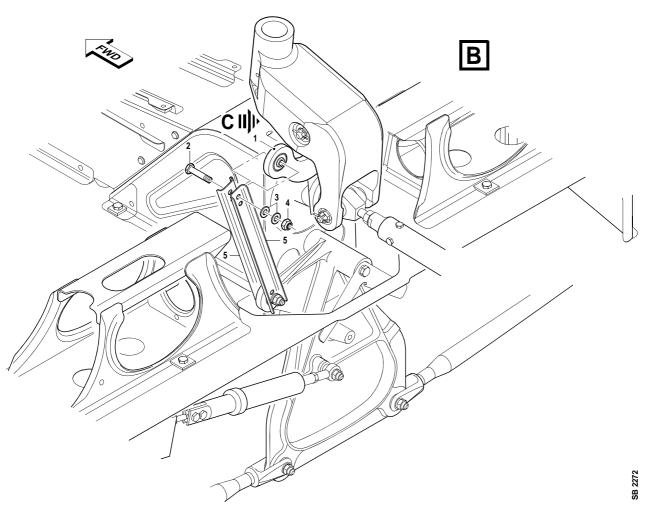
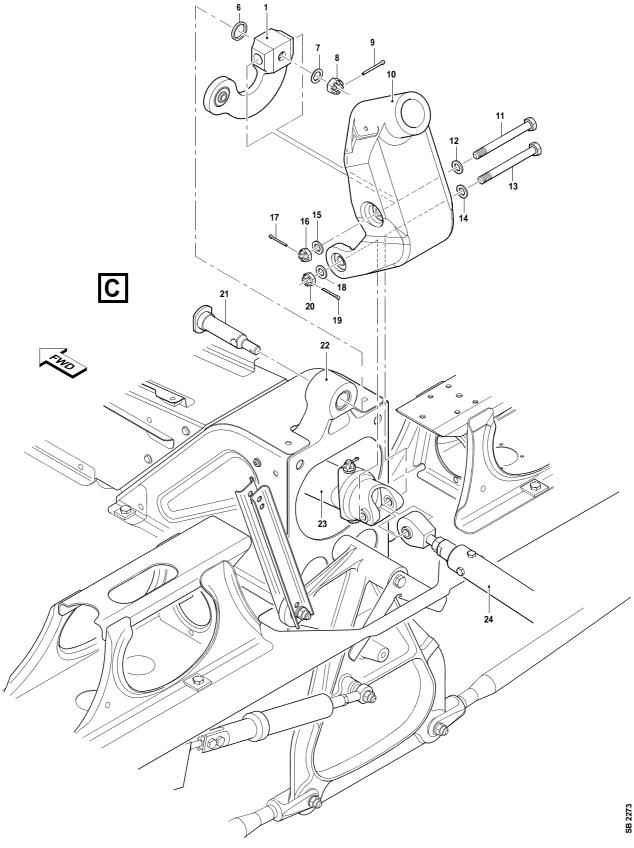
Inspection / Replacement of the Lever on the Rear Control Column Figure 13, Sheet 1 of 2

(6) Inspection and, if Necessary, Replacement of the Lever on the Rear Control-Column (Ref. Fig. 13)

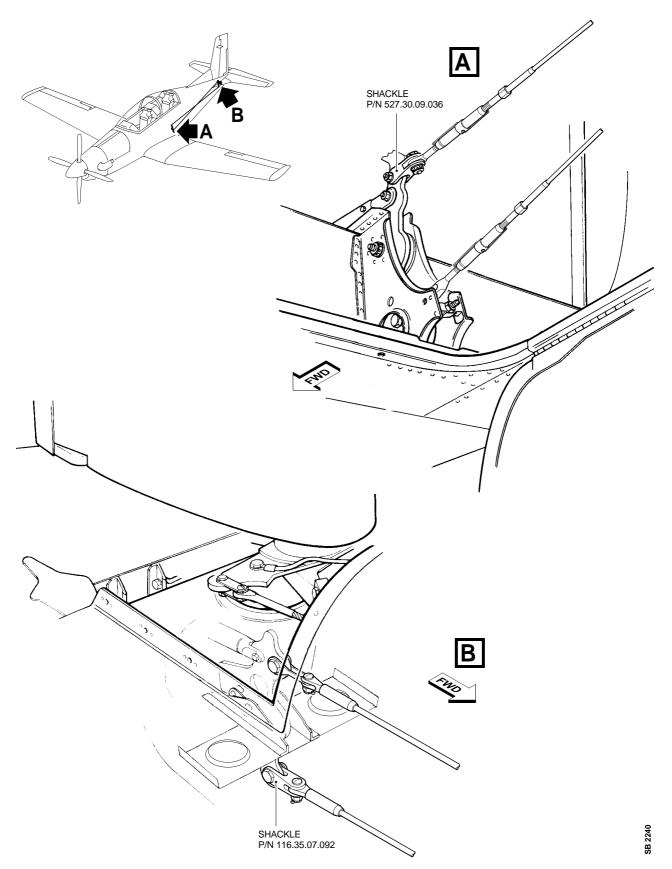
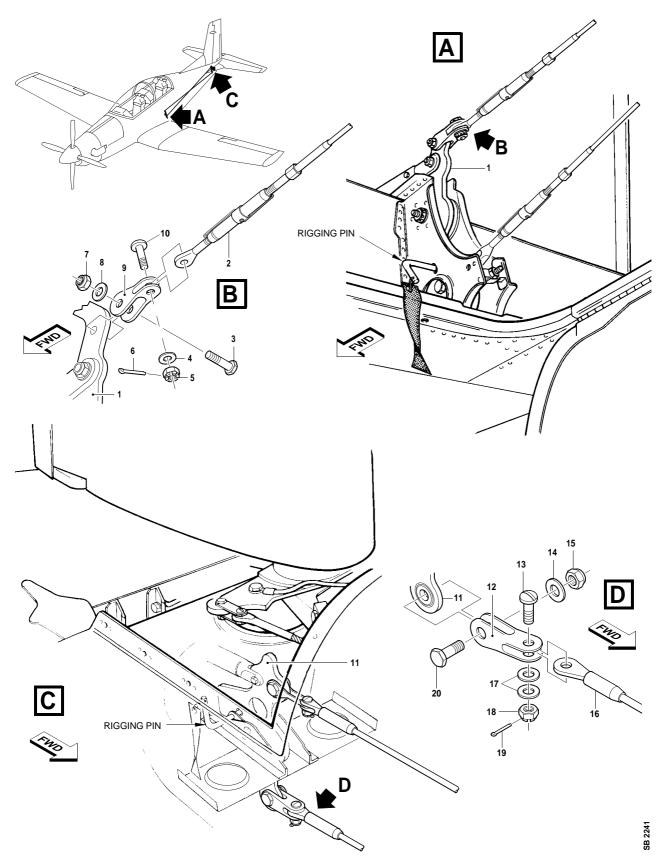
Inspection and, if necessary, Replacement of the Shackles on the Elevator Control Cable Figure 15

(8) Inspection and, if necessary, Replacement of the Shackles on the Elevator Control Cable (Ref. Fig. 15 and Fig. 16)

- <u>11</u> Put the new shackle (9) (P/N 527.30.09.229) in position between the lever (1) and the cable (2).
- Put a layer of the corrosion preventative (Material No. P04-039) on the shank 12 of the bolt (3).

- 13 Install the bolt (3), the washer (8) and the nut (7) that connect the shackle (9) to the lever (1).
- 14 Install the bolt (10), the washer (4) and the nut (5) that connect the shackle (9) to the cable (2).
- 15 Safety the nut (5) with the new cotter pin (6) (P/N 940.17.02.340).
- 16 If the shackle (P/N 116.35.07.092) is made from AA2024-T351, continue this Service Bulletin from Step 3.B.(8)(f).
- 17 If the shackle (P/N 116.35.07.092) is made from AA2124-T851, continue this Service Bulletin from Step 3.B.(8)(f)15.
- (f) Replace the shackle (P/N 116.35.07.092) (Ref. Fig. 15 and Fig. 16):

- 9 Remove, and discard, the shackle (12) from the aircraft.
- Use the absorbent paper (Material No. P02-031) made moist with the solvent (Material No. P01-010) and clean the attachment points on the lever (11) and the cable (16).
- 11 Put the new shackle (12) (P/N 527.30.09.231) in position between the lever (11) and the control cable (16).

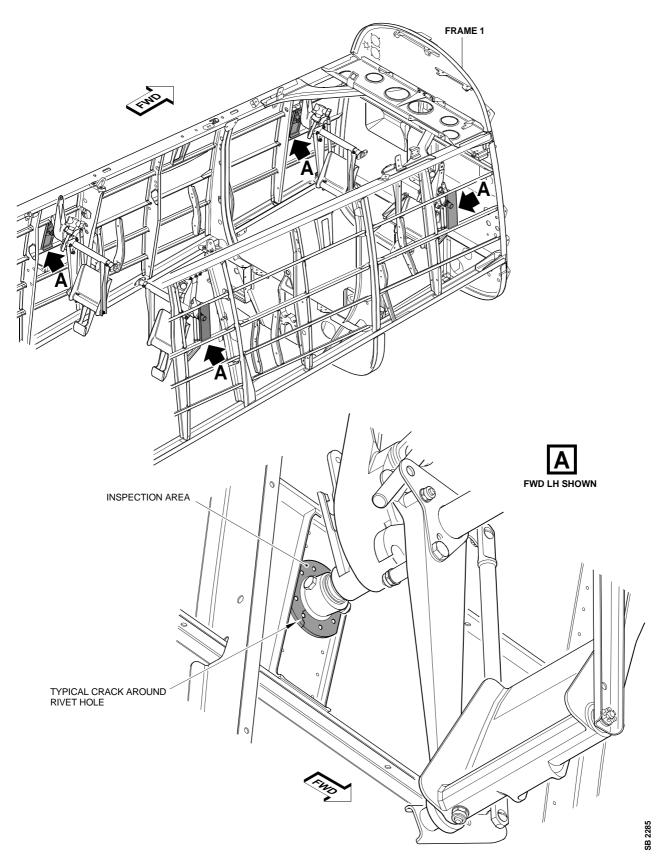
Front and Rear Rudder-Pedal Outboard-Bearings (P/N 553.20.09.235) - Inspection (If Necessary) Figure 17

3 Obey the manufacturer's instructions and use a boroscope to examine the inspection areas of the outboard bearings (P/N 553.20.09.235) for cracks.

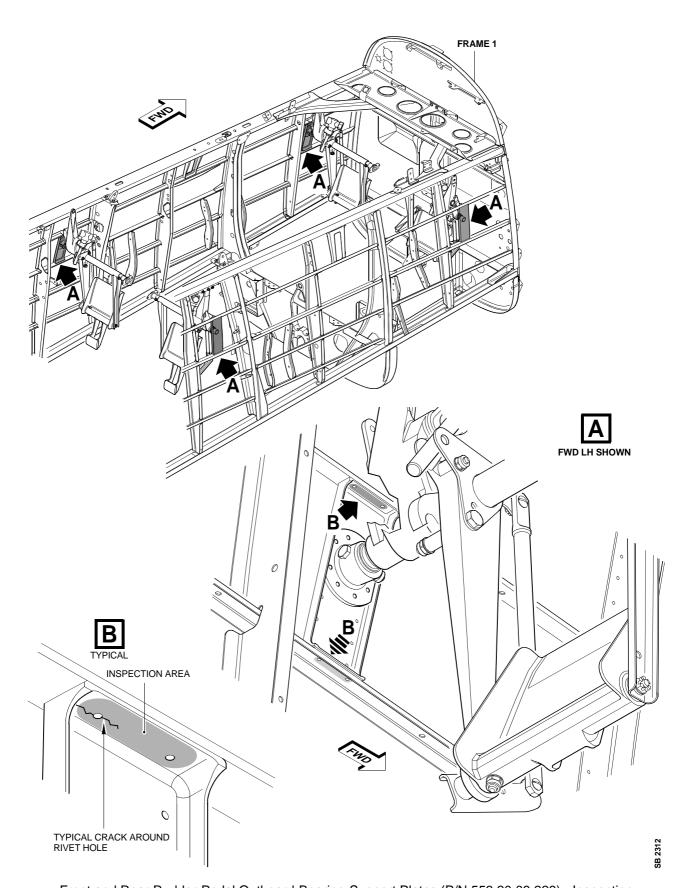
Front and Rear Rudder-Pedal Outboard-Bearing-Support Plates (P/N 553.20.09.229) - Inspection Figure 19

- <u>3</u> Obey the manufacturer's instructions and use a boroscope to examine the inspection areas of the support plates (P/N 553.20.09.229) for cracks.
- 4 If you find cracks:
 - <u>a</u> You must contact Pilatus Customer Support before next flight. The address is:
