PILATUS AIRCRAFT LTD. STANS, SWITZERLAND

SERVICE BULLETIN

Service Bulletin No: 21-006 Ref No: 103

AIR CONDITIONING - DISTRIBUTION INSPECT, AND IF NECESSARY, REPLACE THE AIR CONDITIONING HOSES IN THE DE-FOG SYSTEM

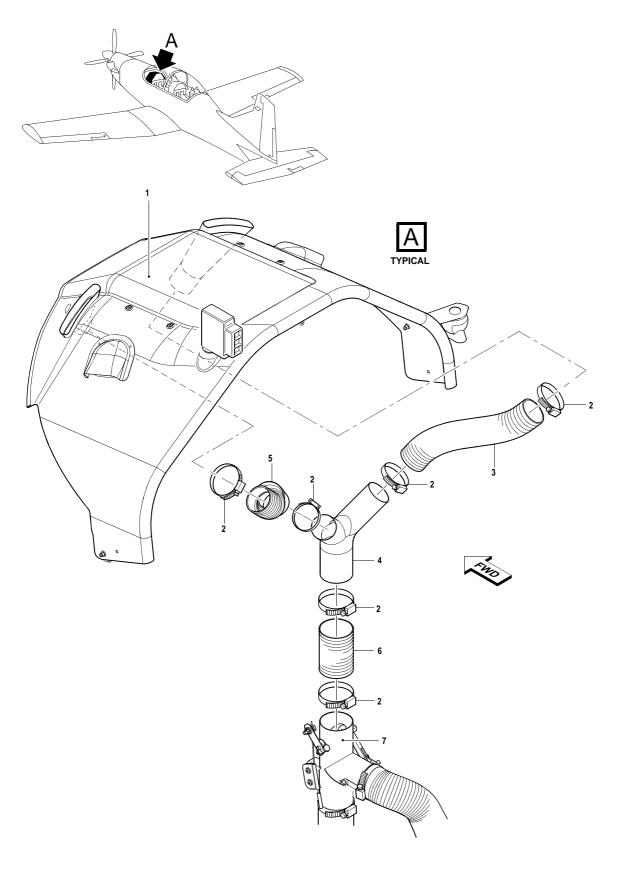
Replacement of the ECS Hoses Figure 1

Some of the ECS air hoses have experienced delamination problems. This type of hose (type 984) was installed in new production and offered as replacement for in-service hoses. If a hose installed in the de-fog system collapses, it can impair the forward vision from the cockpit.

- (1) Do an inspection of the ECS hoses, items (3), (5) and (6).
- (2) If the hoses are dark grey in color, they are type 984 and must be replaced.
- (3) Replace the ECS hoses:

Do a one time inspection and replace all the type 984 hose installed in the de-fog system.

- (a) Remove the ECS hoses:
 - 1 Remove the front coaming (1) (Ref. AMM, 34-13-03, Page Block 401).
 - 2 Loosen the clamps (2) that attach:
 - The air hose (3) to the air distributor (4)
 - The air hose (5) to the air distributor (4)
 - The air hose (6) to the air distributor (4) and the air distributor assembly (7).

- 5 Remove and keep the clamps (2) from:
 - The air hose (3)
 - The air hose (5)
 - The air hose (6).
- 6 Discard:
 - The air hose (3)
 - The air hose (5)
 - The air hose (6).
- (b) Install the new hoses:
 - Put the clamps (2) on: <u>1</u>
 - The new air hose (5) (P/N 917.96.83.051)
 - The air hose (3) (P/N 917.96.83.052)
 - The air hose (6) (P/N 917.96.83.054).
 - 2 Put these hoses in position:
 - The air hose (5) (P/N 917.96.83.051)
 - The air hose (3) (P/N 917.96.83.052)
 - The air hose (6) (P/N 917.96.83.054).
 - 3 Put the clamps (2) in the correct position on:
 - The air hose (5) (P/N 917.96.83.051)
 - The air hose (3) (P/N 917.96.83.052)
 - The air hose (6) (P/N 917.96.83.054)
