PILATUS AIRCRAFT LTD. STANS, SWITZERLAND

PC-9 M

Service Bulletin No: 32-002 Ref No: 57

LANDING GEAR - MAIN GEAR AND DOORS INSPECTION OF THE MAIN-GEAR SUPPORT STRUT

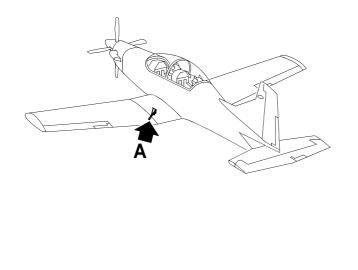
Type of Main-Gear Support Struts Figure 1

- (1) Do a visual examination of the left and right main-gear support struts installed on the aircraft:
 - If the main-gear support struts has rounded clevis lugs, they are made of material with an increased resistance to stress corrosion cracking. Continue the Service Bulletin from Step 3.E.
 - If the main-gear support struts has chamfered clevis lugs, they are made of material which has a lower resistance to stress corrosion cracking. Continue the Service Bulletin from Step 3.B.

- (1) Do a visual examination of the main-gear support struts (P/N 532.10.09.039) held as spare or in stock:
 - If the main-gear support struts has rounded clevis lugs, they are made of material with an increased resistance to stress corrosion cracking, and no further action is required.
 - If the main-gear support struts has chamfered clevis lugs, they are made of material which has a lower resistance to stress corrosion cracking. Return the main-gear support struts (with chamfered clevis lugs) to Pilatus for replacement with a new part (P/N 532.10.09.128).

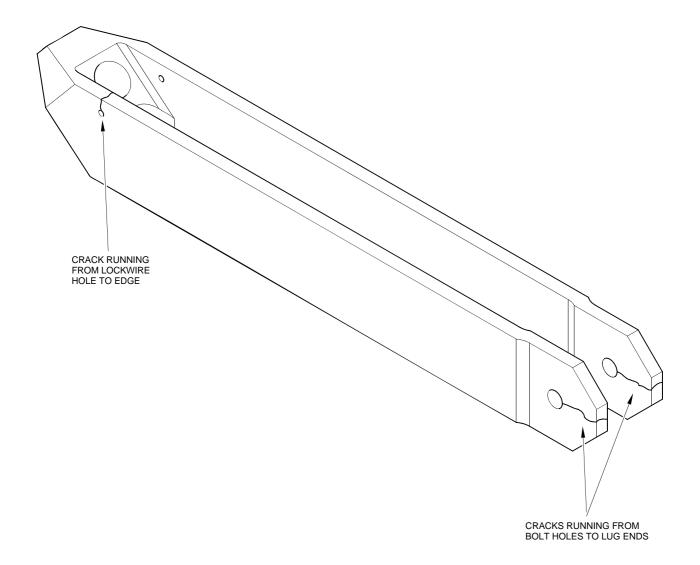
Position of Possible Cracks Figure 3

Cracks have occurred in the main-gear support struts on some aircraft. All the main-gear support struts that had cracks were made from material AA2024-T351. This material has a lower resistance to stress corrosion cracking.

The cause of the cracks is stress corrosion.

- (2) Examine both bolt holes of the left main-gear support strut for cracks with the rotating scanner probe.
- (3) Calibrate the eddy current 90° shielded probe instrument utilising the manufacturers handbook to represent a 75% of full screen height (FSH) response (null point represents 0% FSH) from the calibration standard.

- (4) Examine the area around the hole, for the bolt (4), on the aft surface with a 90° shielded probe.
- (5) Examine the area around the hole, for the bolt (4), on the forward surface with a 90° shielded probe.

- (6) Examine the area adjacent to the lockwire holes with the 90° shielded probe.
- (7) Do steps 3.C.(1) to 3.C.(6) for the right main-gear support strut.
