Service Bulletin No: 52-005

**CANOPY - GENERAL  
INSPECTION FOR CORRECT INSTALLATION OF THE HINGE ATTACHMENT RIVNUTS****1. Planning Information****A. Effectivity**

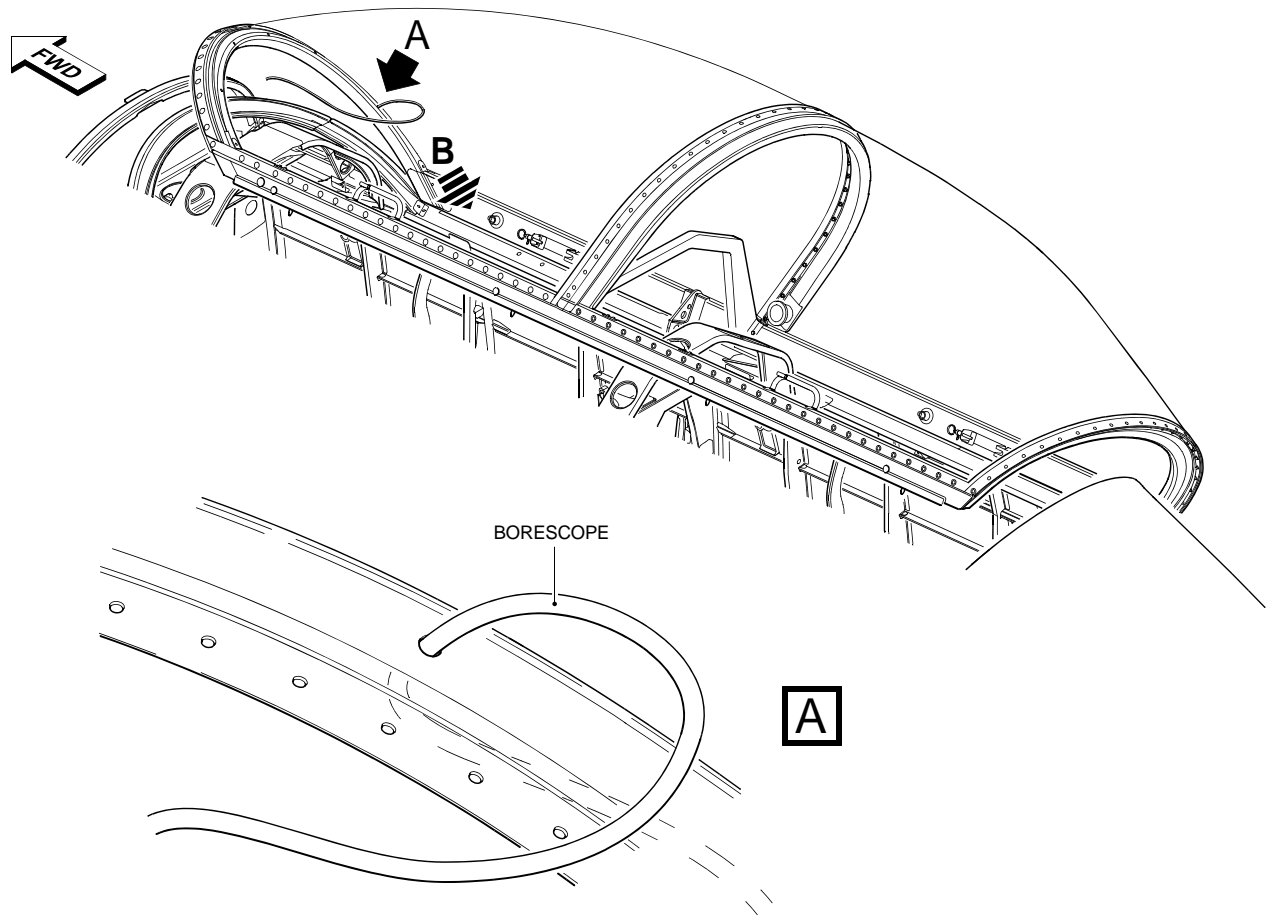
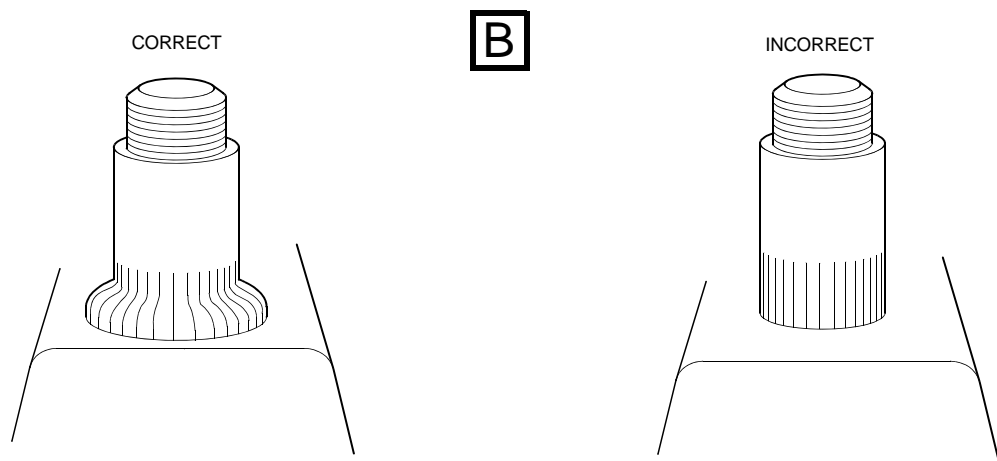
Rivnuts - Inspection  
Figure 1

On some canopy assemblies, the rivnuts which attach the hinge to the canopy frame may not be correctly installed.

- (1) Put the flexible borescope through the tooling hole in the right side of the front frame of the canopy.
- (2) Push the flexible borescope into the right side frame until you can see the rivnuts.
- (3) Examine the first four hinge attachment-screw rivnuts (minimum).
- (4) If the rivnuts have a bulge they are correctly installed. Remove the borescope and do the re-identification procedure (Ref. Para. F.).
- (5) If the rivnuts are cylindrical with no bulge they are not correctly installed. Continue with the rivnut installation procedures.

Do a borescope inspection of the interior of the canopy frame. If the rivnuts are not correctly installed, use a hand tool to correctly install the rivnuts.
