SERVICE BULLETIN

SERVICE BULLETIN NO: 53-007 REF NO: 59

FUSELAGE ENGINE MOUNTING-FRAME ATTACHMENT-FITTINGS - INSPECTION

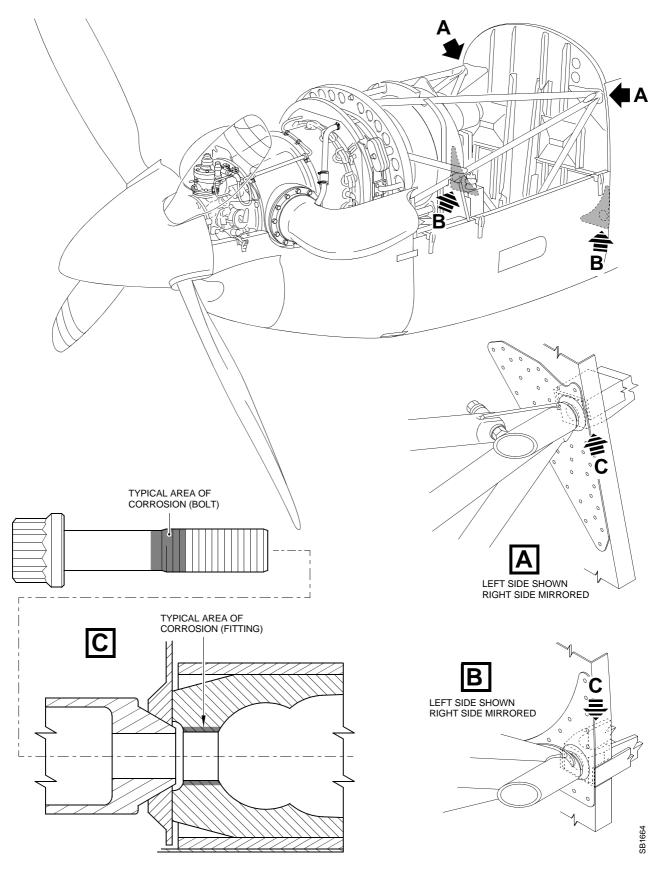
Engine Mount Attachment Fittings - Inspection/Repair Figure 1

Corrosion has been found on the bolts and in the bores of the attachment fittings for the engine mounting frame.

Damage to the cadmium plating of the bolt, or to the surface finish of the attachment fitting, can cause corrosion. The damage is caused when the bolts are removed and installed.

- (1) Remove the bolt and washer from one of the four engine mounting-frame attachment points (Ref. AMM 71-20-01, Page Block 401).
- (2) Do a visual inspection for corrosion on the removed bolt.
- (3) Do a visual inspection for corrosion in the bore of the attachment fitting. Do this with a boroscope. If you find corrosion, do the subsequent steps:

- (a) Use aluminum wool (Material No. P02-002) to remove surface corrosion.
- (b) If you cannot remove all of the corrosion contact Pilatus for repair information.

- (c) Clean the bore and the threads of the barrel nut with solvent (Material No. P01-008) and absorbent paper (Material No. P02-031).
- (d) Remove all swarf and debris from the attachment fitting. If necessary, you must remove the barrel nut and/or the engine mounting frame to do this. Make sure there is no swarf and debris in the joints between:

- · The attachment fitting and the barrel nut
 - The attachment fitting and the engine mounting frame.
- (e) Apply a layer of CCC solution (Material No. P07-001) to the bore.

- (f) If necessary, install the barrel nut and/or the engine mounting frame.
- (4) Install the new bolt (P/N 571.20.09.031) and the washer (P/N 938.75.11.105) (Ref. AMM 71-20-01, Page Block 401).
