Service Bulletin No: 53-010

**FUSELAGE - GENERAL
INSPECTION FOR GALVANIC CORROSION ON THE UPPER LEFT LONGERON AND REPLACEMENT
OF THE CHAFING PLATES****1. Planning Information****A. Effectivity**

PC-9(M) aircraft MSN 605 and MSN 617 thru MSN 670.

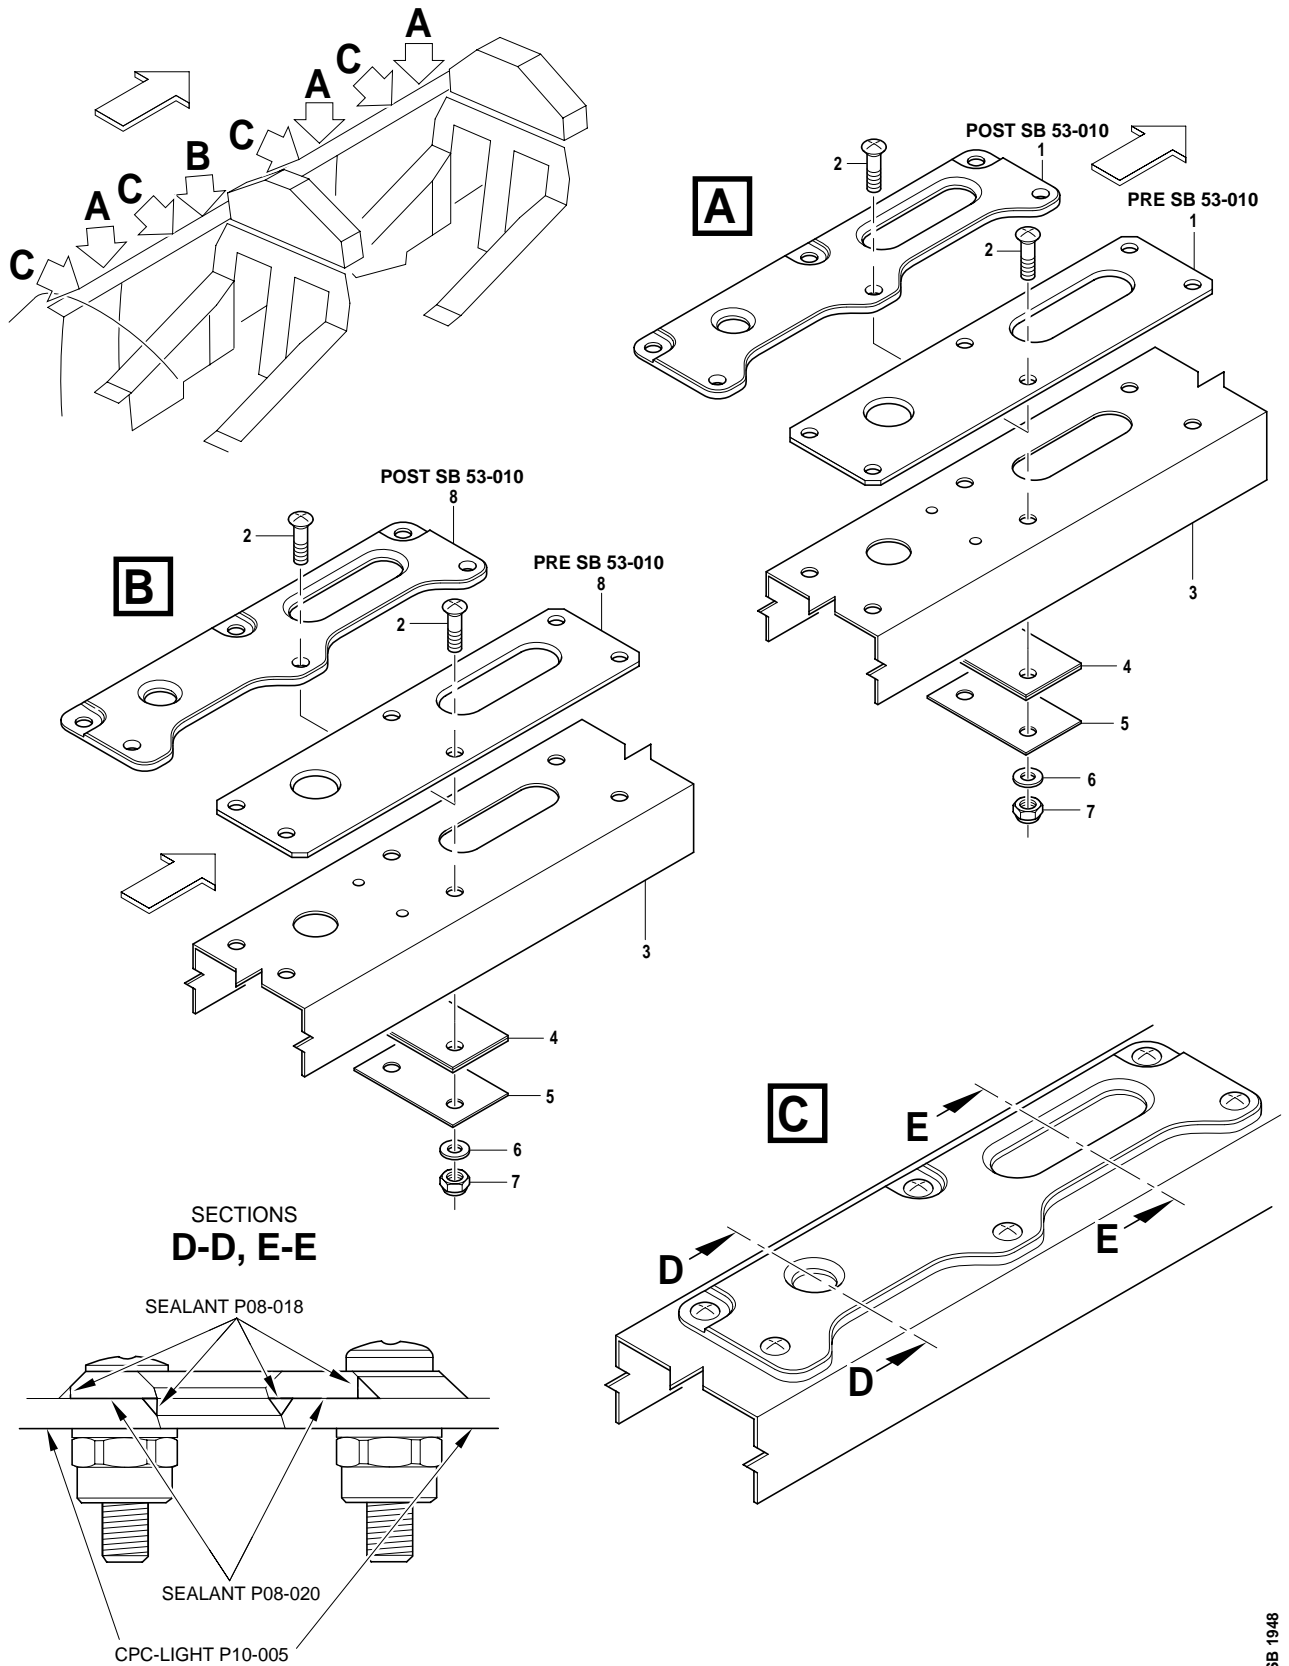
Canopy-lock Chafing Plates - Removal and Installation
Figure 1

Corrosion has been reported on the upper left longeron underneath the chafing plates for the canopy door latches.

The cause of the corrosion can be due to a number of reasons, for example:

- The use of liquid shim
- Excessive latch chafing that damages and causes removal of the sealant and nucleation of further galvanic corrosion
- Poor application of sealant or finishes such as Alodine to the blended aluminium
- The use of chemical paint stripper.

Do an inspection of the longeron in the specified areas and, if necessary, remove the corrosion. Apply to Pilatus for a repair scheme if the removal of corrosion decreases the metal thickness to less than the specified limits. Install new, more robust, chafing plates.

- (c) Use a X 10 magnifier and look for signs of corrosion in the areas of the chafing plates (1 and 8) on the upper and lower surfaces of the longeron (3) (Ref. SRM, 51-10-01).
- (d) If you find corrosion in Para. 3.B.(2)(c), obey the evaluation and assessment instructions (Ref. SRM, 51-10-02).
- (e) Remove the corrosion (Ref. SRM, 51-10-02) from the longeron (3).
- (f) After you have removed the corrosion in Para. 3.B.(2)(e), measure and record the thickness of the metal in the bare metal areas of the longeron (3). Make an entry in the Aircraft Logbook to record these values.

- (g) If the thickness of the remaining metal is less than:
- 1,8 mm (0.071 in.) at the FWD chafing plate (1) in the front cockpit
 - 2,3 mm (0.091 in.) at the AFT chafing plate (1) in the front cockpit
 - 2,1 mm (0.083 in.) at the FWD chafing plate (8) in the rear cockpit
 - 1,8 mm (0.071 in.) at the AFT chafing plate (1) in the rear cockpit,

- (k) Put the new chafing plates (1) (P/N 553.20.09.326) and (8) (P/N 553.20.09.327) in position on the longeron (3).
 - (l) Put the locking plate assemblies (5) and shim packs (4) in their recorded locations on the longeron (3) (Ref. Para 3.B.(1)).

- The chafing plates (1)
 - The chafing plate (8)
- As shown in Detail C and Section D-D and E-E.
- (q) Apply a layer of the CPC-Light (Material No. P10-005) to the lower surface of the longeron (3) in the areas of the chafing plates (1) and the chafing plate (8).
