PILATUS AIRCRAFT LTD. STANS, SWITZERLAND

SERVICE BULLETIN

PC-9 M

DO A CHECK OF THE MATERIAL SPECIFICATION USED IN THE MANUFACTURE OF THE ENGINE MOUNT FITTINGS AND, IF NECESSARY, DO A CHECK FOR CRACKS WITH A BOROSCOPE

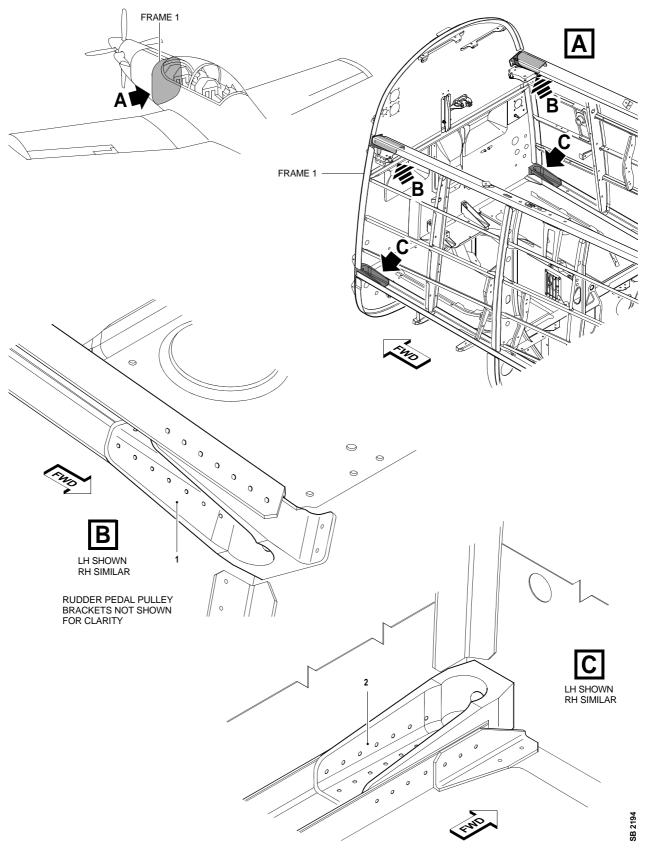
Check of the Material Specification Figure 1

An operator reported Stress Corrosion Cracking (SCC) on the engine mount fittings.

Initially the material specification of the parts was AA2024-T351. The material specification was subsequently changed to AA2124-T851 to decrease the risk of stress corrosion.

B. Do the Test to Find the Material Specification (Ref. Fig. 1)

(1) For the left upper engine-mount attachment-fitting (1) (P/N 553.10.09.123):

- (b) Put the eddy current probe in position on the left upper engine-mount attachment-fitting (1) (P/N 553.10.09.123).
- (c) Record the value shown on the test equipment.

- (d) Compare the value recorded above with the values recorded in Section 3.A.(5) and determine if the attachment fitting is manufactured from AA2024-T351 or AA2124-T851.

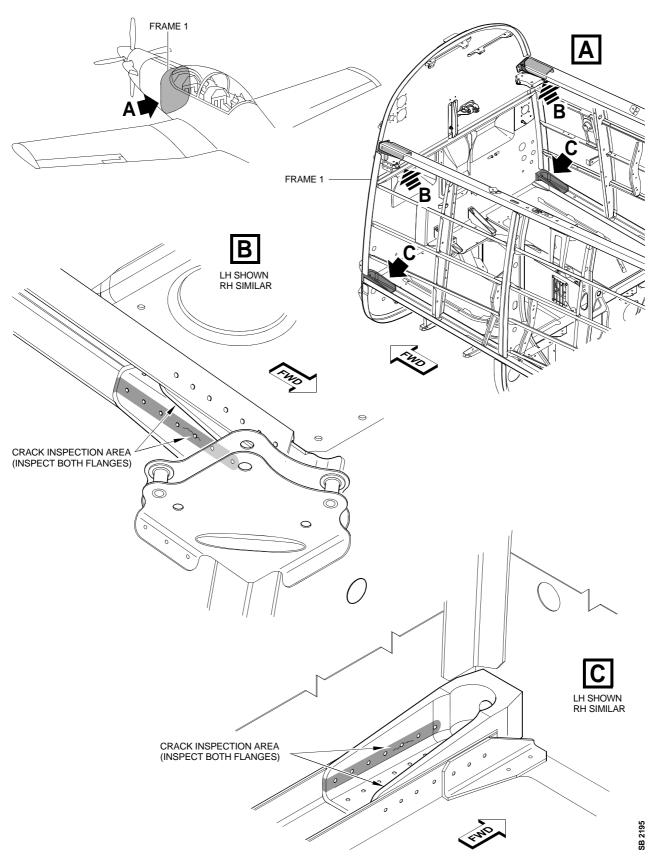
Fittings - Crack Inspection (If Necessary)
Figure 2

- C. Do the Boroscope Inspection to Find Cracks (Ref. Fig. 2)

NOTE: Step 3.C. is only applicable to engine mount fittings made from AA2024-T351.

- (1) Obey the manufacturer's instructions and use a boroscope to examine the areas shown in Fig. 2:
 - (a) Use the aluminium or steel tube as a guide for the boroscope to access the inspection areas.
 - (b) If you find cracks:
 - You must contact Pilatus Customer Support before next flight. The address is:
