Service Bulletin No: 57-011

ATA Chapter: 57

**WINGS - OUTER WING
INSPECTION OF THE LEFT AND RIGHT OUTBOARD AILERON BEARING-BRACKETS****1. Planning Information****A. Effectivity**

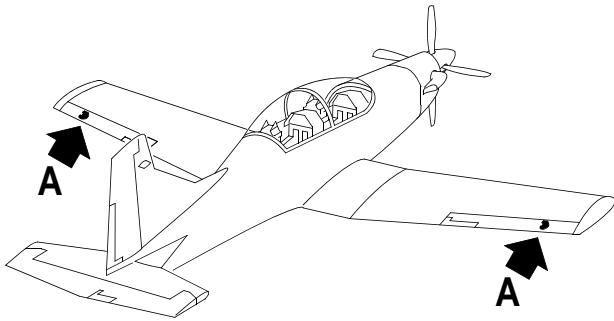
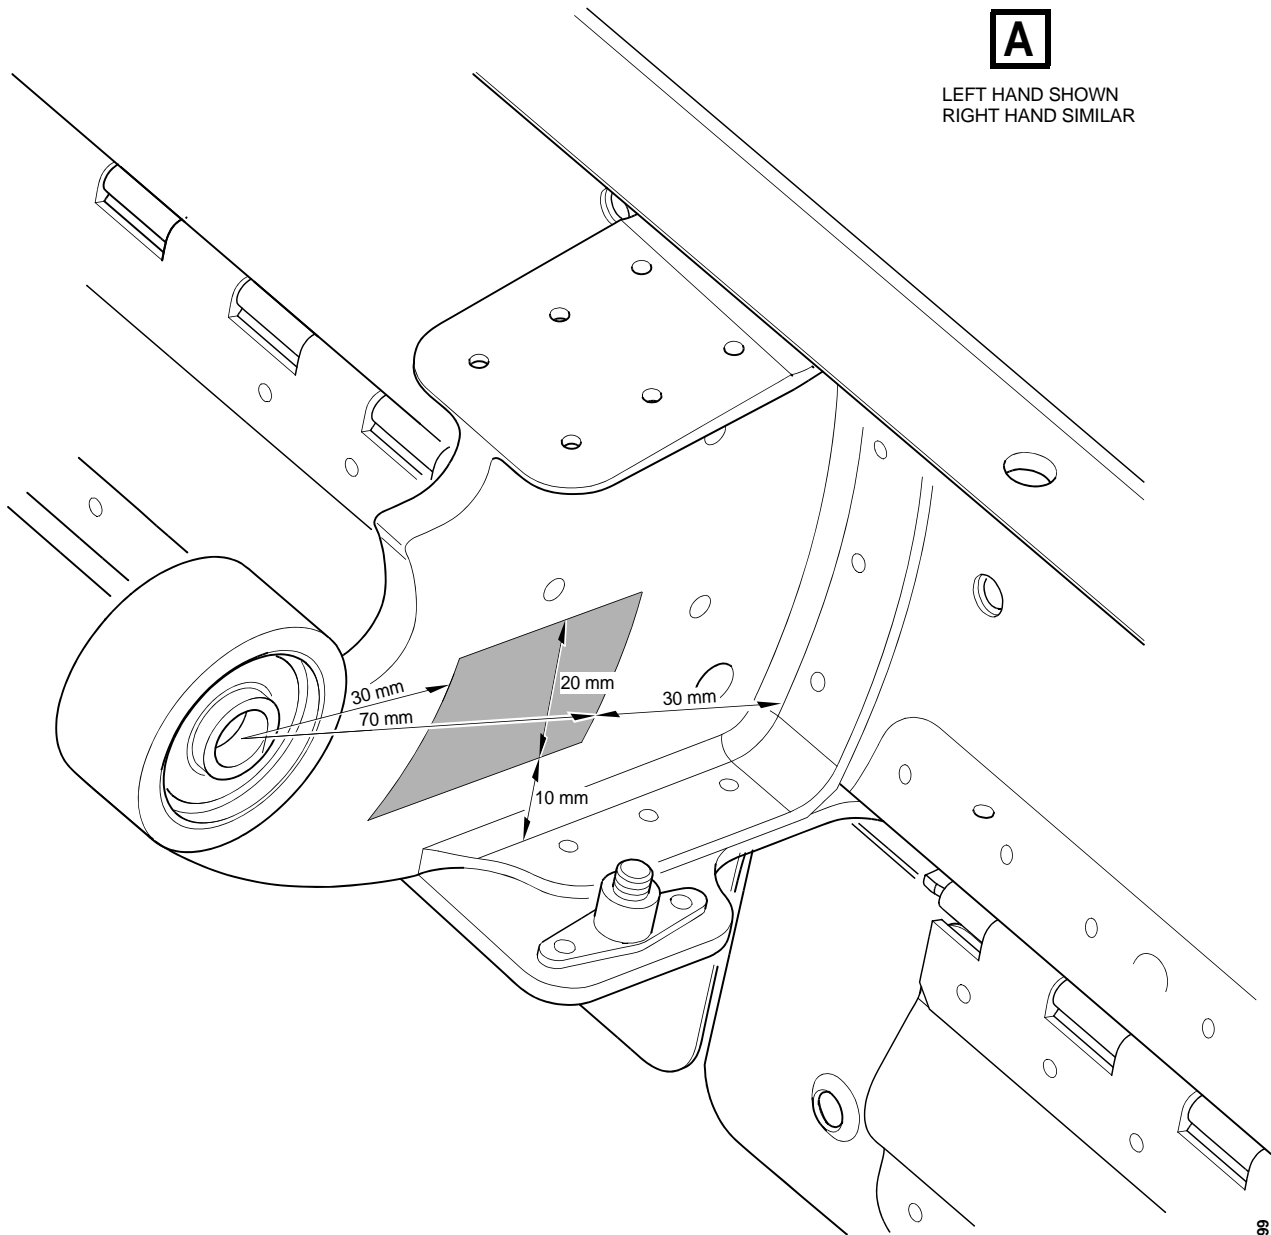
Inspection to Find the Type of Material
Figure 1

- 1 Put the eddy current probe in position in the test area (shown shaded in the Fig 1).
- 2 Record the value shown on the test equipment.
- 3 Put the eddy current probe on:
 - The AA2024-T351 test piece (P/N 513.57.09.149) and record the value
 - The AA2124-T851 test piece (P/N 513.57.09.150) and record the value.
- 4 Do a comparison of the values recorded on the eddy-current conductivity measurement-equipment for:
 - The left bracket assembly (P/N 557.22.09.279)
 - The AA2024-T351 test piece (P/N 513.57.09.149)
 - The AA2124-T851 test piece (P/N 513.57.09.150).

- 1 Put the eddy current probe in position in the test area (shown shaded in the Fig 1).
 - 2 Record the value shown on the test equipment.
 - 3 Put the eddy current probe on:
 - The AA2024-T351 test piece (P/N 513.57.09.149) and record the value
 - The AA2124-T851 test piece (P/N 513.57.09.150) and record the value.
 - 4 Do a comparison of the values recorded on the eddy-current conductivity measurement-equipment for:
 - The left bracket assembly (P/N 557.22.09.279)
 - The AA2024-T351 test piece (P/N 513.57.09.149)
 - The AA2124-T851 test piece (P/N 513.57.09.150).
 - 5 If the value for the left bracket assembly (P/N 557.22.09.279) is similar to the value recorded for the AA2024-T351 test piece (P/N 513.57.09.149), return the part to Pilatus.

LEFT HAND SHOWN
RIGHT HAND SIMILAR

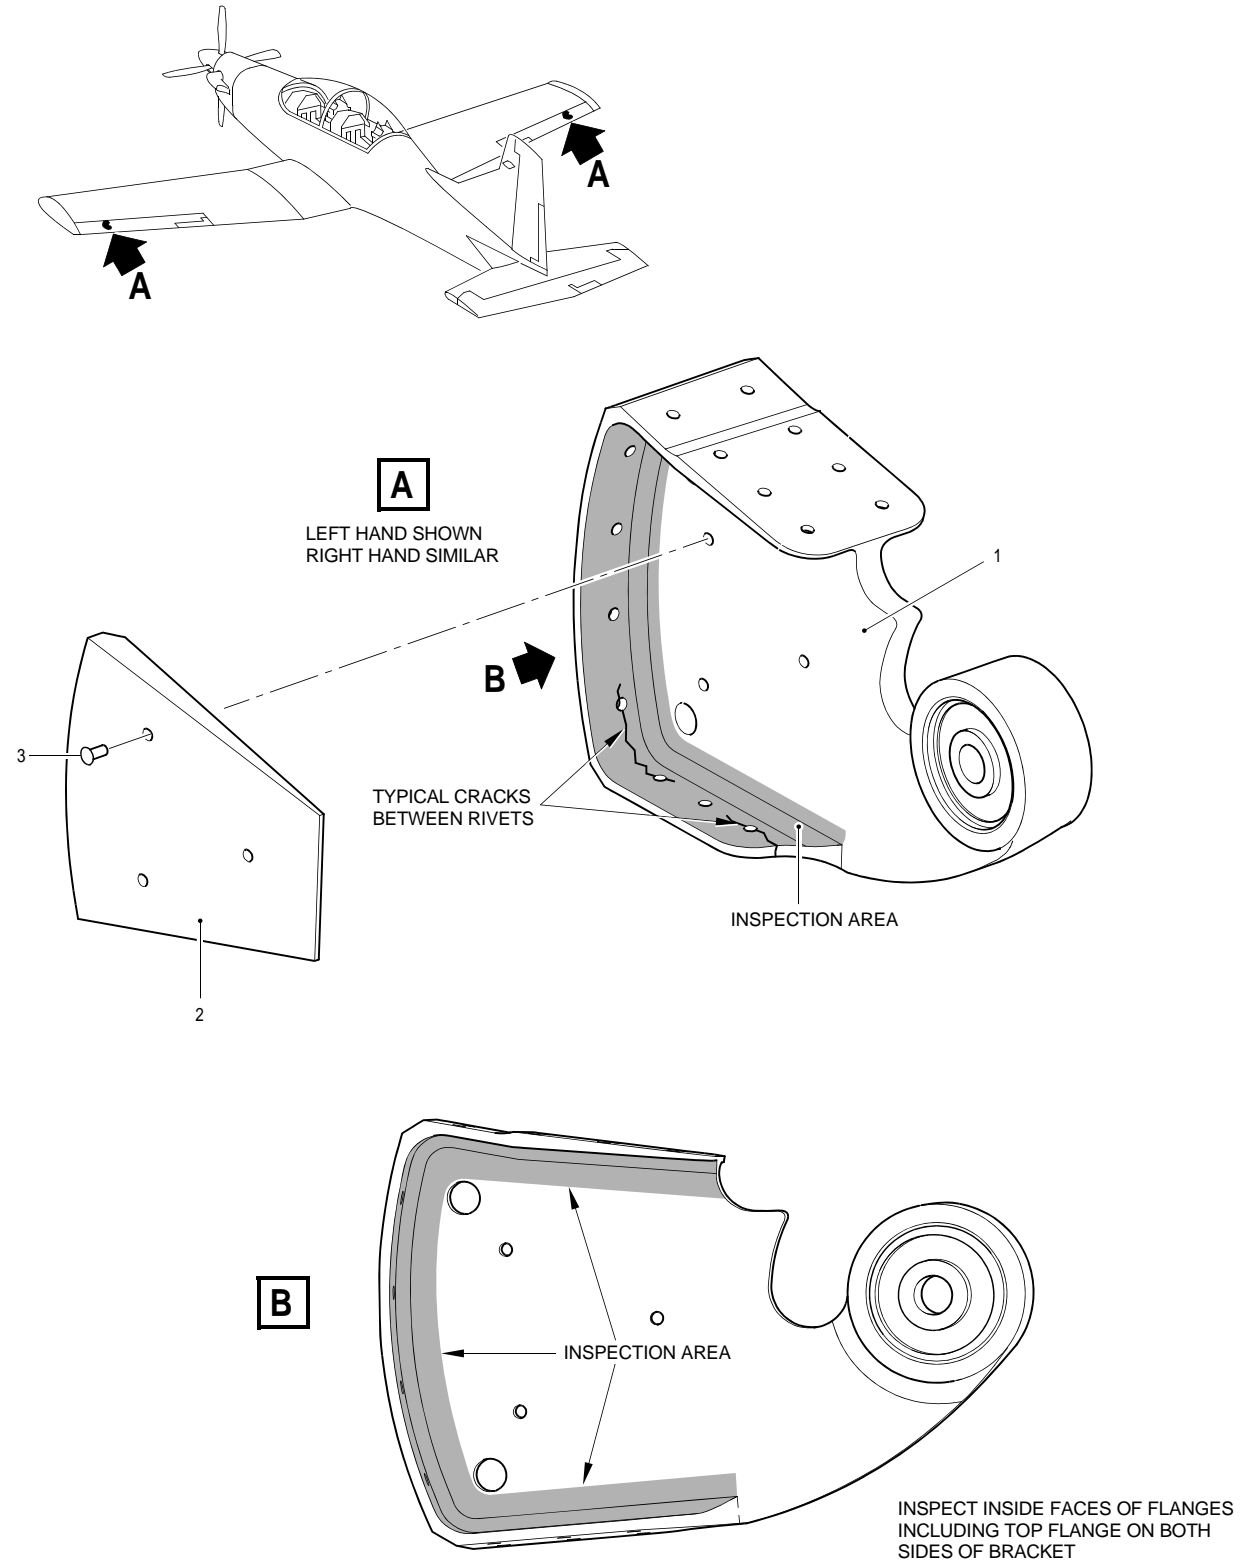
Inspection to find Cracks
Figure 2

It is possible for stress corrosion cracks to occur in brackets, P/N 557.22.09.281 (LH) and P/N 557.22.09.282 (RH) made of aluminium alloy 2024-T351. These cracks would occur in the areas around the attachment fasteners.

NOTE: If you find a crack in one of the bearing brackets, P/N 557.22.09.281 (LH) or P/N 557.22.09.282 (RH) made of aluminium alloy 2024-T351, you must replace the left and right brackets (Ref. Service Bulletin 57-012) before the next flight.

- (9) Install the three rivets (3) (P/N NAS1097AD3) with a countersunk on both sides of the joint.
