# **SERVICE BULLETIN**

SERVICE BULLETIN NO: 57-004

# WING - CENTER WING NOSE SKIN - INSPECTION FOR CRACK DAMAGE

PC-9 (M) aircraft MSN 605 and MSN 617 thru MSN 654.

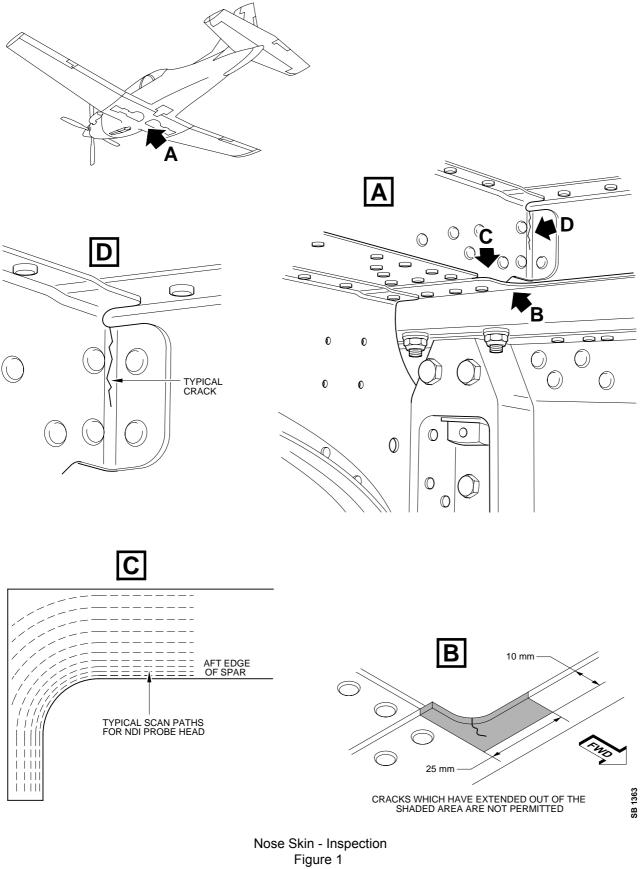
Crack damage can occur in the radii at the rear edge of the nose skin P/N: 557.31.09.120. The radii are adjacent to the left and right corners at the forward edge of the floor panel P/N: 557.31.09.027. Crack damage can also occur in the forward support structure of the floor panel adjacent to the skin panel.

Fatigue damage caused by stresses which occur normally during operation of the aircraft.

- (1) Use a source of bright light and a X10 magnifier and do an inspection of the forward area of the floor panel and the related structure at the locations shown (Ref. View D). Crack damage is not permitted. Apply to PILATUS for instructions if crack damage has occurred.
- (2) Do an NDI of the nose skin (Ref. Sect 4 and Views B and C). Cracks that have not extended out of the limit areas shown are permitted. Instructions to do subsequent inspections will be given in AMM, 05-10-20. The lengths of permitted cracks must also be monitored at the subsequent inspections.

Cracks that have extended out of the limit areas shown are not permitted. Apply to PILATUS for instructions before the next flight if such cracks have occurred.

Do an eddy-current, non-destructive inspection (NDI) of the nose skin for crack damage and if necessary, apply to PILATUS for monitor/repair instructions.

Do an inspection for crack damage in the forward structure of the floor panel.

- (1) Put the probe in position on the top of the skin in the inspection scan area.
- (2) Train the equipment.
- (3) Check train.
- (4) Zero the equipment.
- (5) Do a line scan on the nose skin as near to the edge as possible. Make sure you scan the full radius length (Ref. Fig. 1, Views B and C).
- (6) Do Step (5) again as many times as necessary to fully scan the inspection area shown. Make each line scan approximately 1,0 mm (0.04 in.) apart.
- (7) Do Steps (1) thru (5) again on the lower surface of the nose skin.
- (8) Do Steps (1) thru (7) again on the right inspection areas.
