PILATUS AIRCRAFT LTD. CH-6371 STANS, SWITZERLAND

SERVICE BULLETIN NO: 29-008

HYDRAULIC POWER - AUXILIARY EMERGENCY ACCUMULATOR - INSPECTION FOR CRACKS

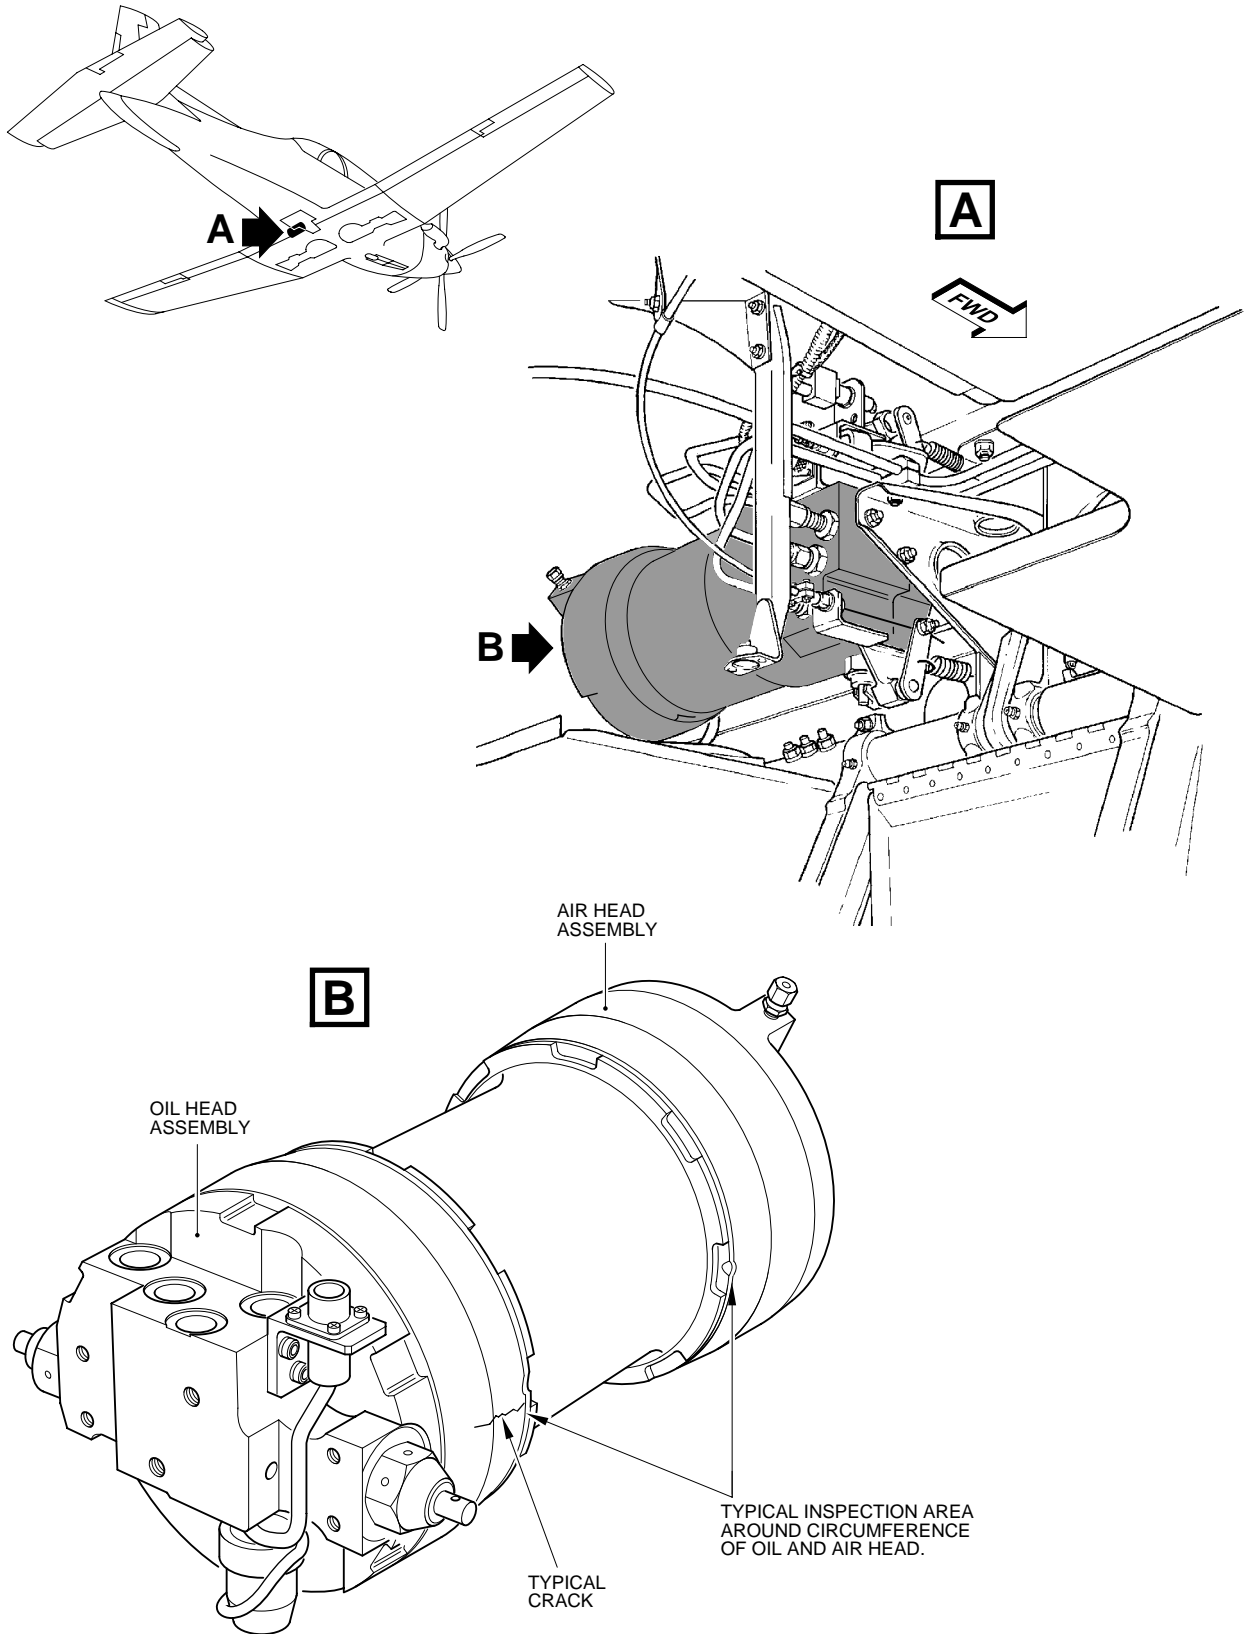
Emergency Accumulator - Inspection
Figure 1

Crack damage has occurred in the (oil head part of the) accumulator of a PC-9 aircraft.

The cause of the crack damage was stress corrosion in the threaded part of the oil head.

- (1) Make sure that the inspection areas of the oil and air heads at each end of the accumulator are clean.
- (2) Use a source of bright light, a X 10 magnifier and a mirror to do an inspection of the accumulator for cracks. Look for signs of cracks (for example, cracks or bubbles in the paint or oil seepage) on the surfaces of the oil and air heads. Do this around the full circumference of the oil and air heads. Look specially around the areas of the lock washers in the oil and air head assemblies. No cracks are permitted

- (1) Make sure that the inspection areas of the oil and air heads at each end of the accumulator are clean.
- (2) Use a source of bright light, a X 10 magnifier and a mirror to do an inspection of the accumulator for cracks. No cracks are permitted. Look for signs of cracks (for example, cracks or bubbles in the paint or oil seepage) on the surfaces of the oil and air heads. Do this around the full circumference of the oil and air heads. Look specially around the areas of the lock washers in the oil and air head assemblies.

You must do the dye-penetrant crack-detection test (Ref. Step 3) if you find signs of cracks. If you find cracks you must replace the accumulator (Ref. AMM, 29-20-01, Page Block 401). Send the unserviceable accumulator to PILATUS or an approved repair station for repair.

No cracks are permitted, if you find cracks you must replace the accumulator (Ref. AMM, 29-20-01, Page Block 401). Send the unserviceable accumulator to PILATUS or an approved repair station for repair.
 - (d) If no cracks are found, obey the manufacturers instructions and apply the layers of surface protection and paint. Do this on the applicable surfaces of the accumulator.
 - (e) Install the emergency package (Ref. AMM, 29-20-01, Page Block 401).
- (4) Assemble the new accumulator and the related components of the emergency package (Ref. AMM, 29-20-01, Page Block 401). This step is only applicable if it is necessary to replace the accumulator after inspection.

You must do the dye-penetrant crack-detection test (Ref. Step 3) if you find signs of cracks. No cracks are permitted, Send the unserviceable accumulator to PILATUS or an approved repair station for repair.

No cracks are permitted, Send the unserviceable accumulator to PILATUS or an approved repair station for repair.
