# SERVICE BULLETIN

SERVICE BULLETIN NO: 53-007

## FUSELAGE - FUSELAGE STRUCTURE INSPECTION FOR CORROSION IN FRAMES 3C AND REPLACEMENT OF WING ATTACHMENT BOLTS

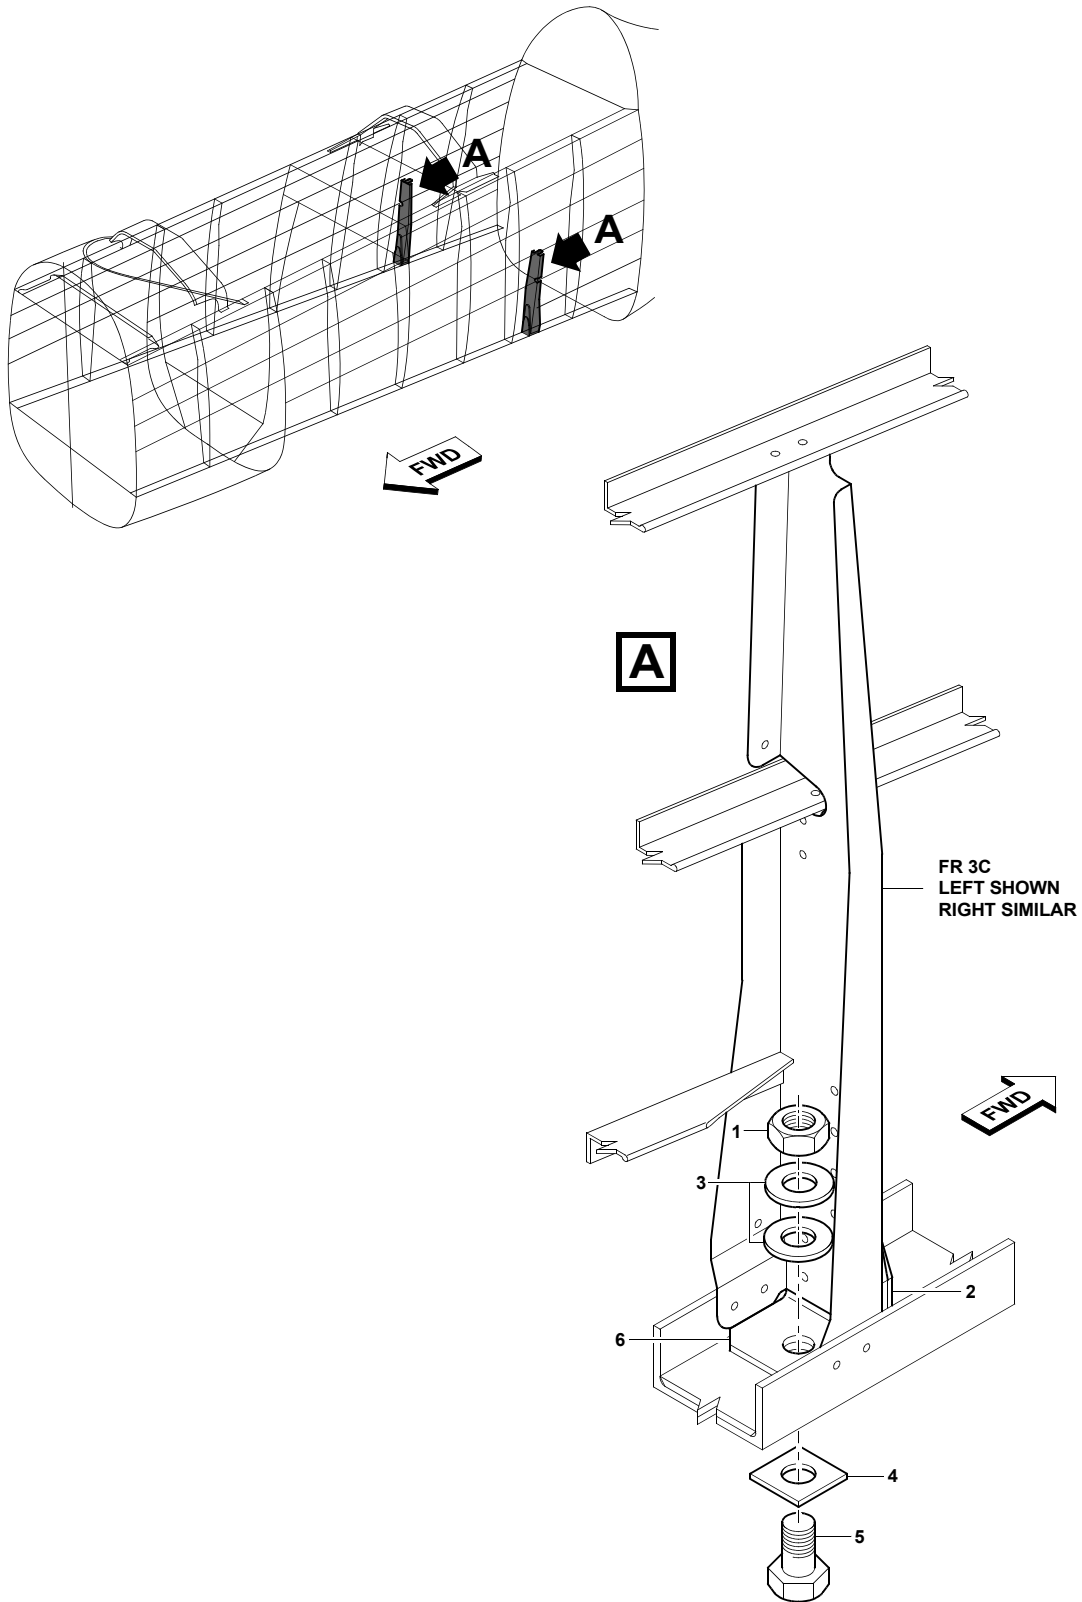
FR 3C Assembly - Inspection and Replacement of Bolt Assembly  
Figure 1

Corrosion has occurred in the pick-up brackets (brackets) (553.20.09.039) of Frame (FR) 3C in some aircraft. The brackets connect FRs 3C to the bottom, left and right longerons. They are also the locations for the wing bolts (bolts) (932.19.60.337).

Electrolytic action between the dissimilar metals of the bolts (932.19.60.337) and the brackets (553.20.09.039) has caused the corrosion.

Corrosion is not permitted in the bolt holes. Surface corrosion on the bracket, shear plate or FR 3C assembly is permitted if in limits (Ref. SRM, 53-20-00, Page Block 101). All other types of corrosion in the bracket, shear plate, FR 3C or the adjacent structure is not permitted. You must:

- (1) Remove and discard the left nut (1), washers (3) & (4) and bolt (5).
- (2) Obey the manufacturers instructions and use the solvent (Material Item No. P01-008 or approved alternative) to clean the surfaces of hole for the bolt (1).
- (3) Use a source of bright light and a X 10 magnifier to do an inspection for signs of corrosion:
  - In the hole for the bolt (1)
  - On the bracket (6), shear plate (2), FR 3C and the adjacent structure.

- Remove surface corrosion (Ref. Step 4)
  - Replace the bracket, shear plate and FR 3C assembly together if you find corrosion in one or more of them (Ref. SRM, 53-20-00, Page Block 201):
  - Apply to PILATUS for instructions if you find corrosion in the skin or structure adjacent to FR 3C.
- (4) If necessary remove the surface corrosion (Ref. SRM, 51-10-02, Page Block 1). You must replace the bracket, shear plate and FR 3C assembly (together) if it is not possible to remove the surface corrosion and stay in limits.
  - (5) Obey the manufacturers instructions and apply layers of the corrosion preventative (Material Item No. P04-012) on the faying surfaces of the new bolt (5), washers (3) & (4) and the bolt hole.
  - (6) Assemble the bolt (5) and washer (4), put the bolt in position and install the washers (3) and nut (1).

- (7) Torque the nut (1) to between 26 and 28 Nm (230 to 248 lbf in.).
- (8) Obey the manufacturers instructions and use the solvent (Material Item No. P01-008 or approved alternative) to remove unwanted corrosion preventative.
- (9) Apply layers of the corrosion preventative (Material Item No. P10-015) on the FR 3C assembly and adjacent skin and structure.
- (10) Do Steps (1) thru (9) again to:
  - Do an inspection for corrosion in the right bolt hole, bracket (5), shear plate (6), FR 3C and the adjacent structure.
  - Replace the right bolt assembly
