PILATUS AIRCRAFT LTD. CH-6371 STANS, SWITZERLAND

SERVICE BULLETIN NO: 55-004

STABILIZERS - HORIZONTAL STABILIZER ELEVATOR - INSPECTION AND REPAIR TO PREVENT SKIN DISTORTION

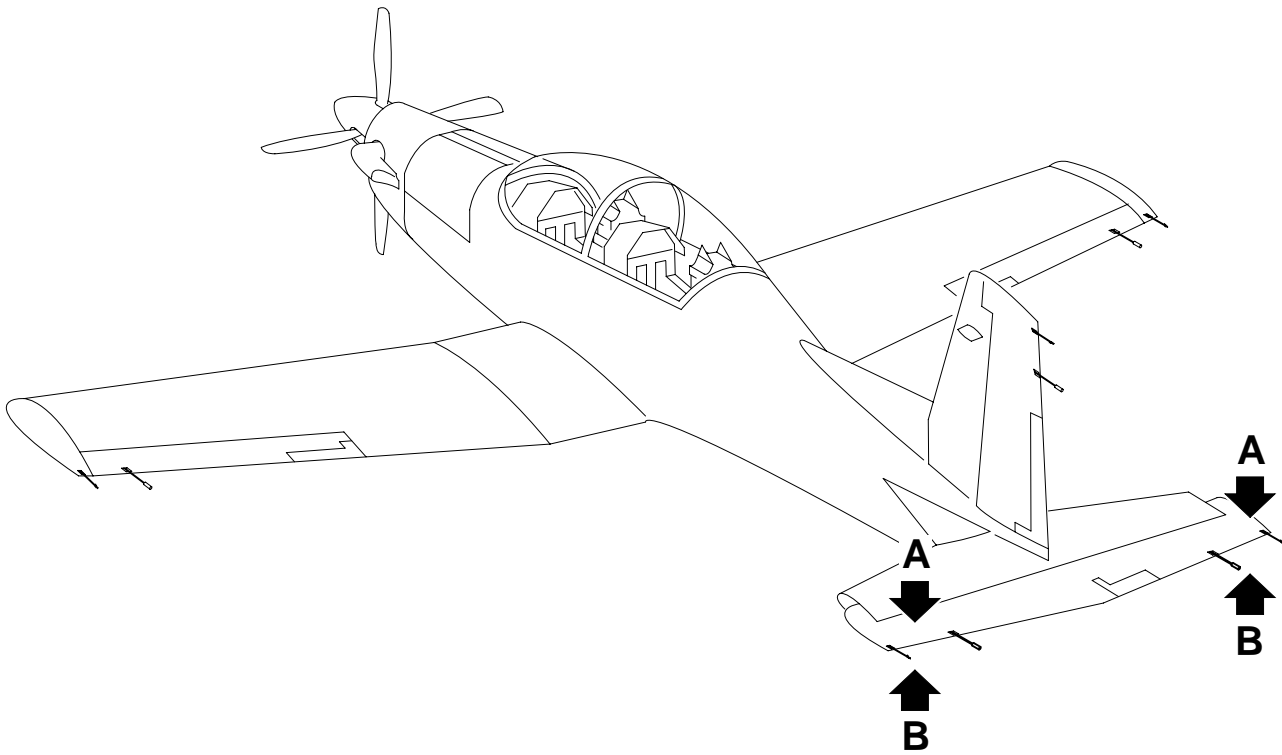
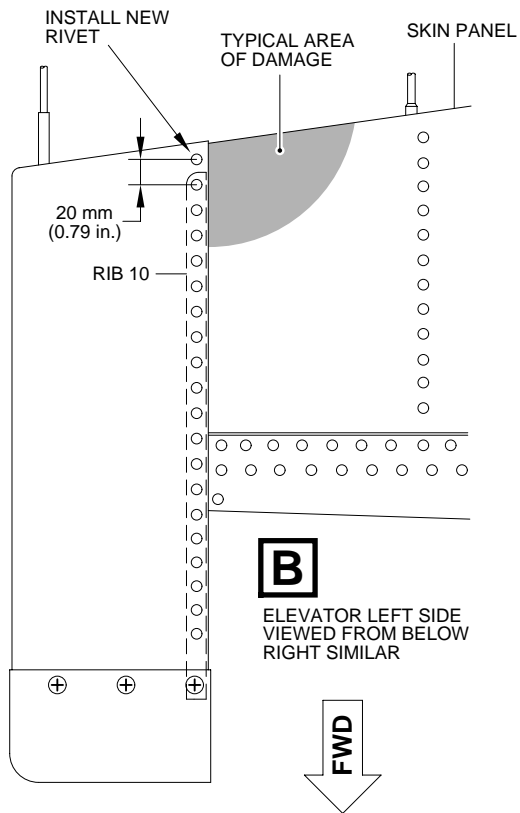
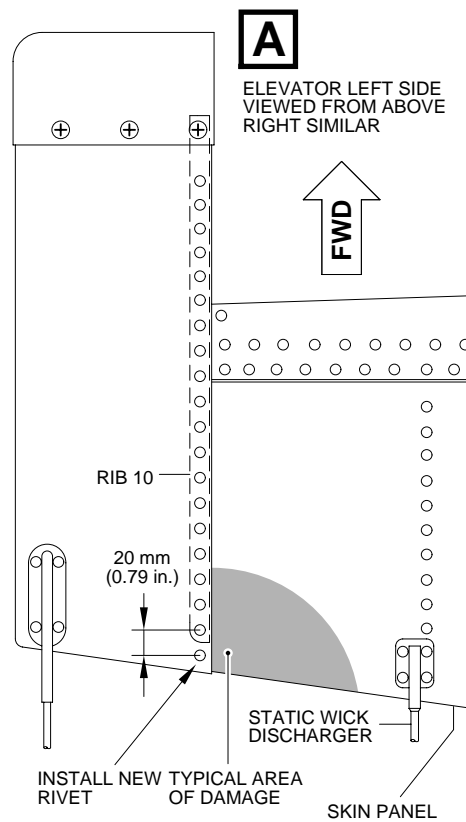
Elevator - Inspection and Repair
 Figure 1

It is possible for damage to occur in the bottom skin panels of the elevator during some flight conditions. The areas at risk of damage are adjacent to the trailing edges, immediately inboard of left and right rib 10.

There are no fasteners (rivets) to hold the top and bottom skin panels in the areas between the last rivets at the rear ends of ribs 10 and the trailing edges of elevator. Thus, during unusually high aerodynamic loads, unwanted movement and separation of the skin from the internal structure can occur.

- (1) Do an inspection of the elevator for signs of buckling and crack damage in the top and bottom skin panels. Do this in the areas immediately inboard of Rib 10 (left and right) and adjacent to the trailing edges.
- (2) Do an inspection of the elevator trailing edges for signs of distortion and crack damage.
- (3) Replace the elevator assembly if you find buckling, distortion or crack damage in the inspection areas (Ref. AMM, 27-30-01, Page Block 401). Send the unserviceable elevator to PILATUS for repair.

- (1) Make marks to show the new rivet locations on the bottom skin panels.
 - (a) Make a mark to show the centerline of the rivets which attach the top and bottom skin panels to the left Rib 10. Make sure the centerline continues to the trailing edge.

- (b) Make marks to show intersections of the rivet centerline at 20 mm (0.79 in.) aft of the last rivets which attach the (top and bottom) skin panels to Rib 10 (left and right). The intersections of the marks shows the locations of the rivets.

- (c) Do Steps (a) and (b) again to show the new rivet location on the right side of the elevator.
- (2) Install the rivets in the top and bottom skin panels.

- (a) Use a 2.5 mm (3/32 in.) and a 3.3 mm (1/8 in.(clearance)) diameter drills in sequence to make the rivet holes at the intersections of the marks on the left top and bottom skin panels (left).
