PILATUS AIRCRAFT LTD. CH-6371 STANS, SWITZERLAND

SERVICE BULLETIN NO: 28-008

FUEL - DISTRIBUTION ENGINE DRIVEN PUMP - TORQUE CHECK OF RELIEF-VALVE-BODY SCREWS

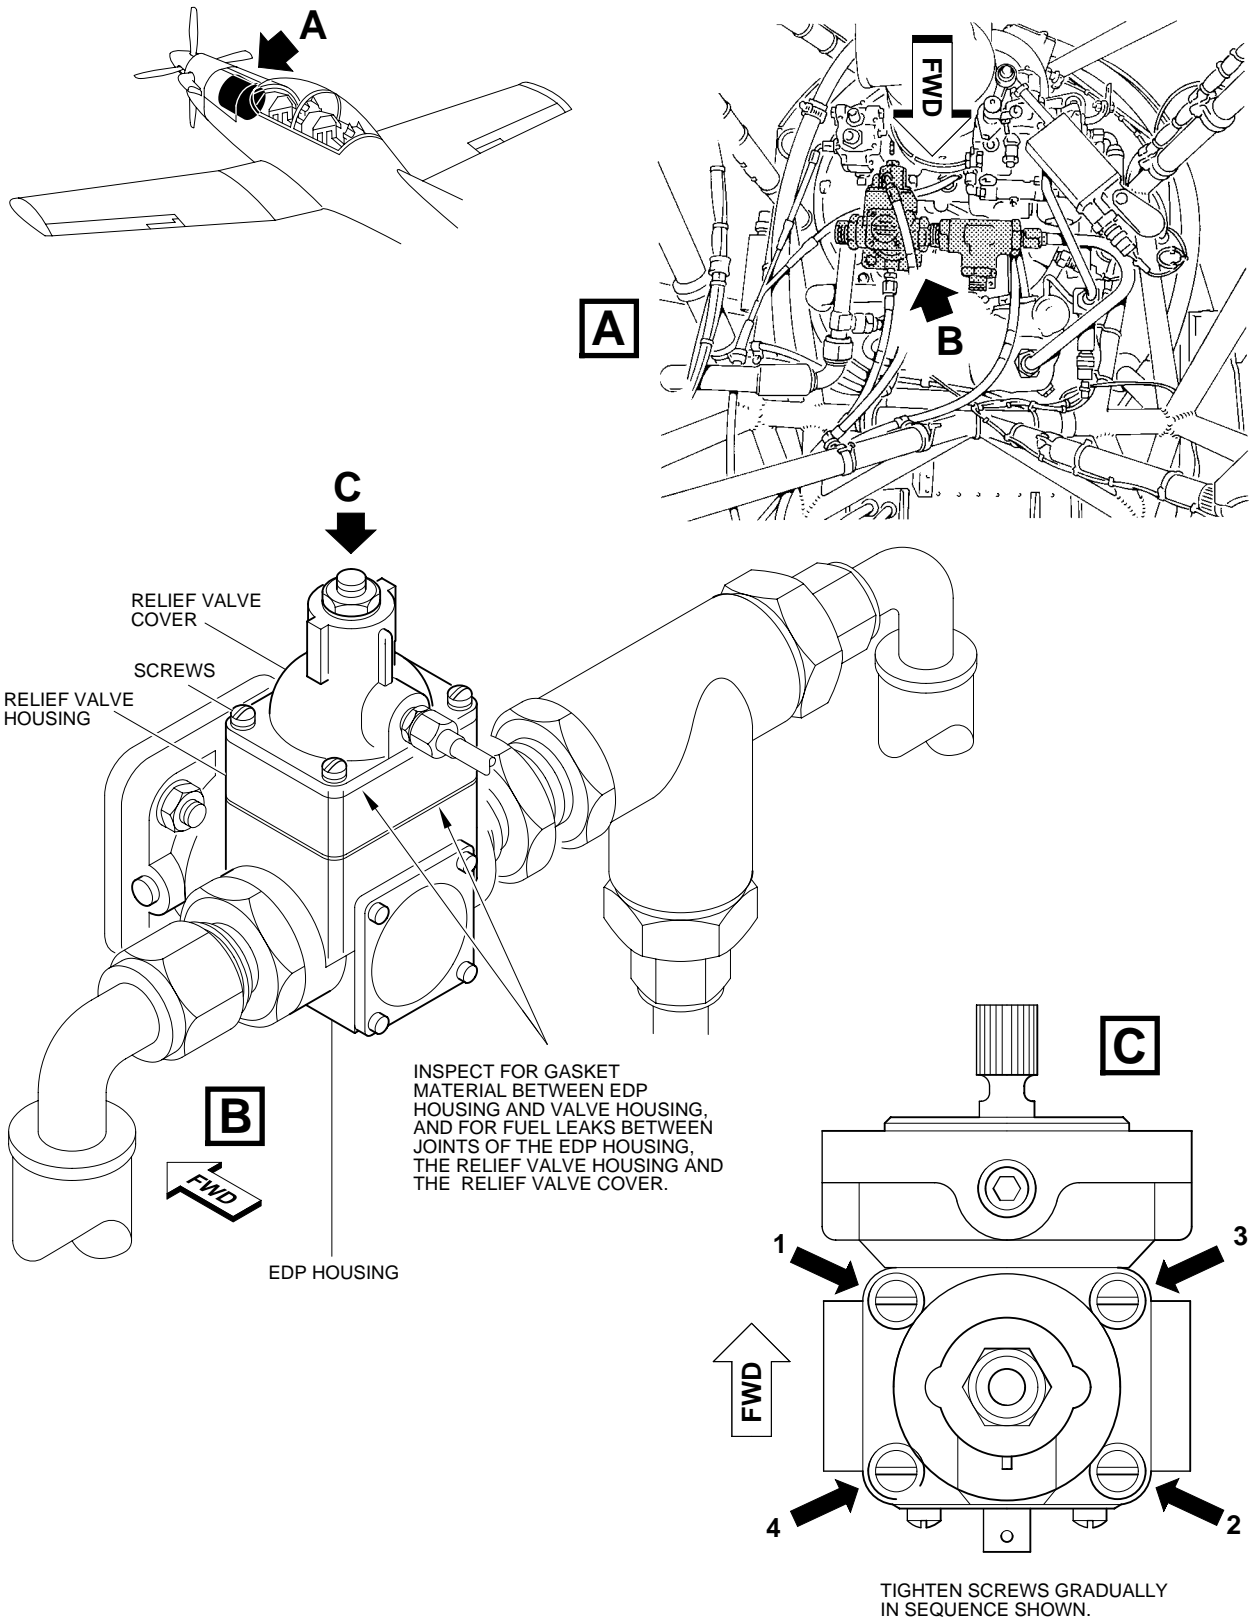
Torque Check and Fuel Leak Inspection of the EDP
Figure 1

Fuel leakage through the gasket of the EDP relief valve.

It is possible the torque of the screws that attach the EDP relief-valve cover to the relief valve housing is not correct. It is also possible that the gasket between the EDP relief-valve housing and the EDP housing has been pushed out.

- (1) Visually inspect the joints between the EDP housing, relief valve housing and the relief valve cover for:
 - Fuel leakage
 - Gasket material pushed out

- (2) If the EDP shows signs of fuel leakage or the gasket between the EDP housing and the relief valve housing has been pushed out, replace the EDP (Ref. AMM, 28-20-10, Page Block 401).

- (3) Use a torque screwdriver to do a check of the torque value of the relief-valve-cover screws. Do the check clockwise only. The minimum torque must be 23 lbf in. (2,6 Nm).

- (5) If the relief-valve-cover screws are loose, or the torque found at Step (3) is less than 23 lbf in. (2,6 Nm), do as follows:

- (b) Torque the screws gradually to between 23 and 25 lbf in. (2,6 and 2,83 Nm). Do this in the sequence shown in Figure 1, Detail B.
