PILATUS AIRCRAFT LTD. STANS, SWITZERLAND

PC-9

Service Bulletin No: 53-021 Ref No: 159

DO A CHECK OF THE MATERIAL SPECIFICATION OF THE FRAME 11 FITTINGS AND, IF NECESSARY, DO A CHECK FOR CRACKS

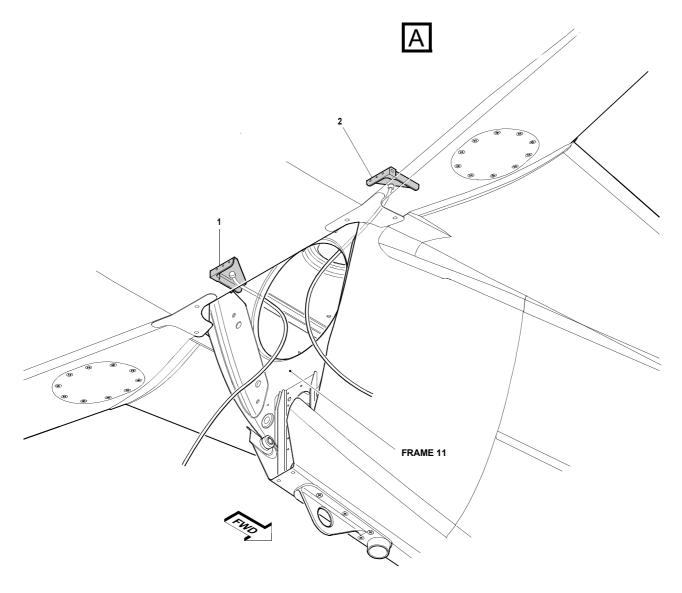
Check of the Material Specification Figure 1

An operator reported Stress Corrosion Cracking (SCC) on the FR 11 left fitting P/N 112.35.07.489 and right fitting P/N 112.35.07.490 (known hereafter as "fittings").

Initially the material specification of the parts was AA2024-T351.

- (1) For the left fitting (1) (P/N 112.35.07.489):
 - (a) Remove the dirt and grease from the test area with the absorbent paper (Material No. P02-031) made moist with the solvent (Material No. P01-010).

(b) Put the eddy current probe in position on the left fitting (1) (P/N 112.35.07.489).

Do this through the hole on FR11. Use a torch and mirror to make sure the eddy current probe is in the correct position.

- Record the value shown on the test equipment. (c)
- (d) Compare the value recorded above with the values recorded in Step 3.A.(6) and determine if the fitting is manufactured from AA2024-T351 or AA2124-T851.
- Do Steps 3.B(1)(b) thru (d) again to make sure the result is the same. (e)
- Make a note of the type of material that the left fitting (1) (P/N 112.35.07.489) is (f) made from.
- Do Step 3.B.(1) of this Service Bulletin again on the right fitting (2) (P/N 112.35.07.490). (2)
- If you find a left or right fitting made from AA2024-T351, continue this Service Bulletin from (3)Step 3.C.
- If the left and right fittings are made from AA2124-T851, continue this Service Bulletin from (4) Step 3.D.
- C. Do an Inspection to Find Cracks with the Borescope and / or Eddy Current (Ref. Fig. 2)

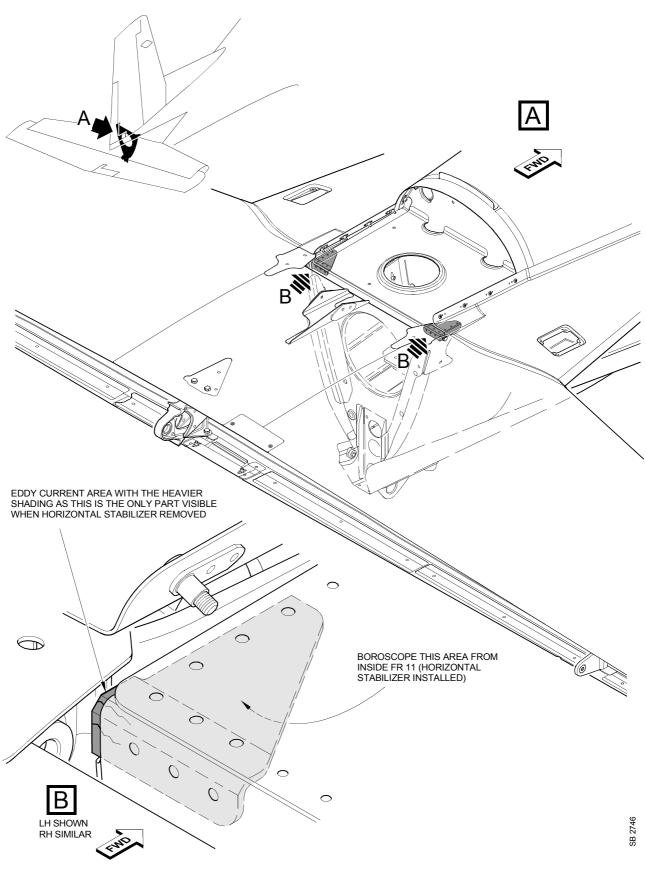
Fittings - Crack Inspection (If Necessary)
Figure 2

NOTE: Step 3.C. is only applicable to fittings made from AA2024-T351.

NOTE: If you find cracks, you must replace the fitting before the next flight (Ref. Service Bulletin 53-022).

Obey the manufacturer's instructions and use a borescope to examine the fitting from (1) inside FR11 (looking AFT) for cracks (Ref. Fig. 2).

Make sure you examine all the visible faces of the fittings.

- If you find cracks, you must replace the fitting before the next flight (Ref. Service Bulletin (2)53-022). Make a copy of the Inspection Report Form (Ref. Fig. 3).
- (3)If you do not find cracks in the area examined in Step 3.C.(1):
 - Remove the horizontal stabilizer (Ref. AMM, 55-10-00, Page Block 401). (a)

- (b) Obey the manufacturer's operating instructions and calibrate the eddy current equipment.
- Examine the area shown in Fig. 2 with the eddy current equipment. (c)

- (4) If you find cracks, you must replace the fitting before the next flight (Ref. Service Bulletin 53-022). Make a copy of the Inspection Report Form (Ref. Fig. 3).
- (5) If you do not find cracks in the area examined in Steps 3.C.(1) and Step. 3.C.(3), make a report of the inspection results, refer Step 3.D.
