Service Bulletin No: 51-001

ATA Chapter: 51

AIRCRAFT STRUCTURE - GENERAL**DO A CHECK OF THE MATERIAL SPECIFICATION USED DURING MANUFACTURE AND, IF NECESSARY, DO A CHECK FOR CRACKS OR REPLACE THE PART****1. Planning Information****A. Effectivity**

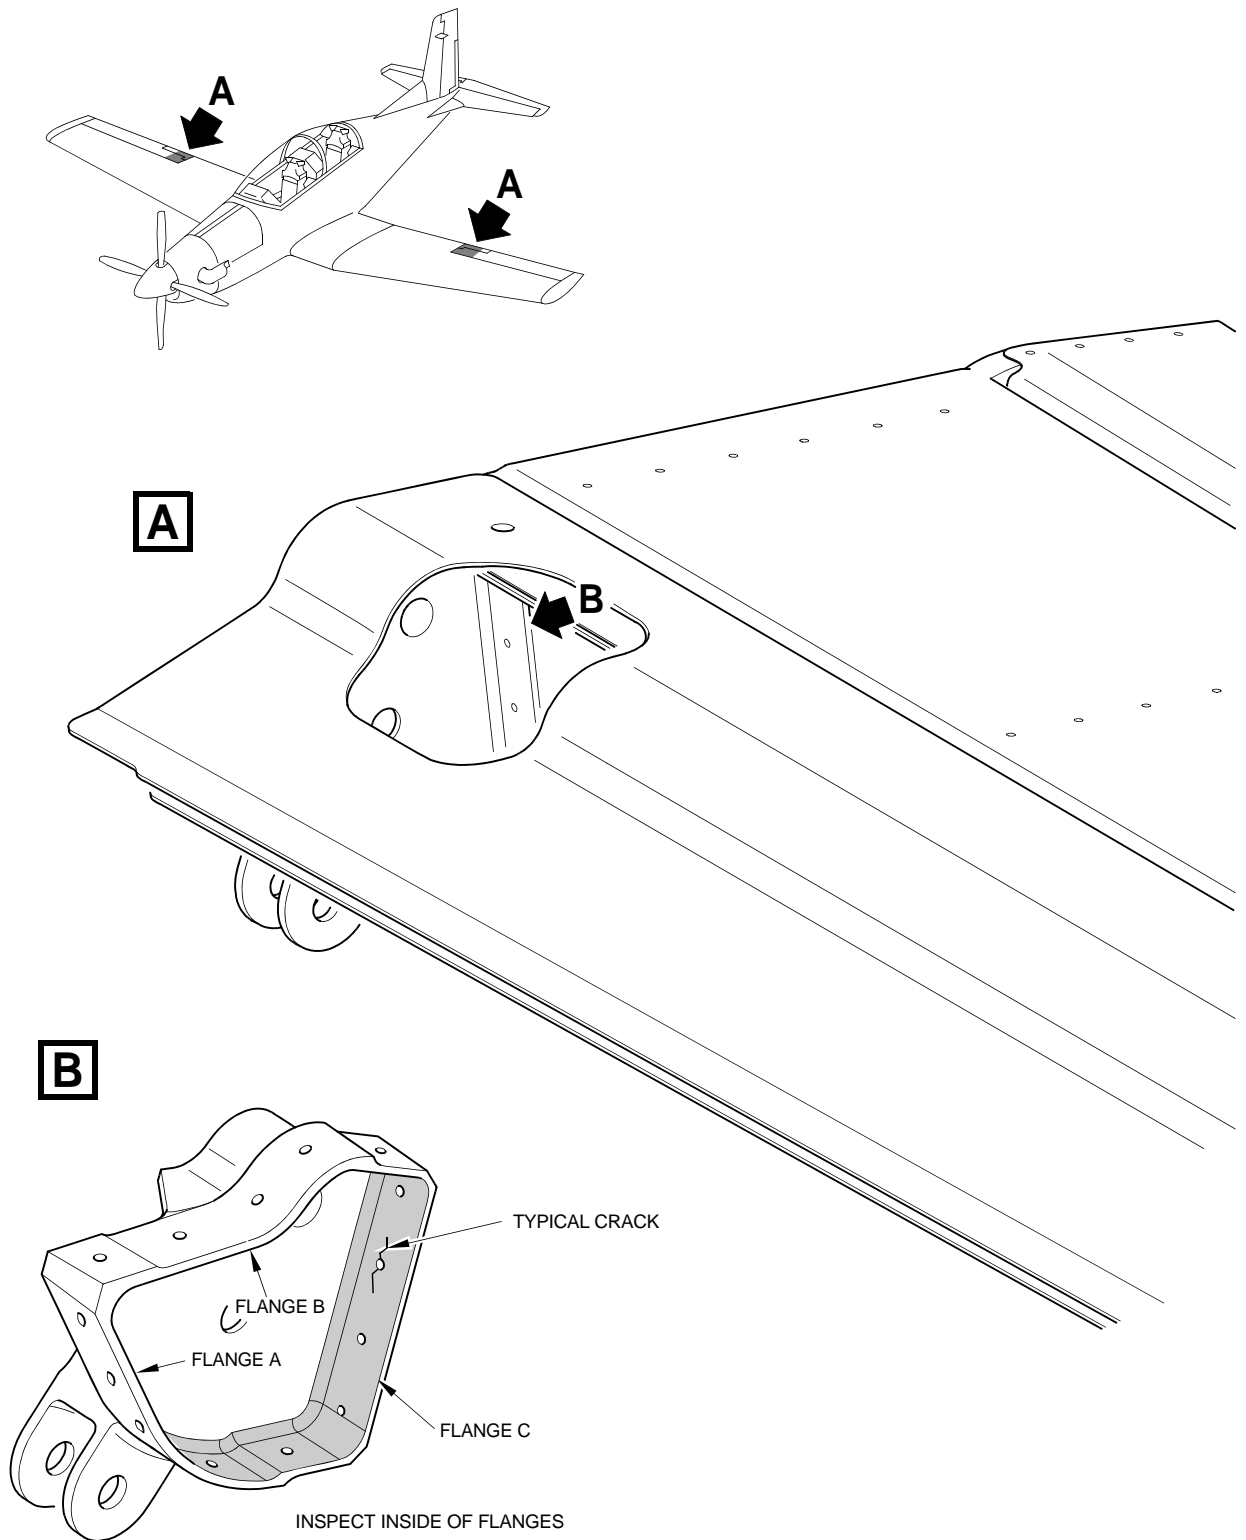
Nose Rib 1 - Inspection (If Necessary)
Figure 3

- 2 Use a bright light source and a mirror to examine the inspection areas of the left-aileron nose-rib 1 for cracks.

- 3 If you find cracks:

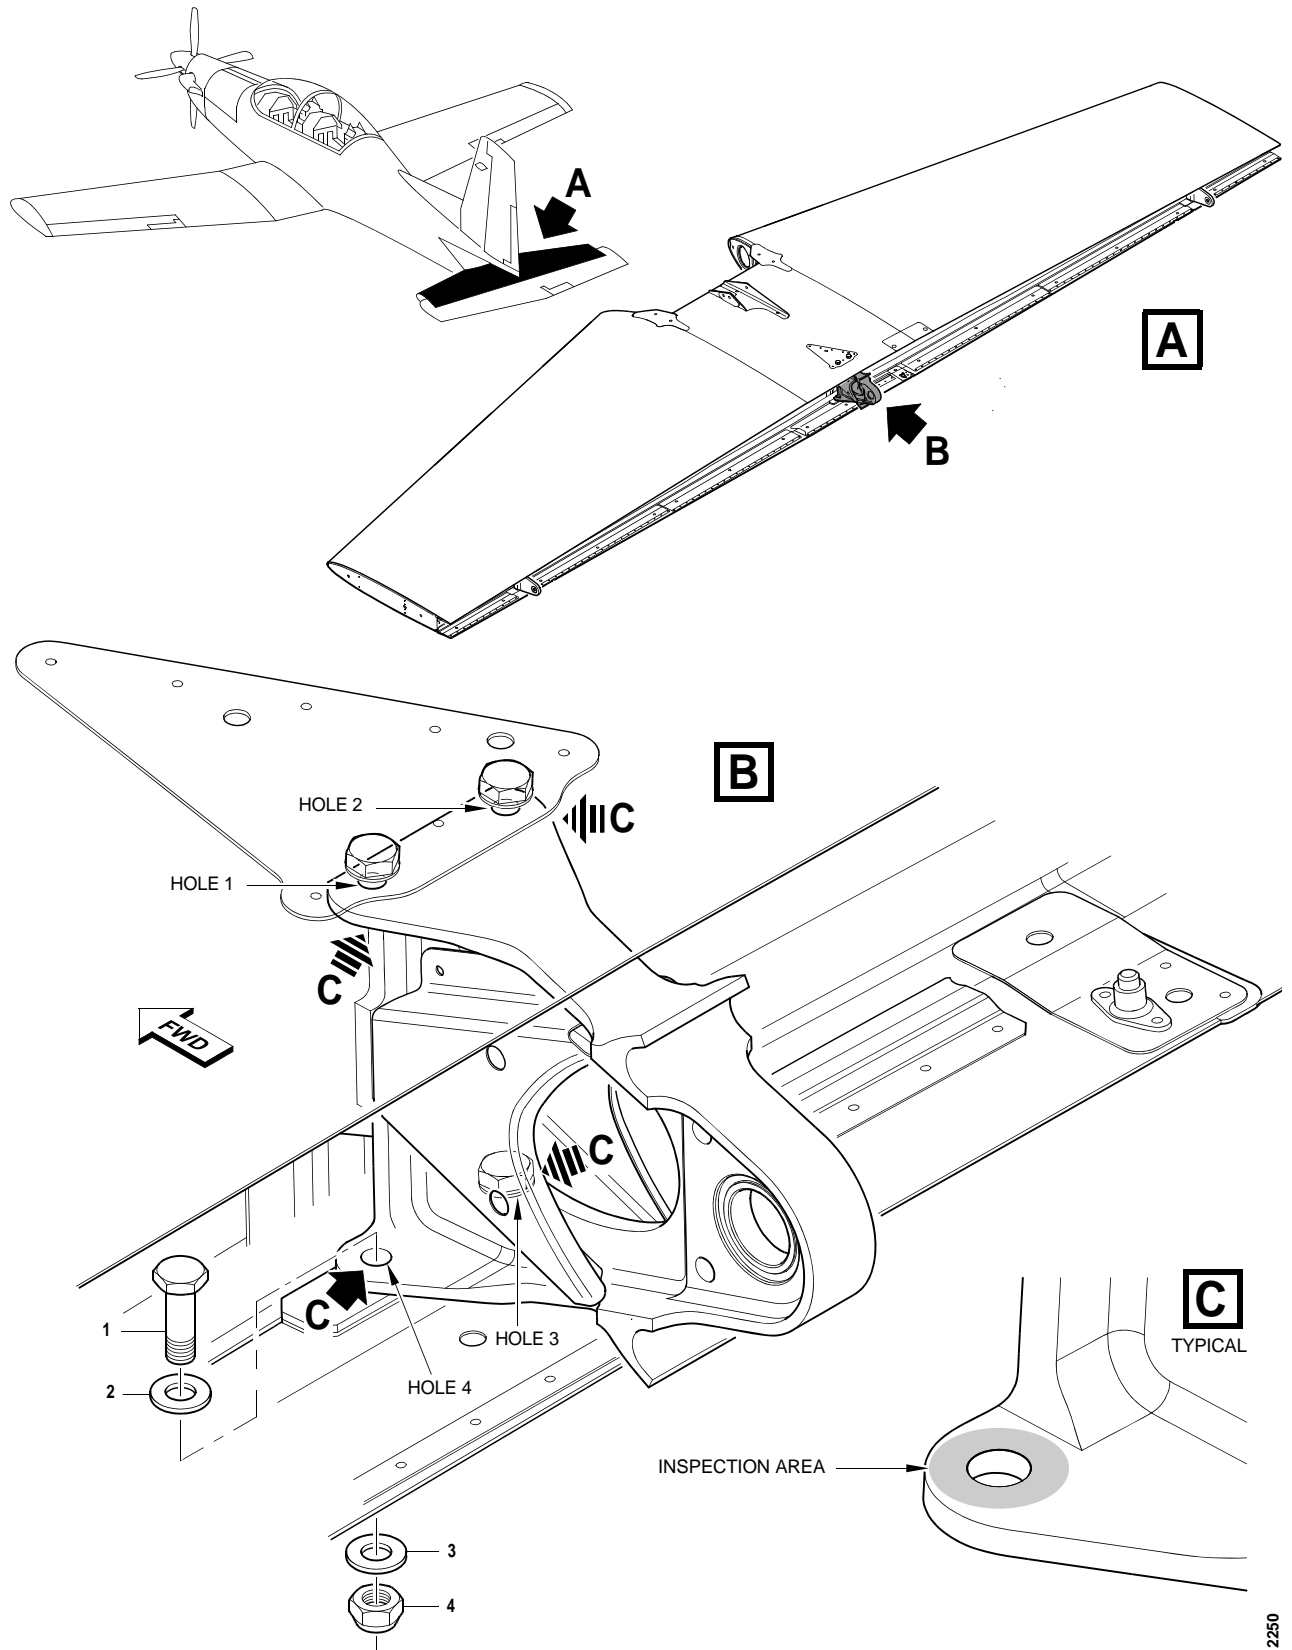
Elevator Center-Attachment Bearing-Bracket - Inspection (If Necessary)
Figure 5

- 5 Obey the manufacturer's instructions and move the probe of the eddy-current NDI equipment over the inspection areas shown in Fig. 5.
- 6 Apply a layer of the corrosion preventative (Material No. P04-039) to the shank of the bolt (1).

- 7 Install the bolt (1), the washer (2), the washer (3) and the nut (4).
- 8 Do Steps 3.B (2)(d)2 thru 7 again for the other 3 holes.
- 9 If you find cracks:

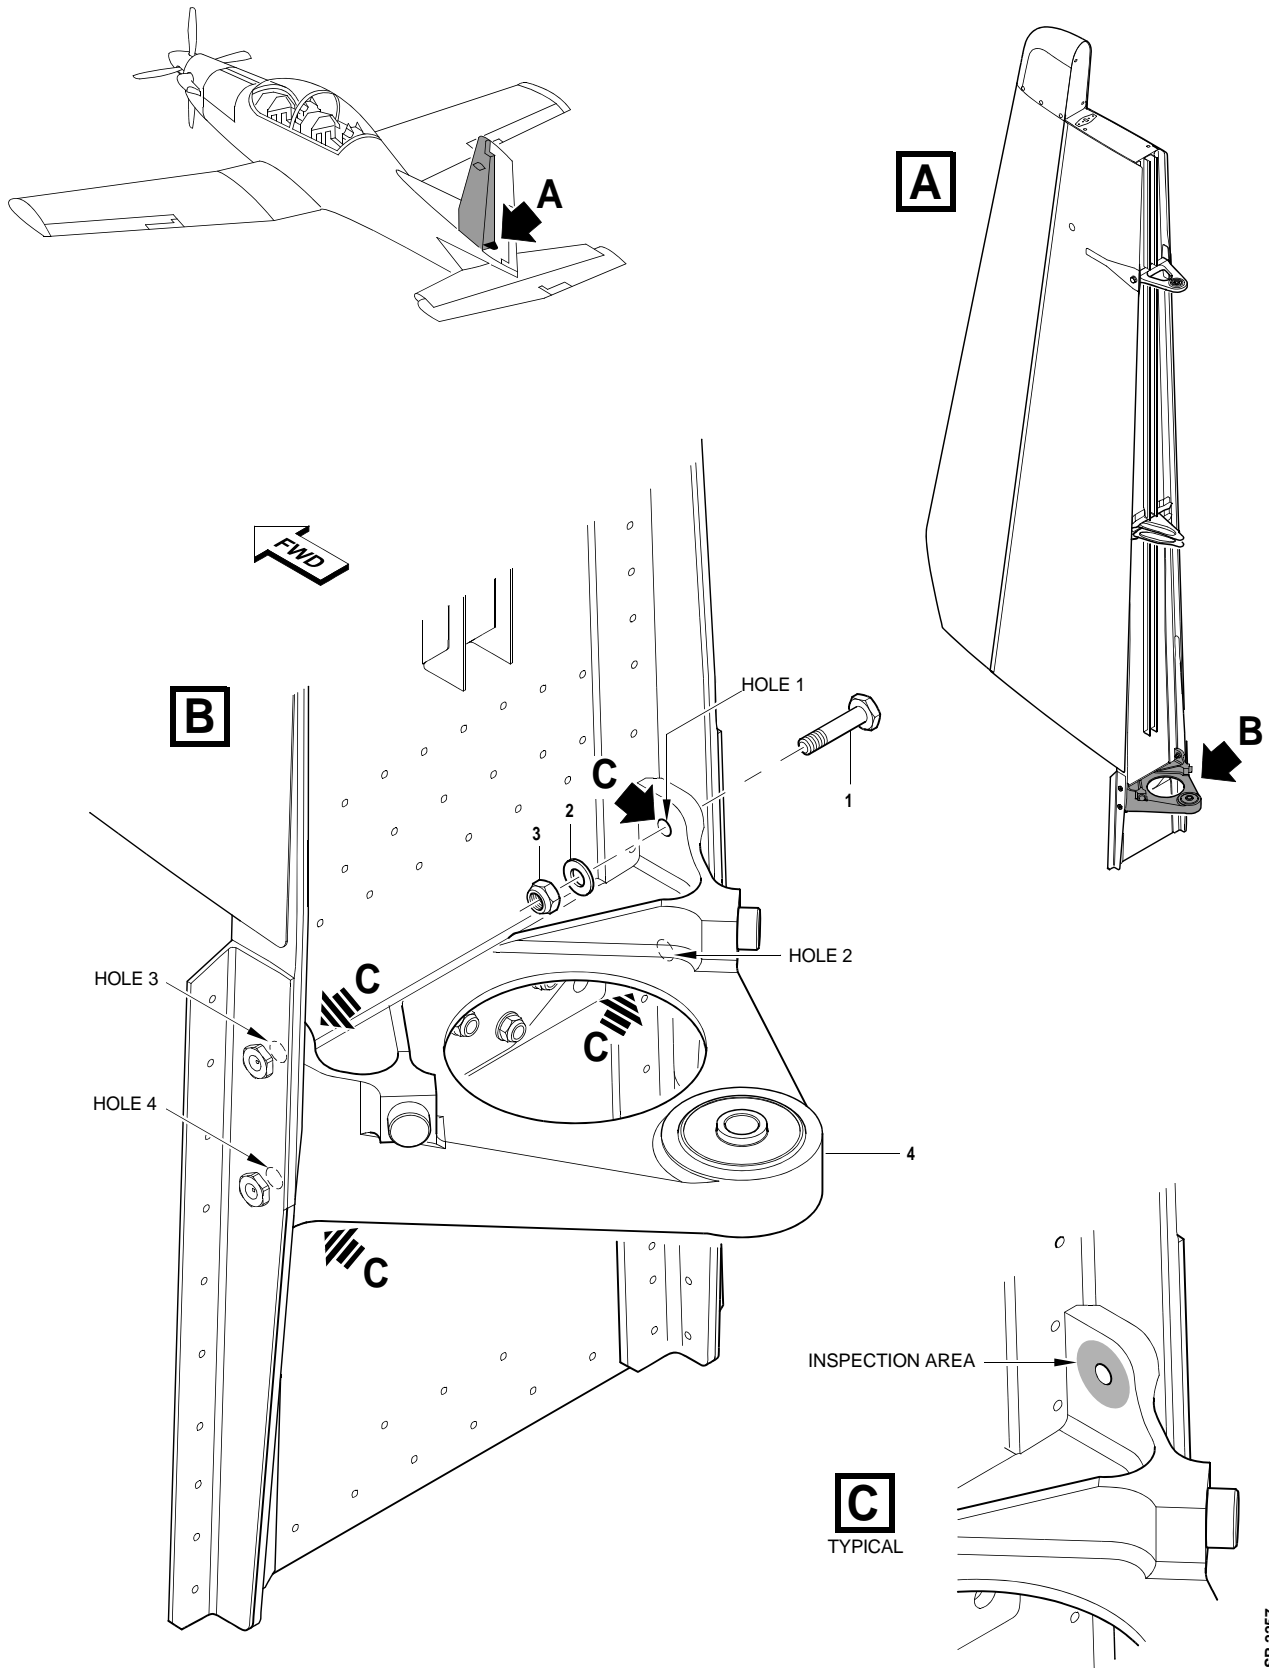
Lower Rudder Bracket - Inspection (If Necessary)
Figure 7

CAUTION: DO NOT PUT LOADS ON THE RUDDER LOWER-HINGE-BRACKET (4) WHEN THE BOLTS (1) ARE REMOVED. THIS COULD CAUSE THE RUDDER LOWER-HINGE-BRACKET (4) TO MOVE SLIGHTLY.

- 8 If you find cracks:

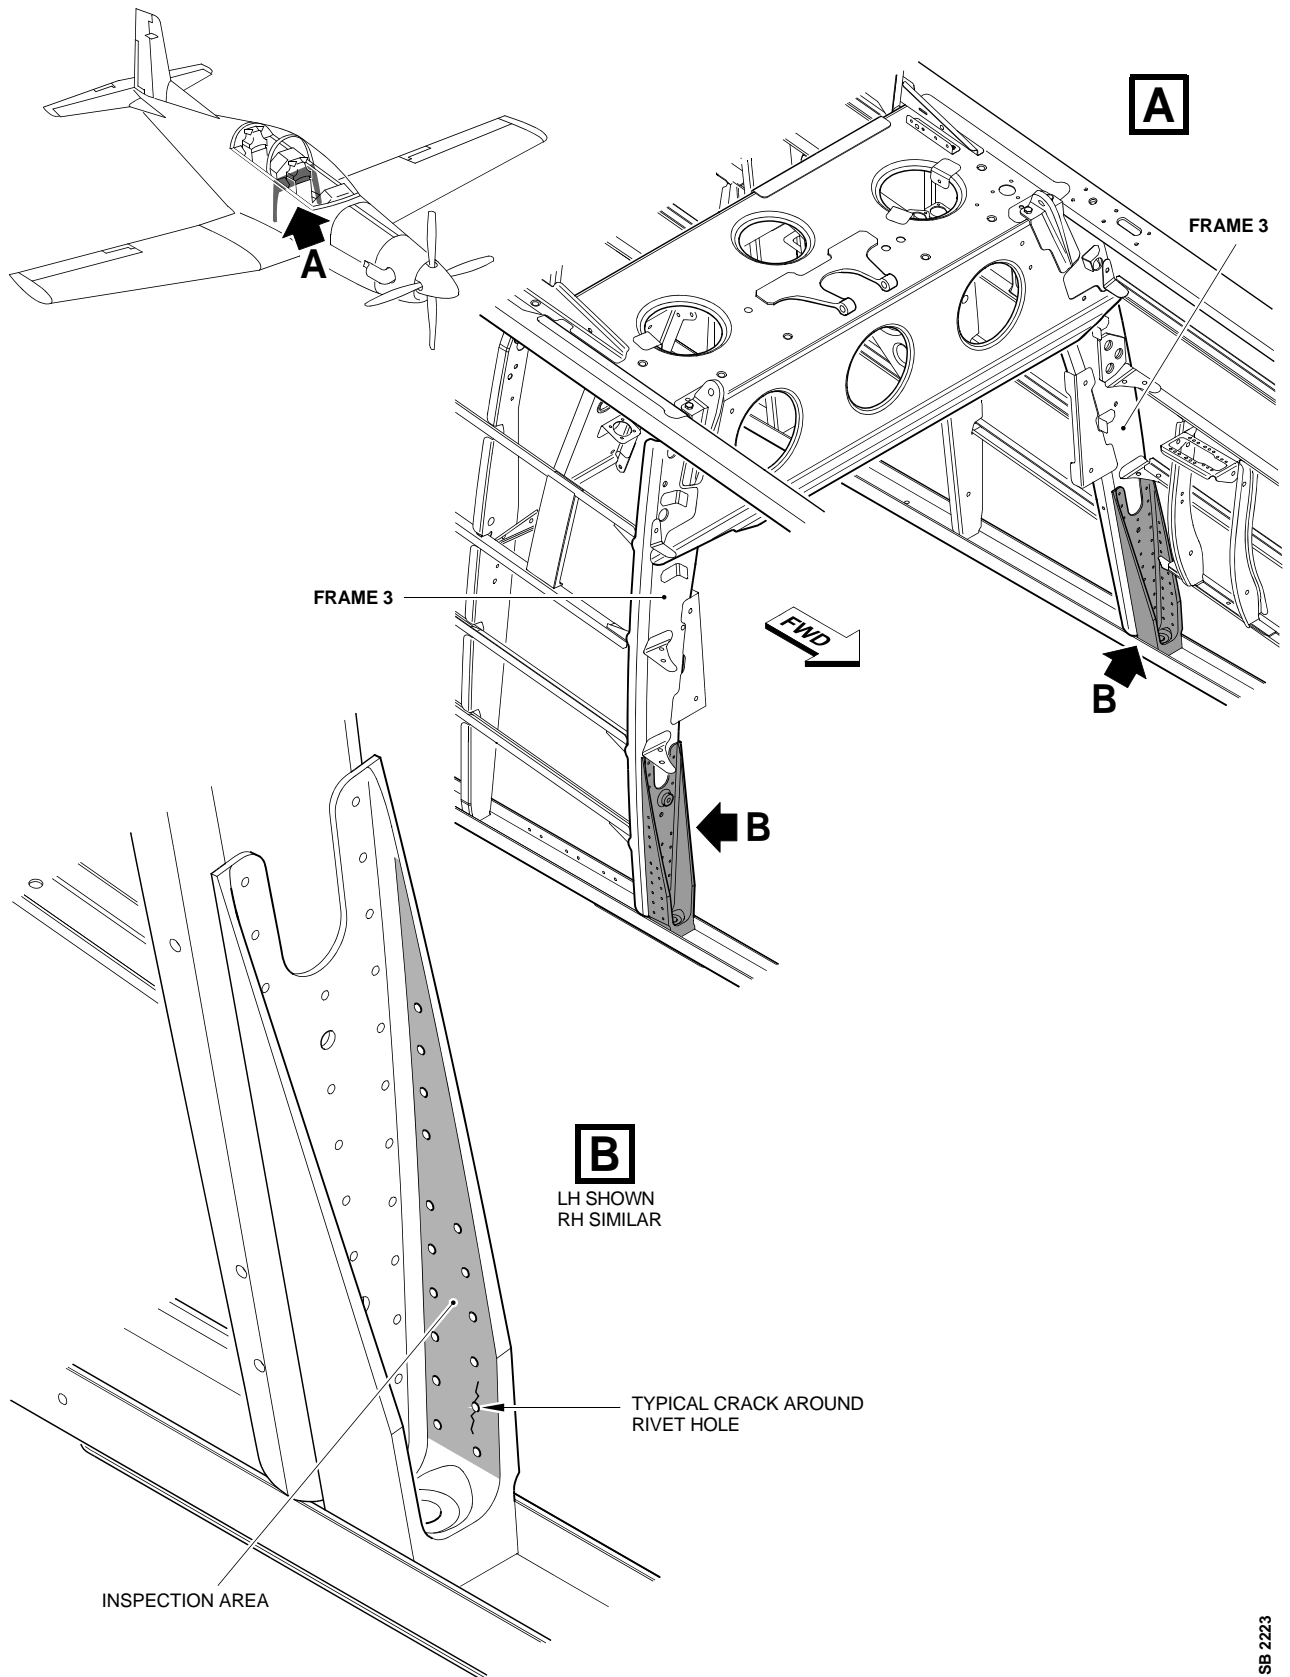
Frame 3 Pick-Up Brackets - Inspection (If Necessary)
Figure 9

2 Obey the manufacturer's instructions and use a boroscope to examine the inspection areas of the left frame 3 pick-up bracket for cracks.

3 If you find cracks:

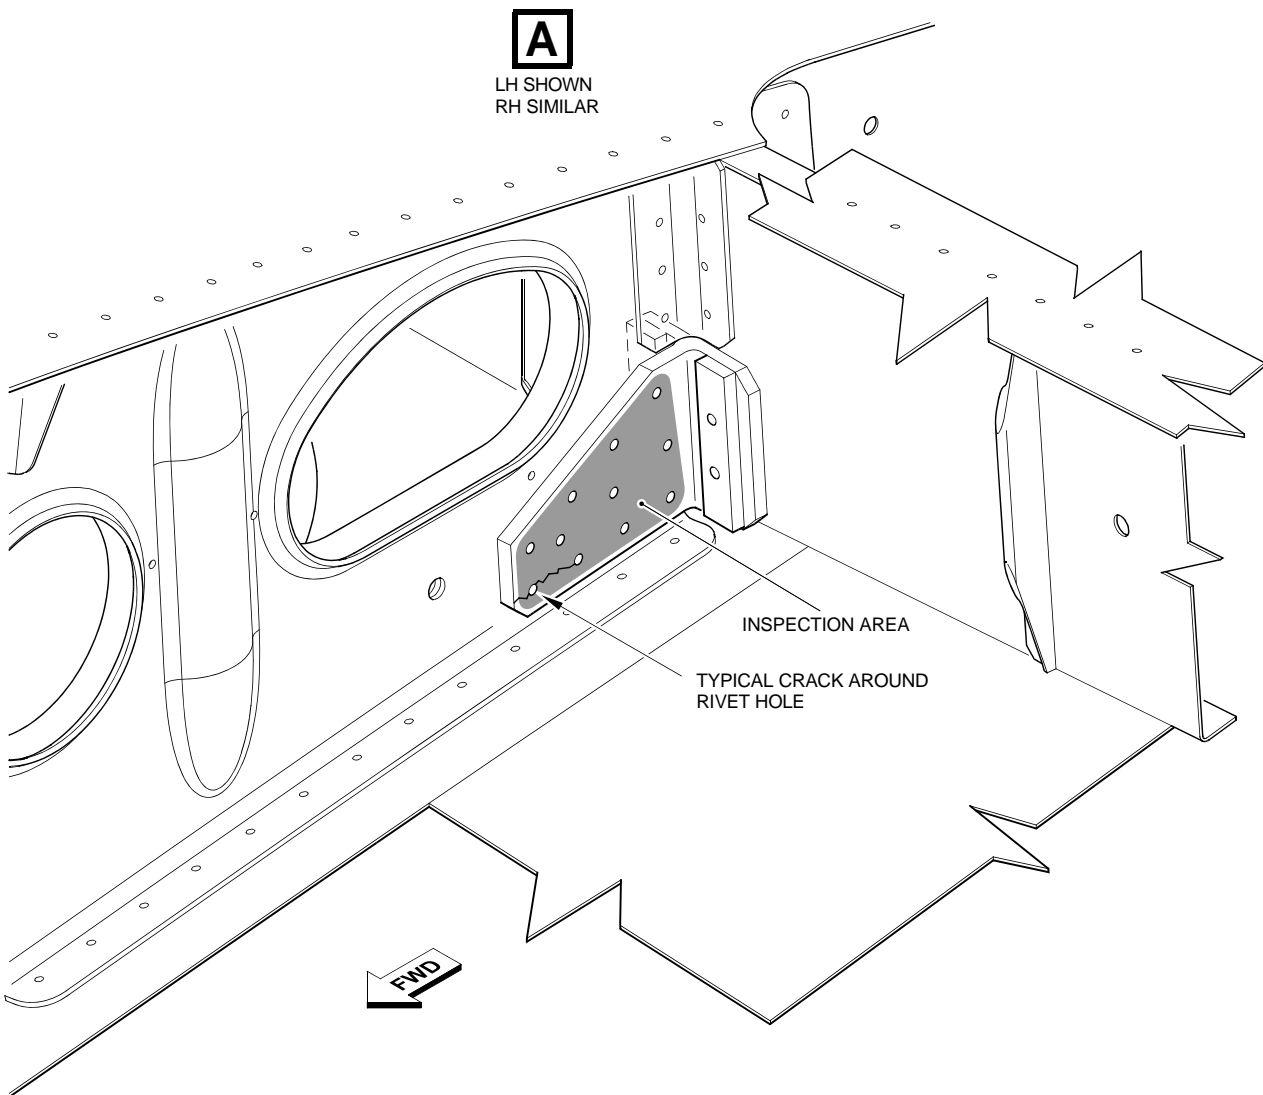
Left and Right Flap Bearing Support-Bracket - Inspection (If Necessary)
Figure 11

2 Obey the manufacturer's instructions and use a boroscope to examine the inspection areas of the left flap bearing support-bracket for cracks.

3 If you find cracks:

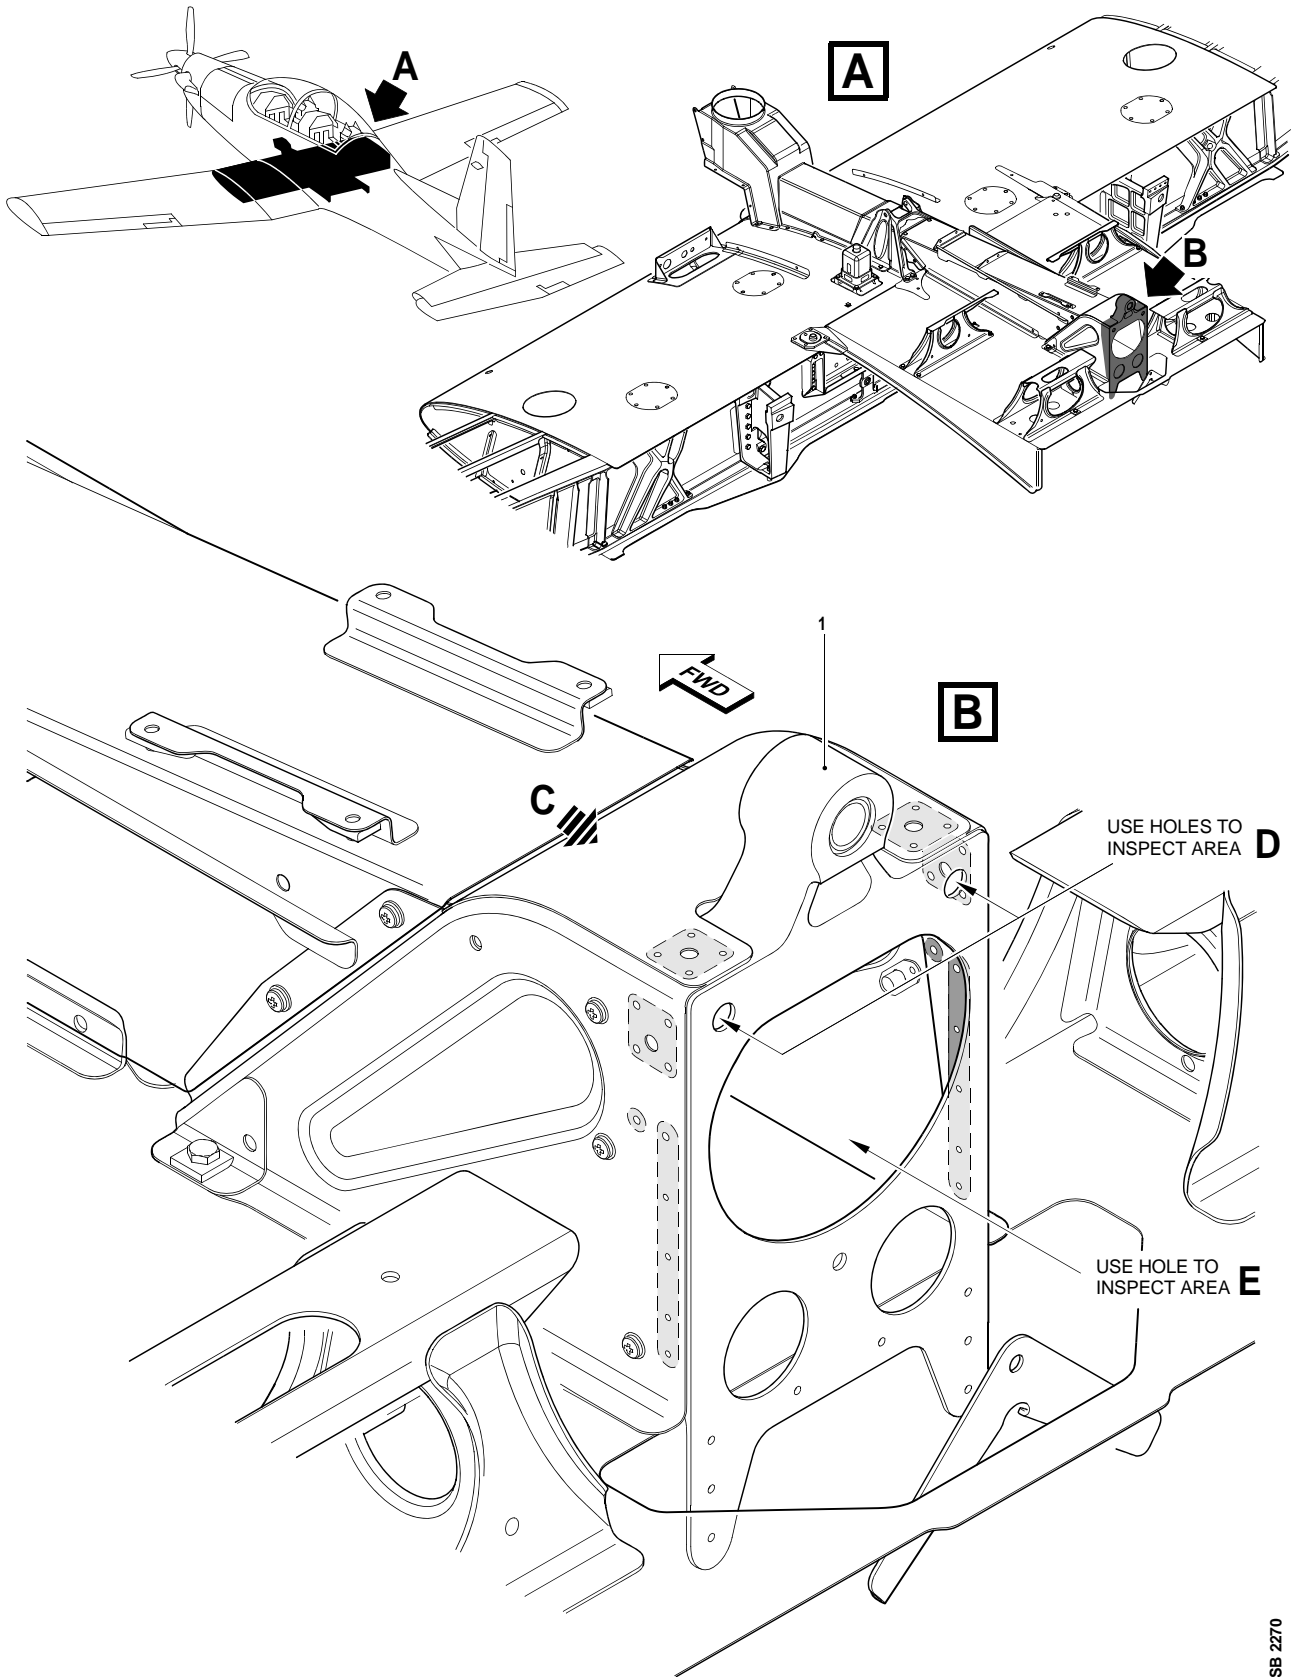
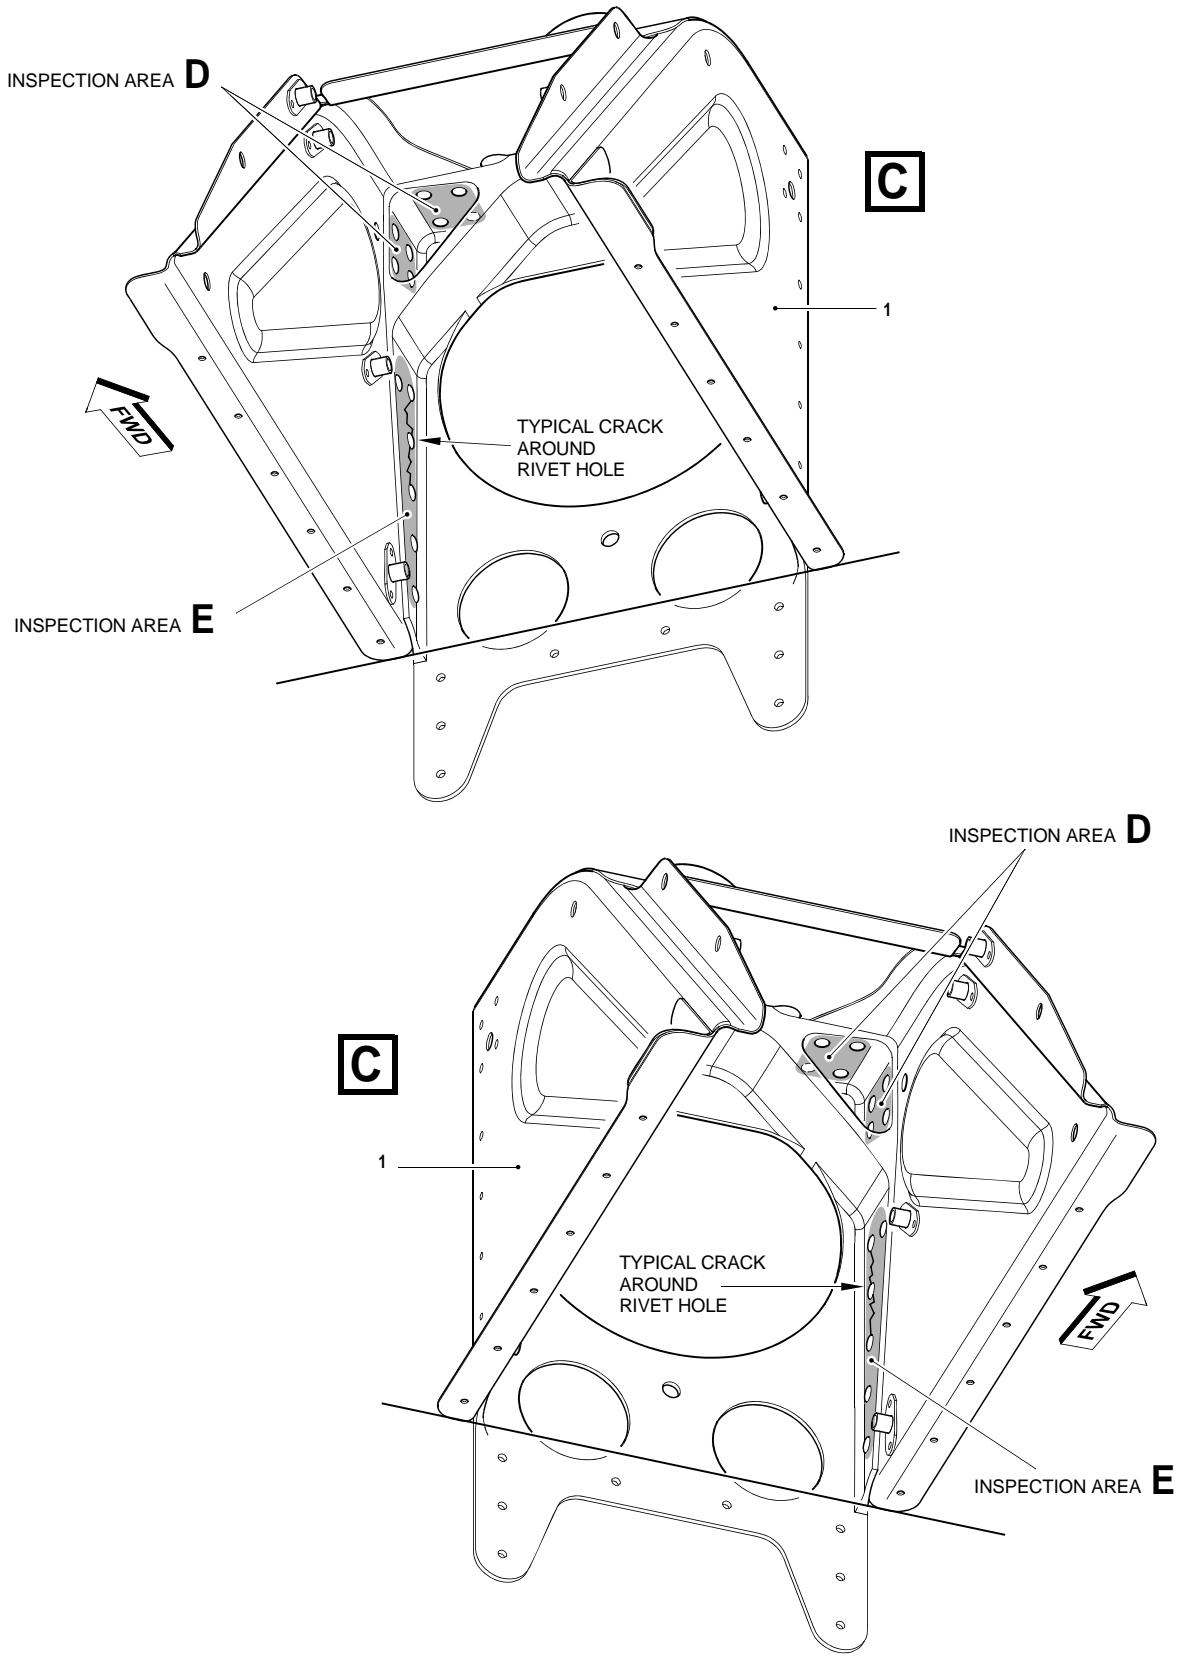
Rear Control-Column Support-Bearing Bracket - Inspection (If Necessary)
Figure 13, Sheet 1 of 2

2 Obey the manufacturer's instructions and use a boroscope to examine the inspection areas of the rear control-column support-bearing bracket (1) for cracks.

3 If you find cracks:

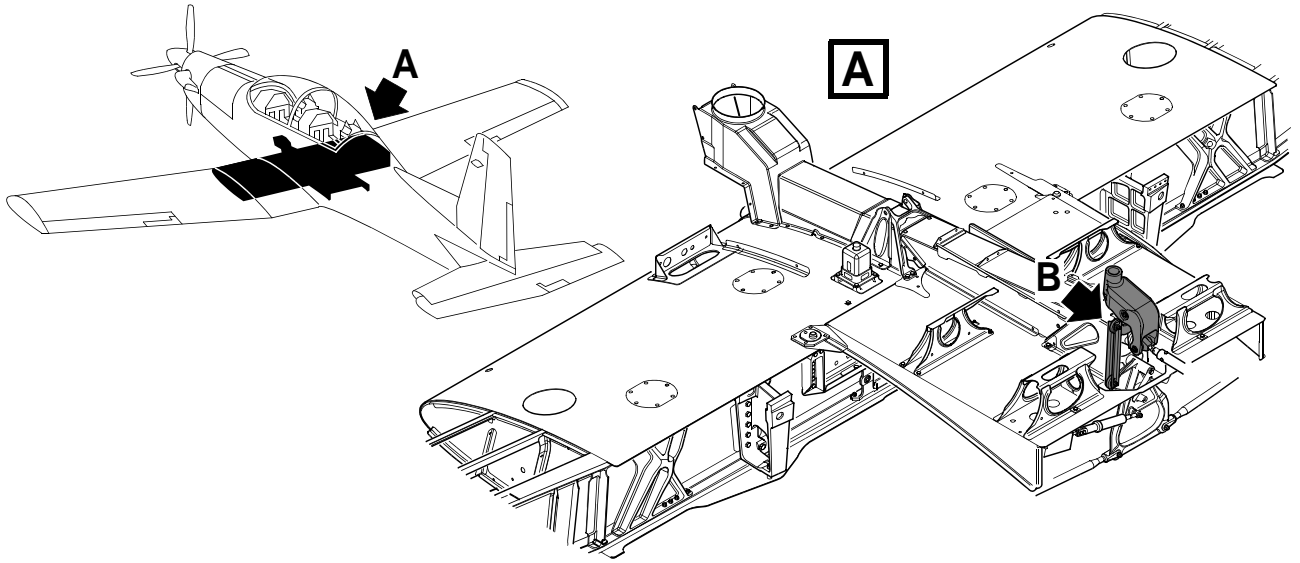
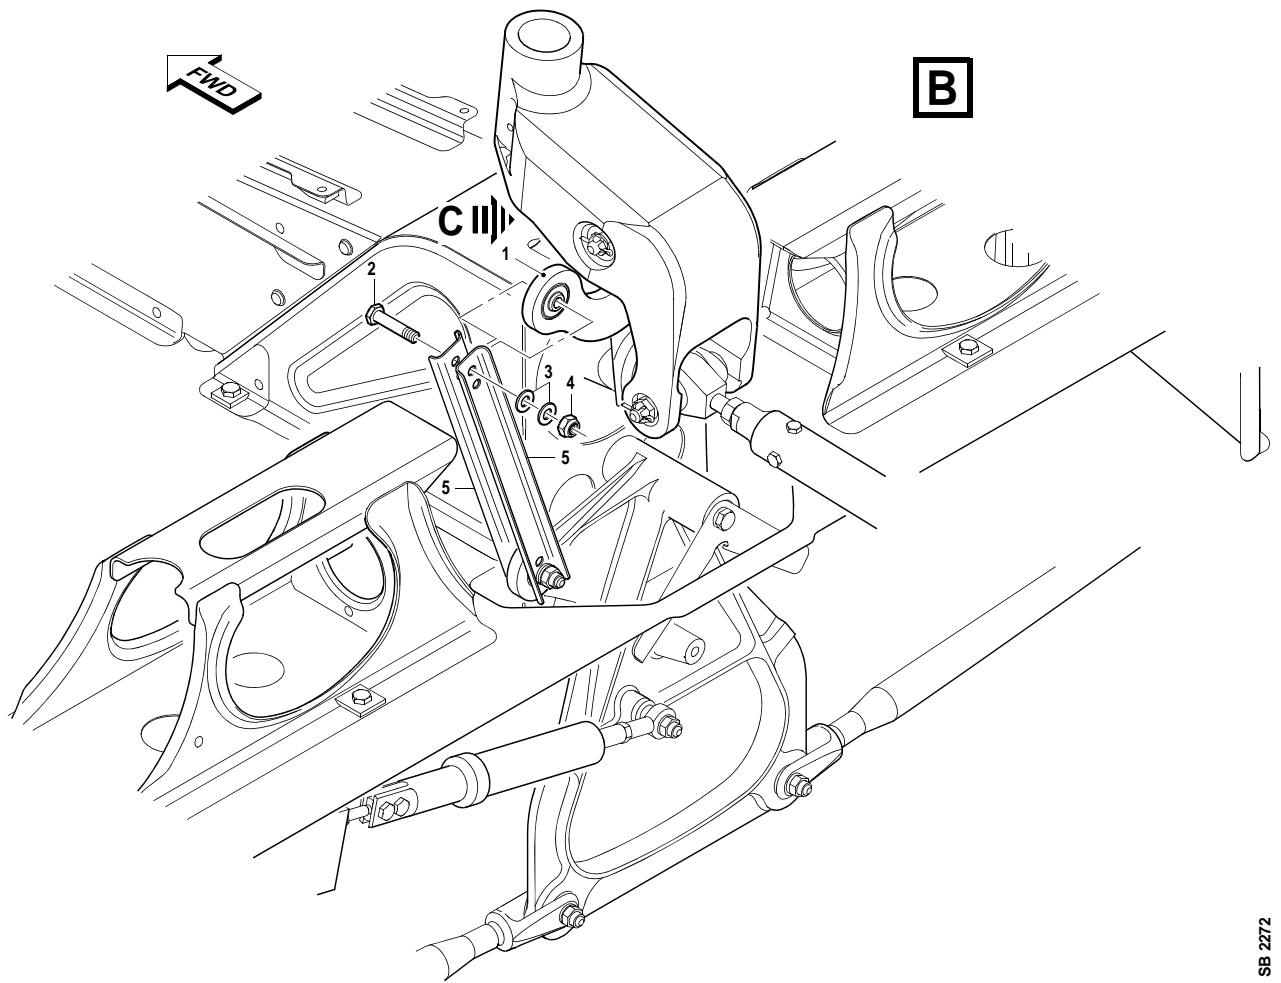
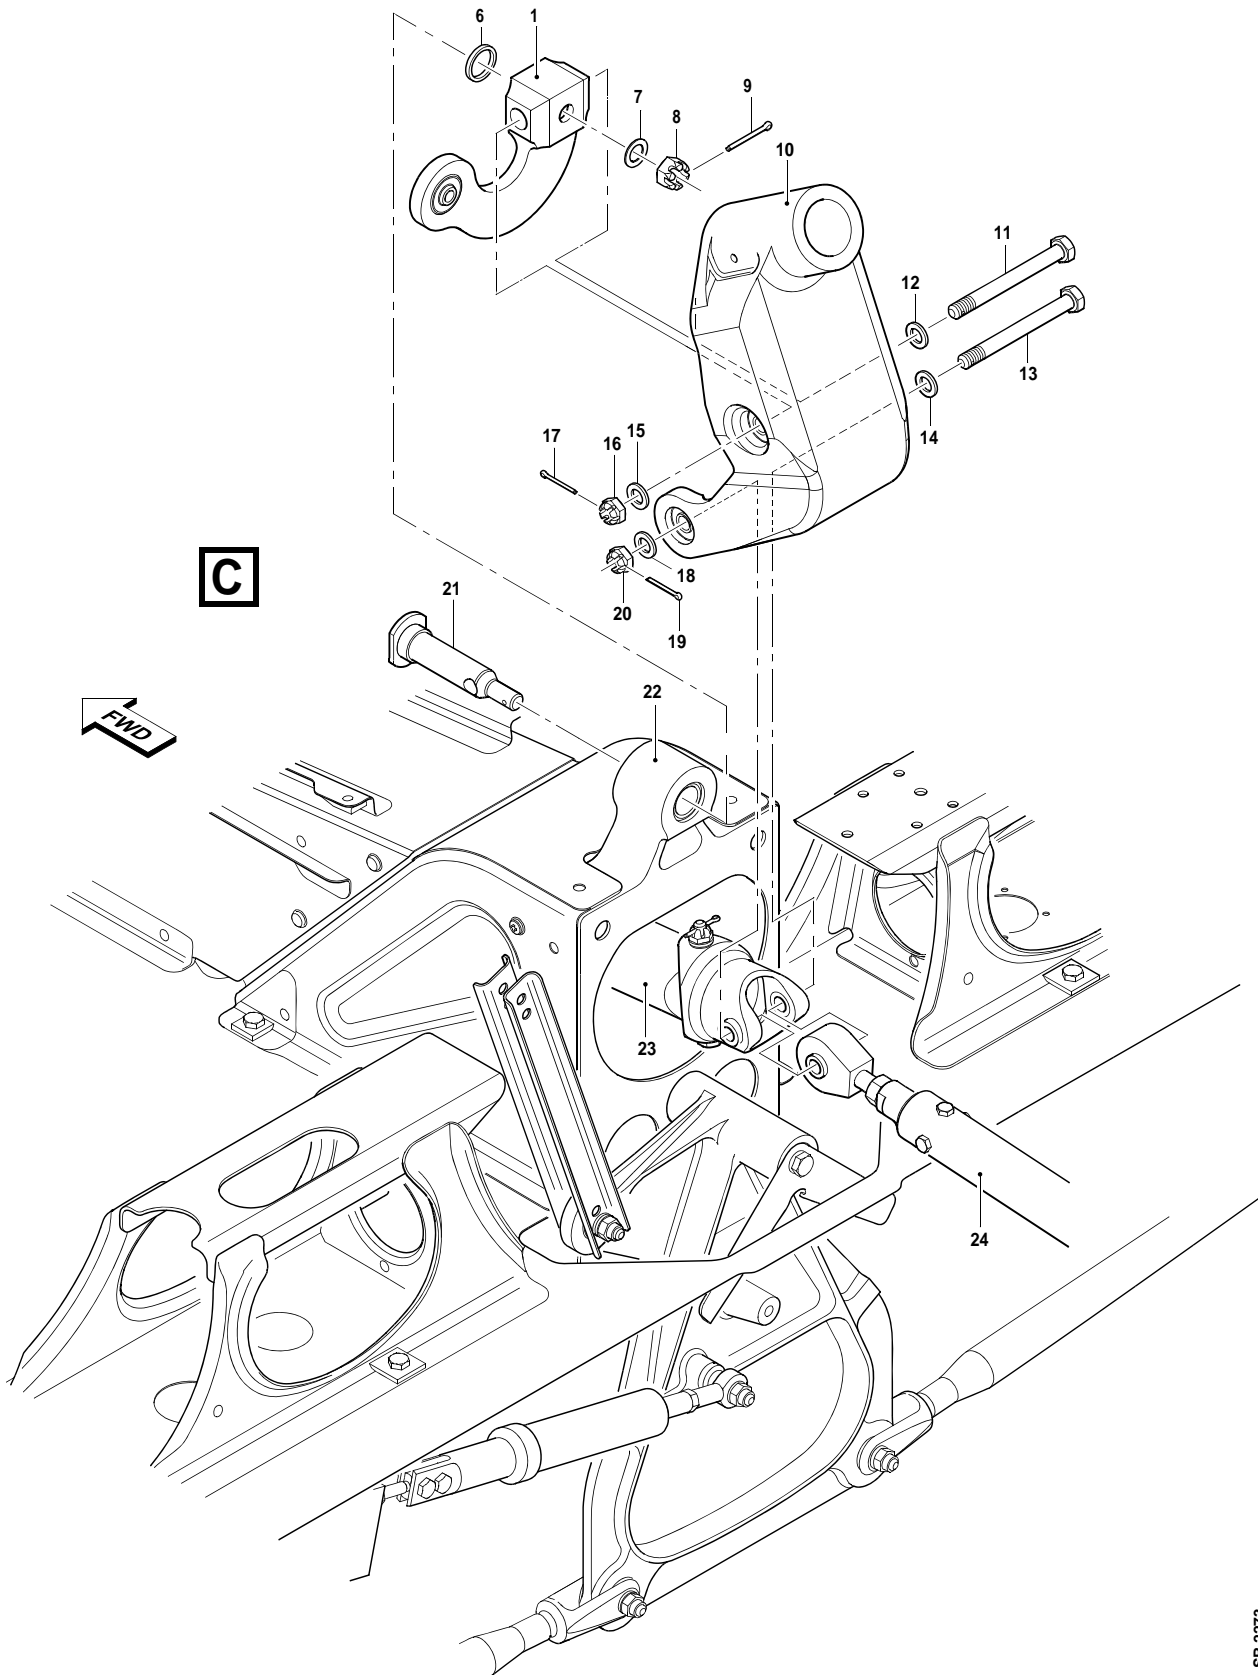
Inspection / Replacement of the Lever on the Rear Control Column
Figure 15, Sheet 1 of 2

(7) Inspection and, if Necessary, Replacement of the Lever on the Rear Control-Column (Ref. Fig. 15)

(d) Replace the lever (Ref. Fig. 15):

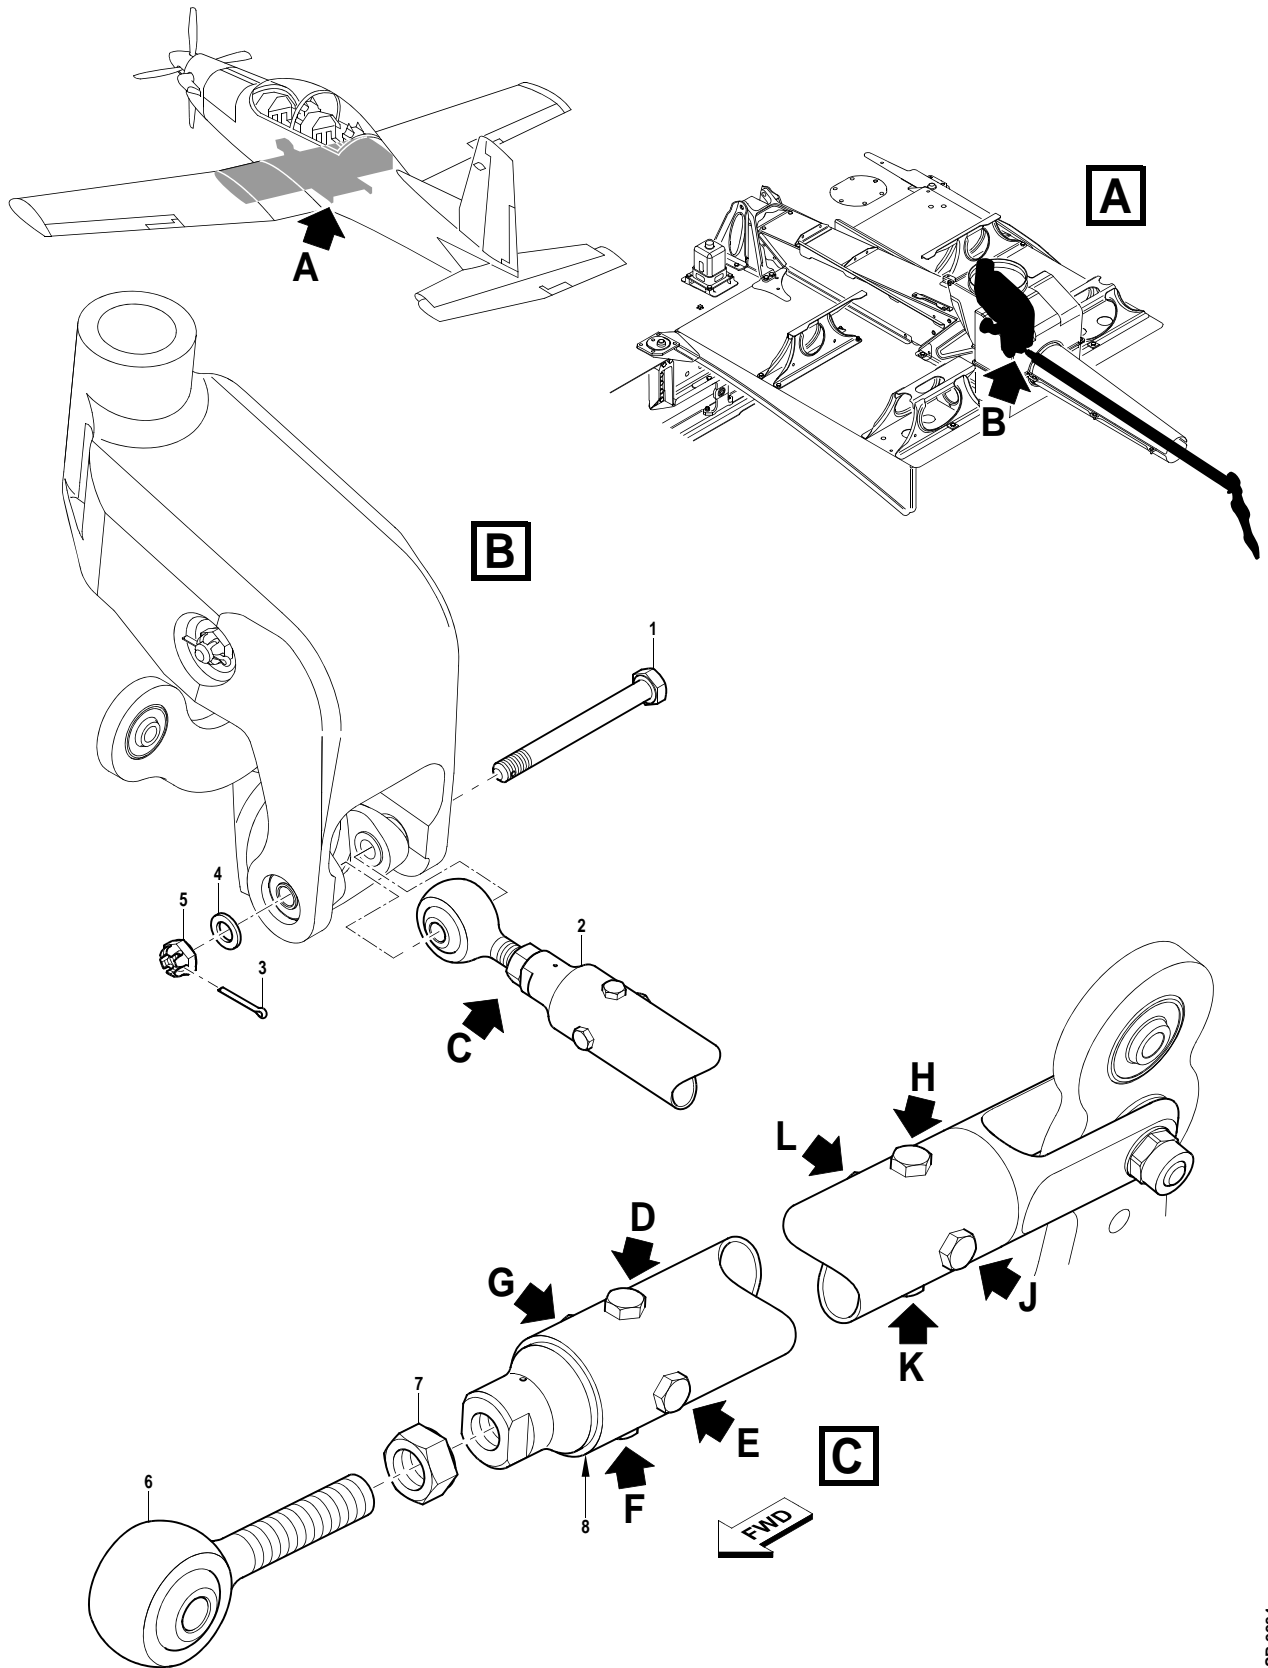
Elevator Center Control-Rod - Inspection (If Necessary)
Figure 16

(c) Do an inspection for cracks (Ref. Fig. 16):

(d) If you find cracks:
