Service Bulletin No: 51-001

ATA Chapter: 51

AIRCRAFT STRUCTURE - GENERAL**DO A CHECK OF THE MATERIAL SPECIFICATION USED DURING MANUFACTURE AND, IF NECESSARY, DO A CHECK FOR CRACKS OR REPLACE THE PART****1. Planning Information****A. Effectivity**

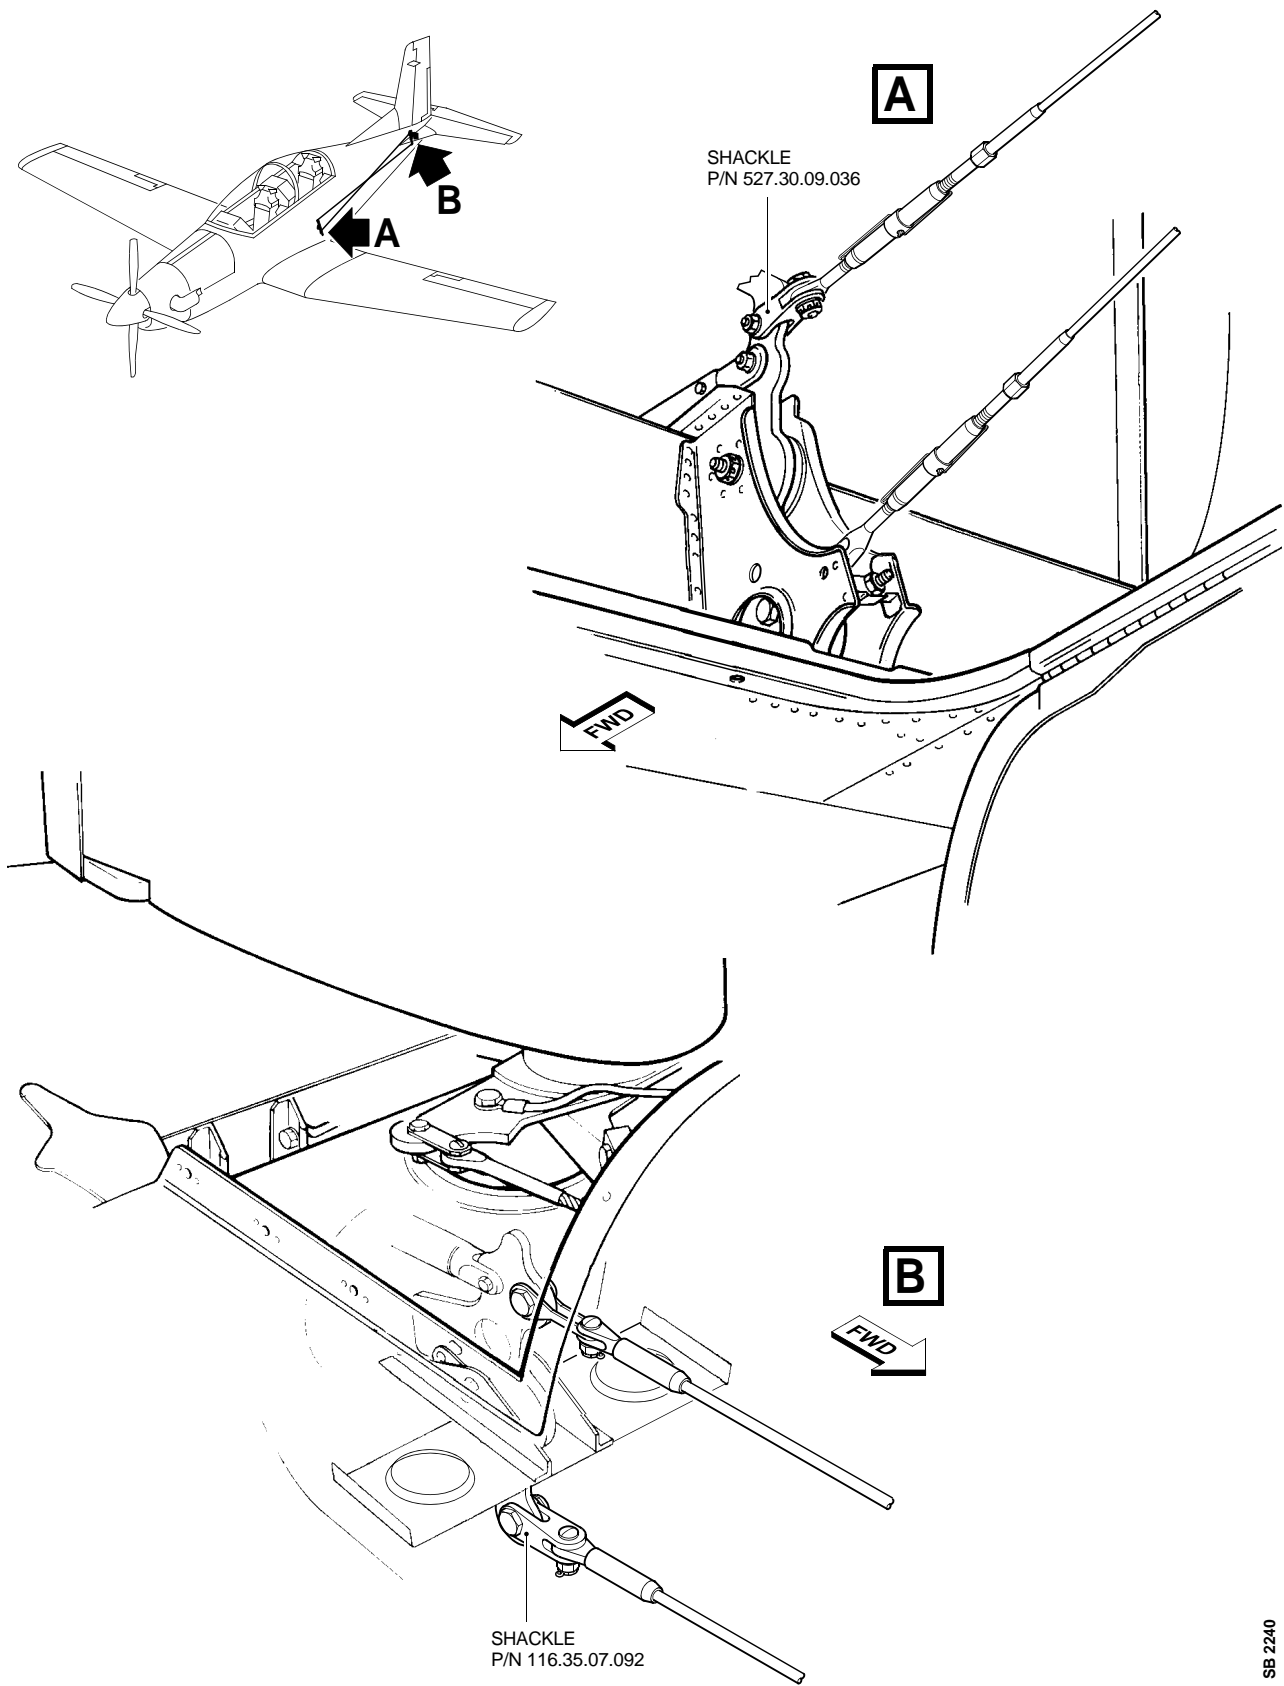
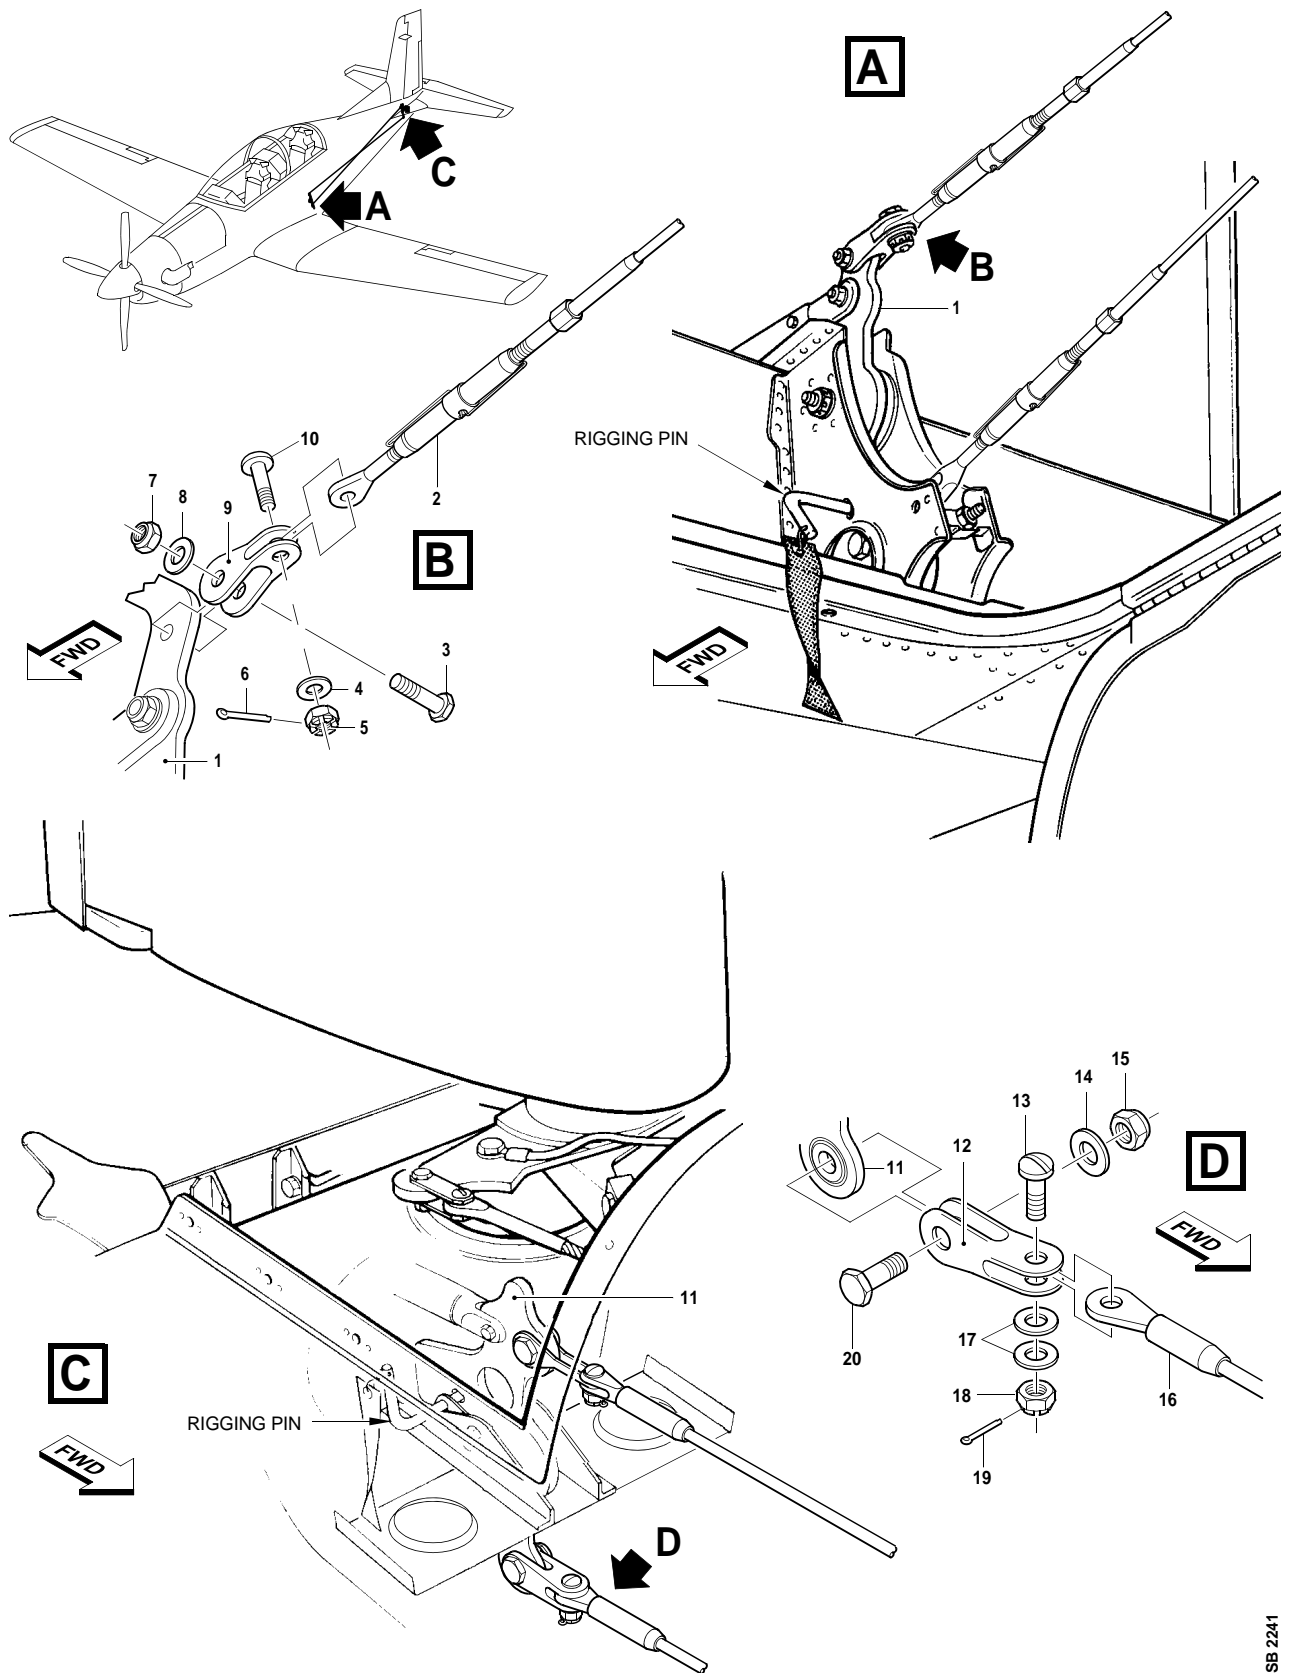
Inspection and, if necessary, Replacement of the Shackles on the Elevator Control Cable
Figure 21

(11) Inspection and, if necessary, Replacement of the Shackles on the Elevator Control Cable (Ref. Fig. 21 and Fig. 22)

- 8 Remove, and discard, the shackle (12) from the aircraft.
- 9 Use the absorbent paper (Material No. P02-031) made moist with the solvent (Material No. P01-010) and clean the attachment points on the lever (11) and the cable (16).
- 10 Put the new shackle (12) (P/N 527.30.09.231) in position between the lever (11) and the control cable (16).
- 11 Install the bolt (13), the washers (17) and the nut (18) that connect the shackle (12) to the control cable (16).
