SERVICE BULLETIN NO: 53-009 REF NO: 108

FUSELAGE ENGINE MOUNTING-FRAME ATTACHMENT-FITTINGS - INSPECTION

■PILATUS PC 9 SERVICE BULLETIN

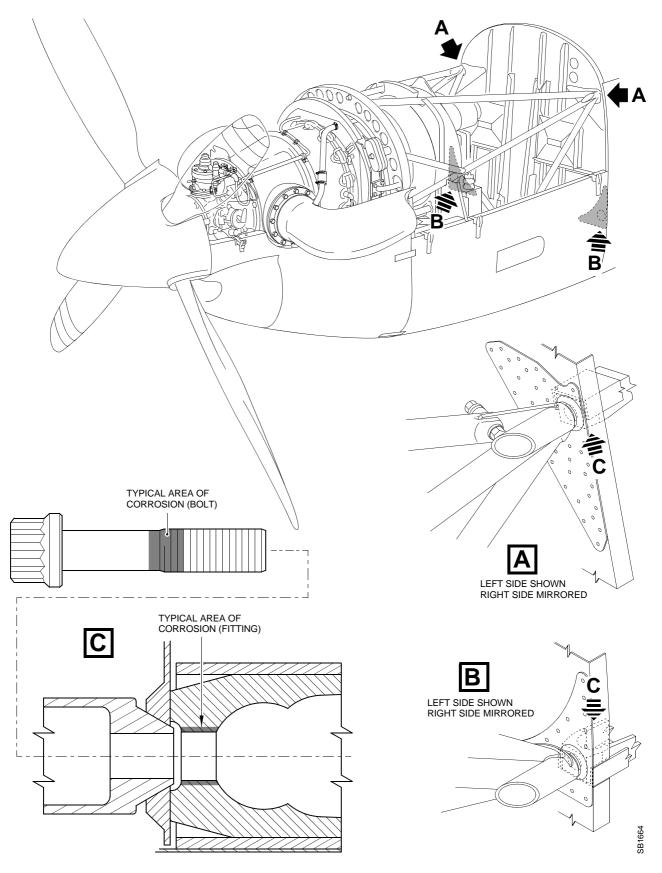
Engine Mount Attachment Fittings - Inspection/Repair Figure 1

Corrosion has been found on the bolts and in the bores of the attachment fittings for the engine mounting frame.

Damage to the cadmium plating of the bolt, or to the surface finish of the attachment fitting, can cause corrosion. The damage is caused when the bolts are removed and installed.

- (1) Remove the bolt and washer from one of the four engine mounting-frame attachment points (Ref. AMM 71-20-01, Page Block 401).
- (2) Do a visual inspection for corrosion on the removed bolt.
- (3) Do a visual inspection for corrosion in the bore of the attachment fitting. Do this with a boroscope. If you find corrosion, do the subsequent steps:

- (a) Use aluminum wool (Material No. P02-002) to remove surface corrosion.
- (b) If you cannot remove all of the corrosion contact Pilatus for repair information.

- (c) Clean the bore and the threads of the barrel nut with solvent (Material No. P01-008) and absorbent paper (Material No. P02-031).
- (d) Remove all swarf and debris from the attachment fitting. If necessary, you must remove the barrel nut and/or the engine mounting frame to do this. Make sure there is no swarf and debris in the joints between:

- · The attachment fitting and the barrel nut
 - The attachment fitting and the engine mounting frame.
- (e) Apply a layer of CCC solution (Material No. P07-001) to the bore.

- (f) If necessary, install the barrel nut and/or the engine mounting frame.
- (4) Install the new bolt (P/N 571.20.09.031) and the washer (P/N 938.75.11.105) (Ref. AMM 71-20-01, Page Block 401).
