PILATUS AIRCRAFT LTD. STANS, SWITZERLAND

PC-9

Service Bulletin No: 53-015 Ref No: 135

DO A CHECK OF THE MATERIAL SPECIFICATION USED IN THE MANUFACTURE OF THE ENGINE MOUNT FITTINGS AND, IF NECESSARY, DO A CHECK FOR CRACKS WITH A BOROSCOPE

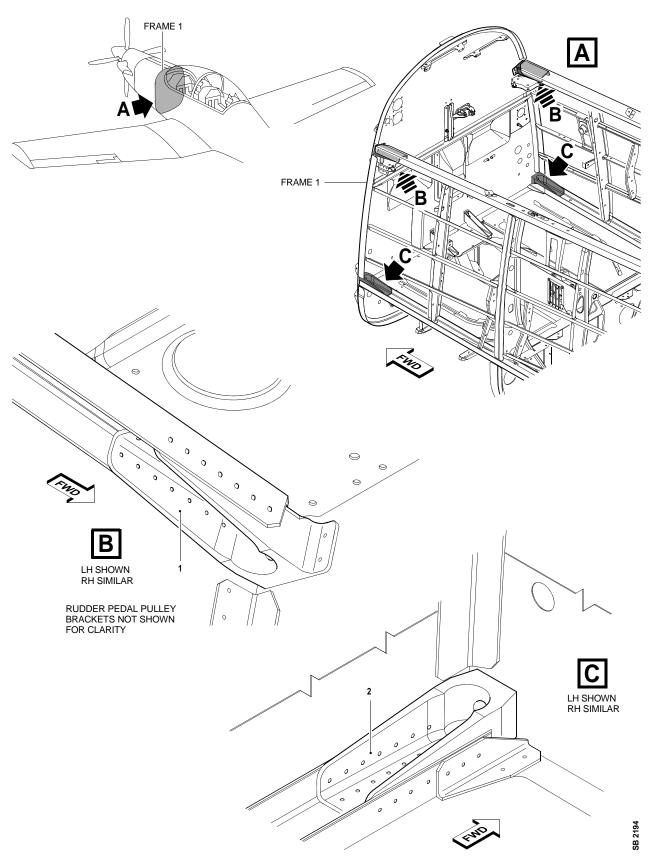
Check of the Material Specification Figure 1

B. Do the Test to Find the Material Specification (Ref. Fig. 1)

(1) For the left upper engine-mount attachment-fitting (1) (P/N 553.10.09.123):

- (b) Put the eddy current probe in position on the left upper engine-mount attachmentfitting (1) (P/N 553.10.09.123).
- Record the value shown on the test equipment. (c)

- (d) Compare the value recorded above with the values recorded in Section 3.A.(5) and determine if the attachment fitting is manufactured from AA2024-T351 or AA2124-T851.

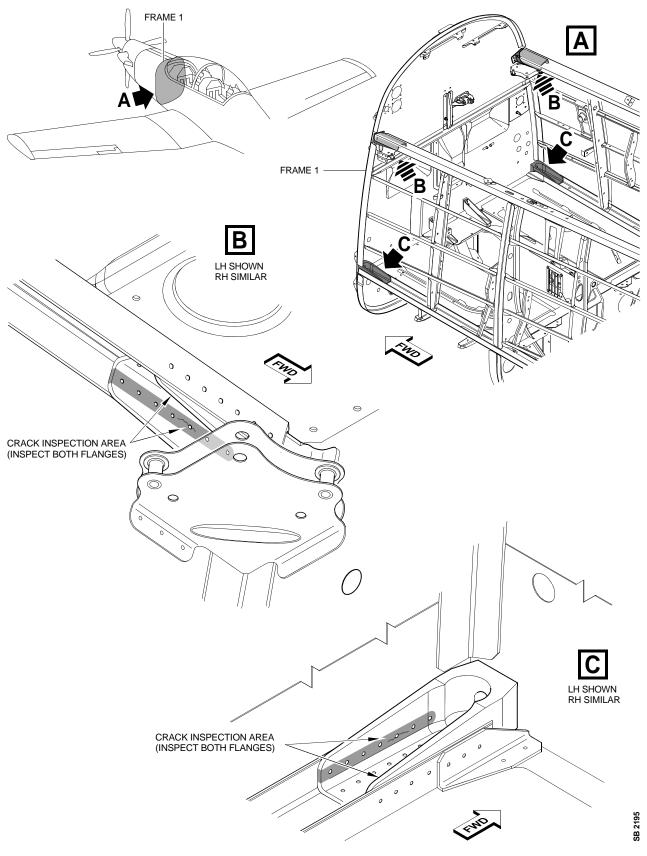
Fittings - Crack Inspection (If Necessary)
Figure 2

An operator reported Stress Corrosion Cracking (SCC) on the engine mount fittings.

Initially the material specification of the parts was AA2024-T351. The material specification was subsequently changed to AA2124-T851 to decrease the risk of stress corrosion.

- C. Do the Boroscope Inspection to Find Cracks (Ref. Fig. 2)

- (1) Obey the manufacturer's instructions and use a boroscope to examine the areas shown in Fig. 2:
 - (a) Use the aluminium or steel tube as a guide for the boroscope to access the inspection areas.
 - If you find cracks: (b)
 - You must contact Pilatus Customer Support before next flight. The address 1 is:
