Service Bulletin No: 57-016

**WINGS - GENERAL
INSPECTION OF THE LEFT AND RIGHT AILERON OUTBOARD BEARING-BRACKETS****1. Planning Information****A. Effectivity**

PC-9 aircraft MSN 101 thru MSN 248 and MSN 501 thru MSN 567 without Service Bulletin 57-017 accomplished.

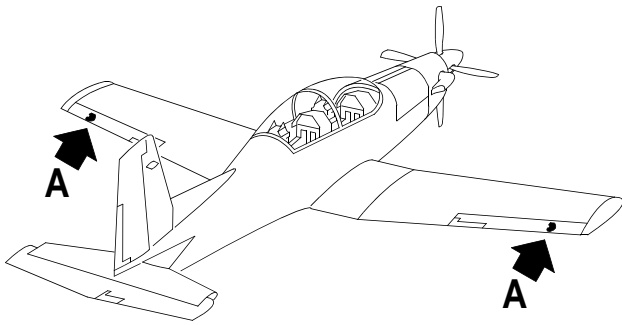
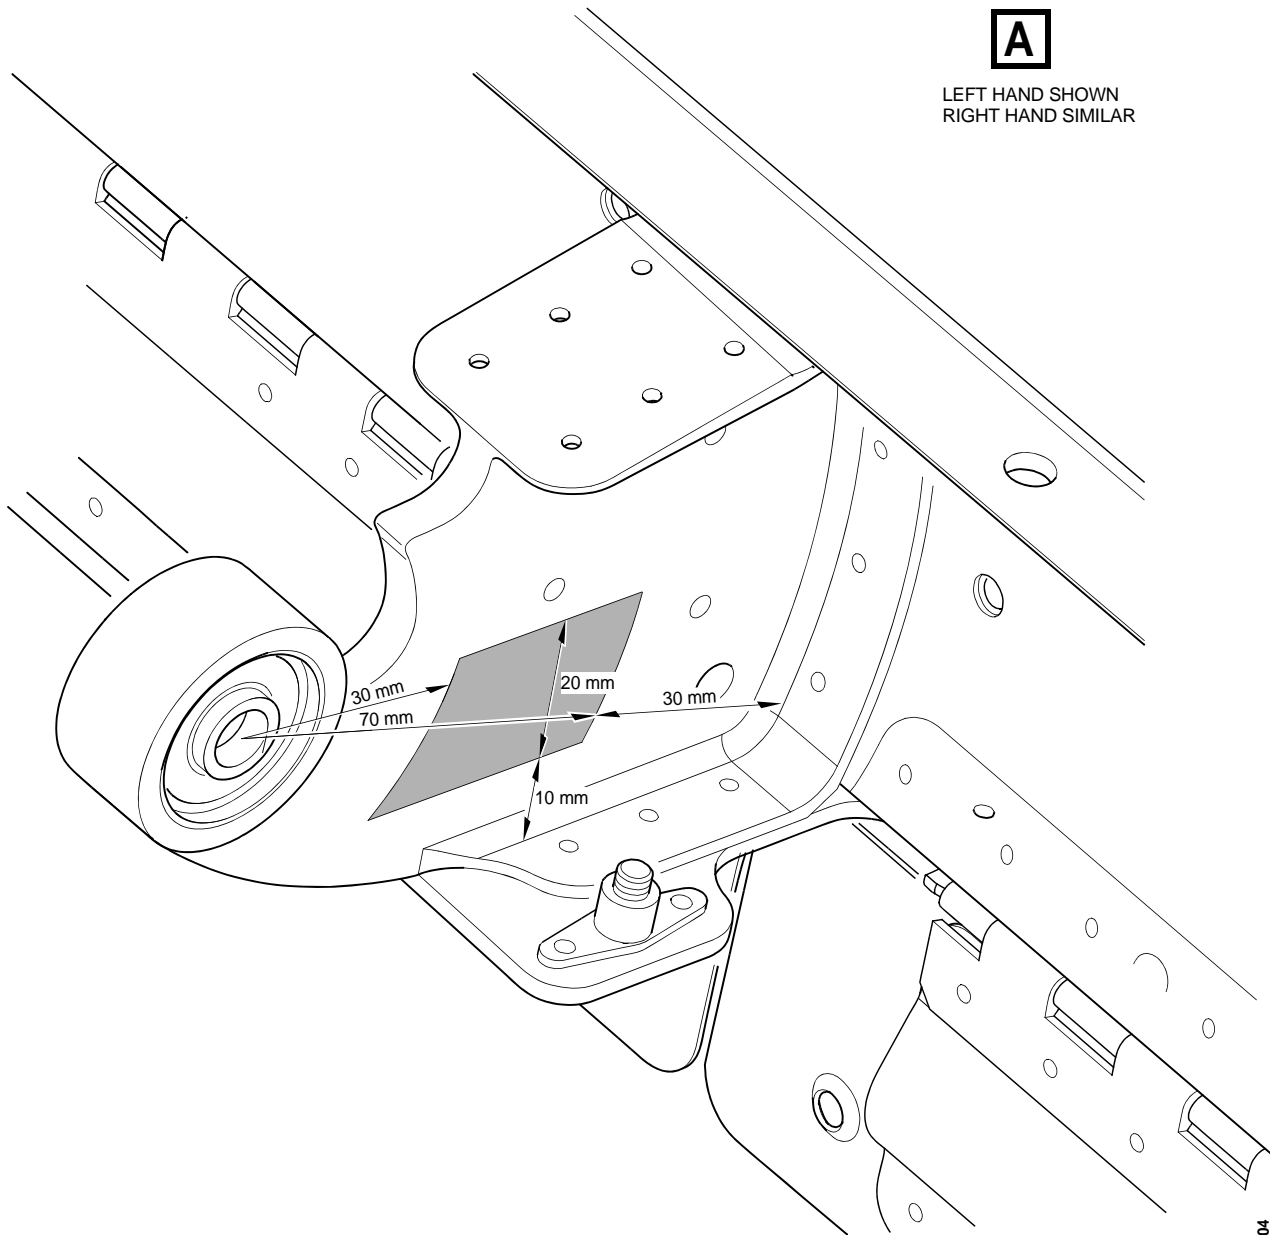
Inspection to Find the Type of Material
Figure 1

- 1 Put the eddy current probe in position in the test area (shown shaded in the Fig 1).
- 2 Record the value shown on the test equipment.
- 3 Put the eddy current probe on:
 - The AA2024-T351 test piece (P/N 513.57.09.149) and record the value
 - The AA2124-T851 test piece (P/N 513.57.09.150) and record the value.
- 4 Do a comparison of the values recorded on the eddy-current conductivity measurement-equipment for:
 - The left bracket assembly (P/N 557.22.09.279)
 - The AA2024-T351 test piece (P/N 513.57.09.149)
 - The AA2124-T851 test piece (P/N 513.57.09.150).

- 1 Put the eddy current probe in position in the test area (shown shaded in the Fig 1).
 - 2 Record the value shown on the test equipment.
 - 3 Put the eddy current probe on:
 - The AA2024-T351 test piece (P/N 513.57.09.149) and record the value
 - The AA2124-T851 test piece (P/N 513.57.09.150) and record the value.
 - 4 Do a comparison of the values recorded on the eddy-current conductivity measurement-equipment for:
 - The left bracket assembly (P/N 557.22.09.279)
 - The AA2024-T351 test piece (P/N 513.57.09.149)
 - The AA2124-T851 test piece (P/N 513.57.09.150).
 - 5 If the value for the left bracket assembly (P/N 557.22.09.279) is similar to the value recorded for the AA2024-T351 test piece (P/N 513.57.09.149), return the part to Pilatus.

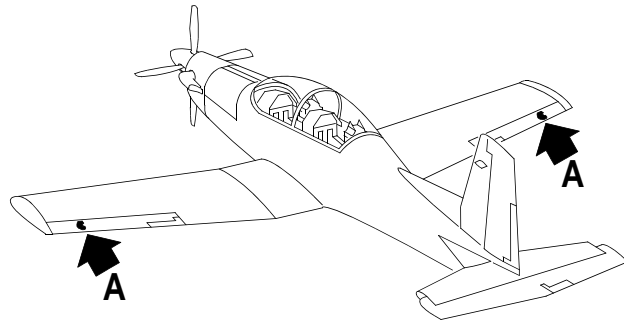
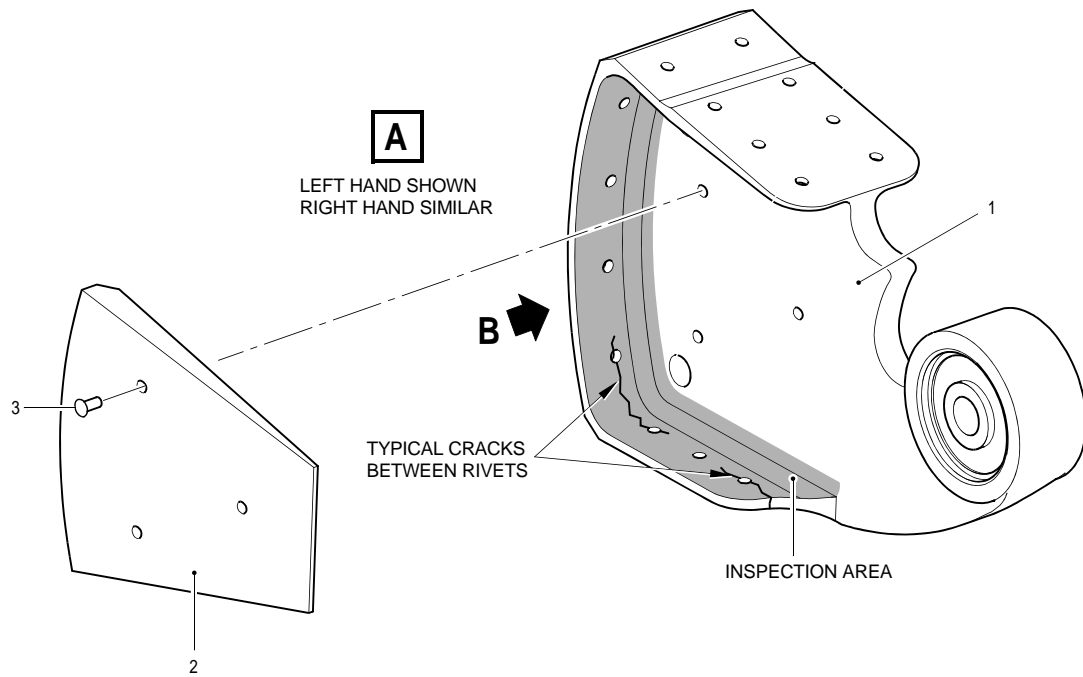
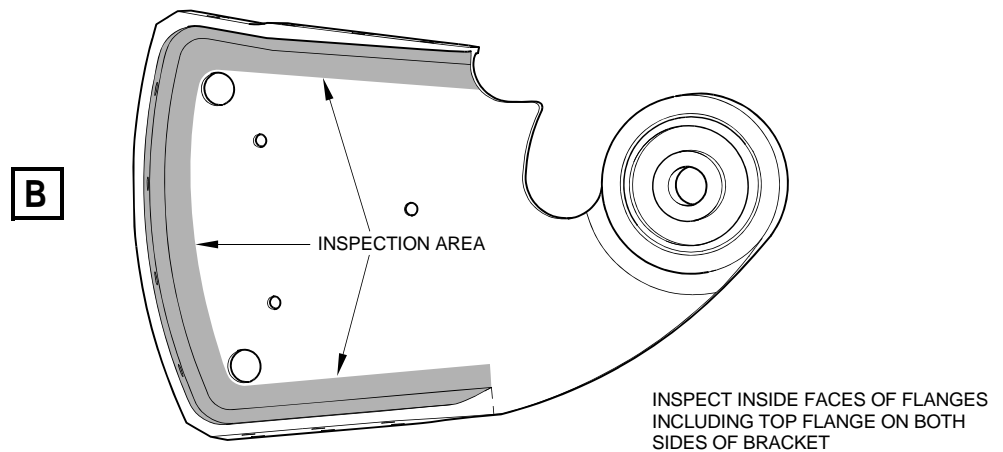
Inspection to find Cracks
Figure 2

An Operator has found cracks in the outboard aileron bearing-bracket (bracket), P/N 557.22.09.281 (LH) and P/N 557.22.09.282 (RH) installed on some of his aircraft. If the rivets in the affected location come out, they could cause the aileron to become jammed or lost in flight.

The cause of the cracks is stress corrosion.

It is possible for stress corrosion cracks to occur in brackets, P/N 557.22.09.281 (LH) and P/N 557.22.09.282 (RH) made of aluminium alloy 2024-T351. These cracks would occur in the areas around the attachment fasteners.

Do an eddy-current conductivity measurement-test to identify the material specification of the brackets, P/N 557.22.09.281 (LH) and P/N 557.22.09.282 (RH). If the brackets, P/N 557.22.09.281 (LH) and P/N 557.22.09.282 (RH) are made of aluminium alloy 2024-T351 and not replaced (Ref. Service Bulletin 57-017), do an eddy-current inspection in the areas around the attachment fasteners.

NOTE: If you find a crack in one of the bearing brackets, P/N 557.22.09.281 (LH) or P/N 557.22.09.282 (RH) made of aluminium alloy 2024-T351, you must replace the left and right brackets (Ref. Service Bulletin 57-017) before the next flight.
