**KNVvL Gliding Dept.**  
KNVvL safety commission (CVZ)

**Investigation Report (English):**

**Incident 2020-005**

**Failure gear operating mechanism Duo  
Discus XLT**

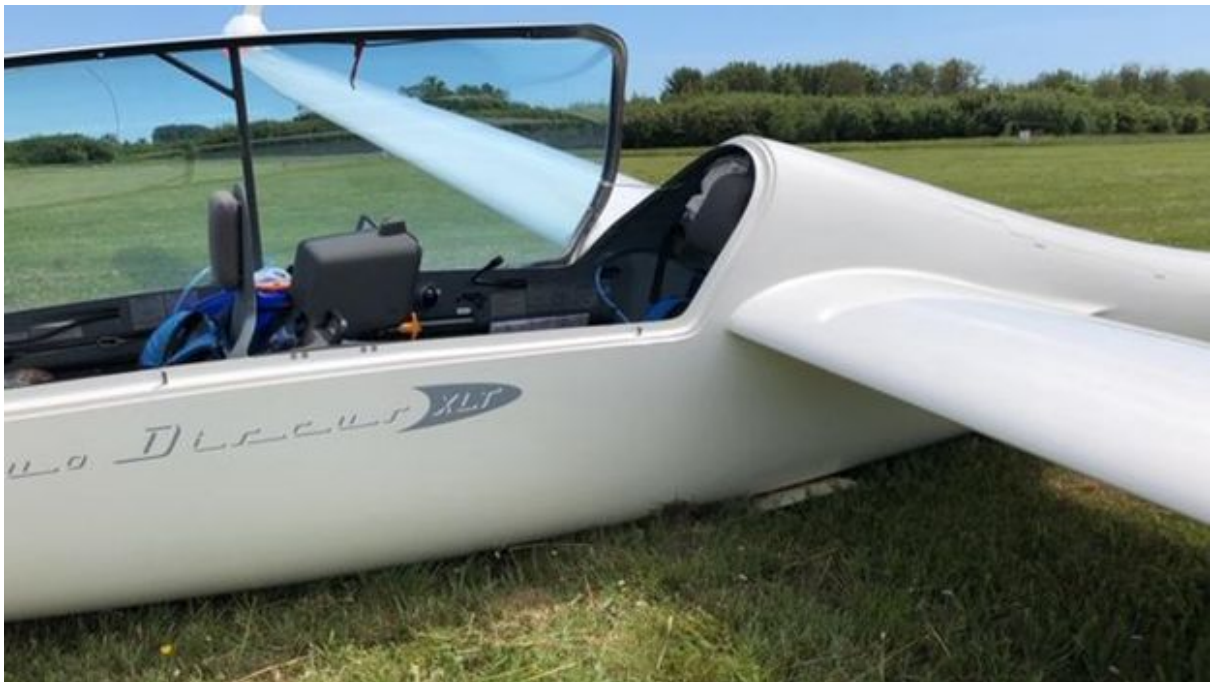
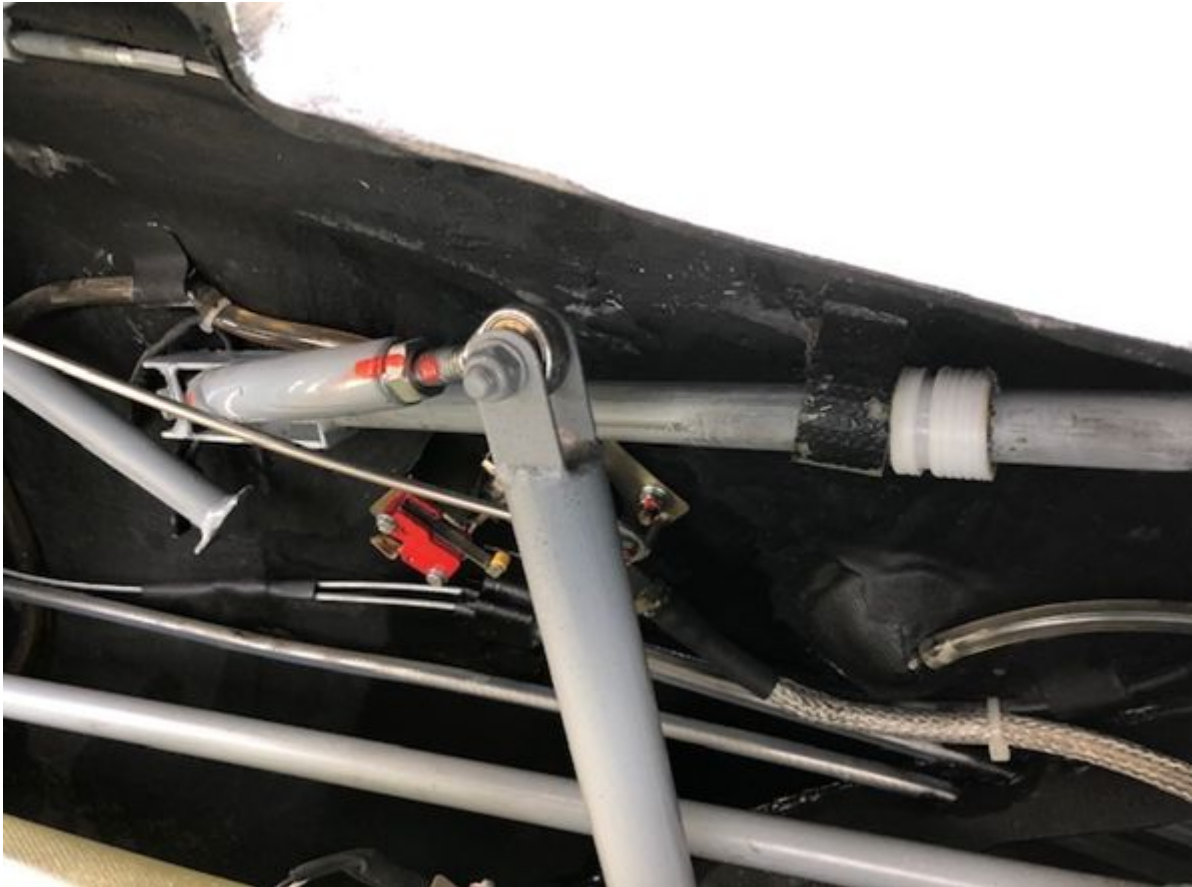
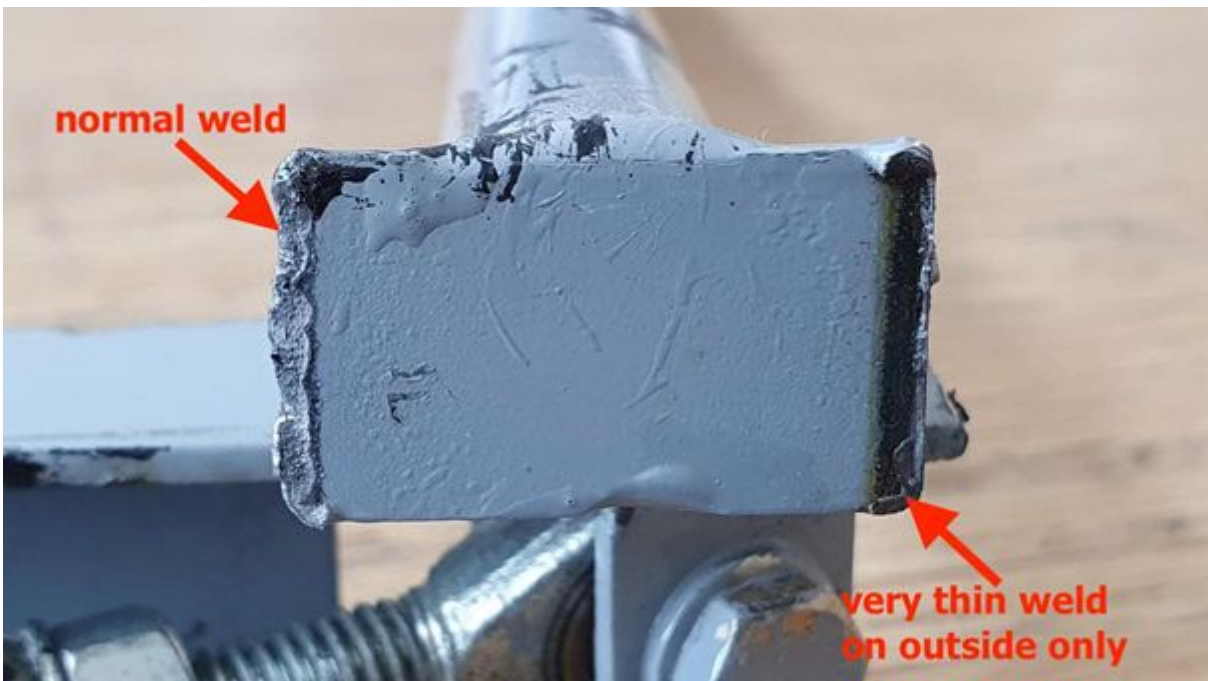
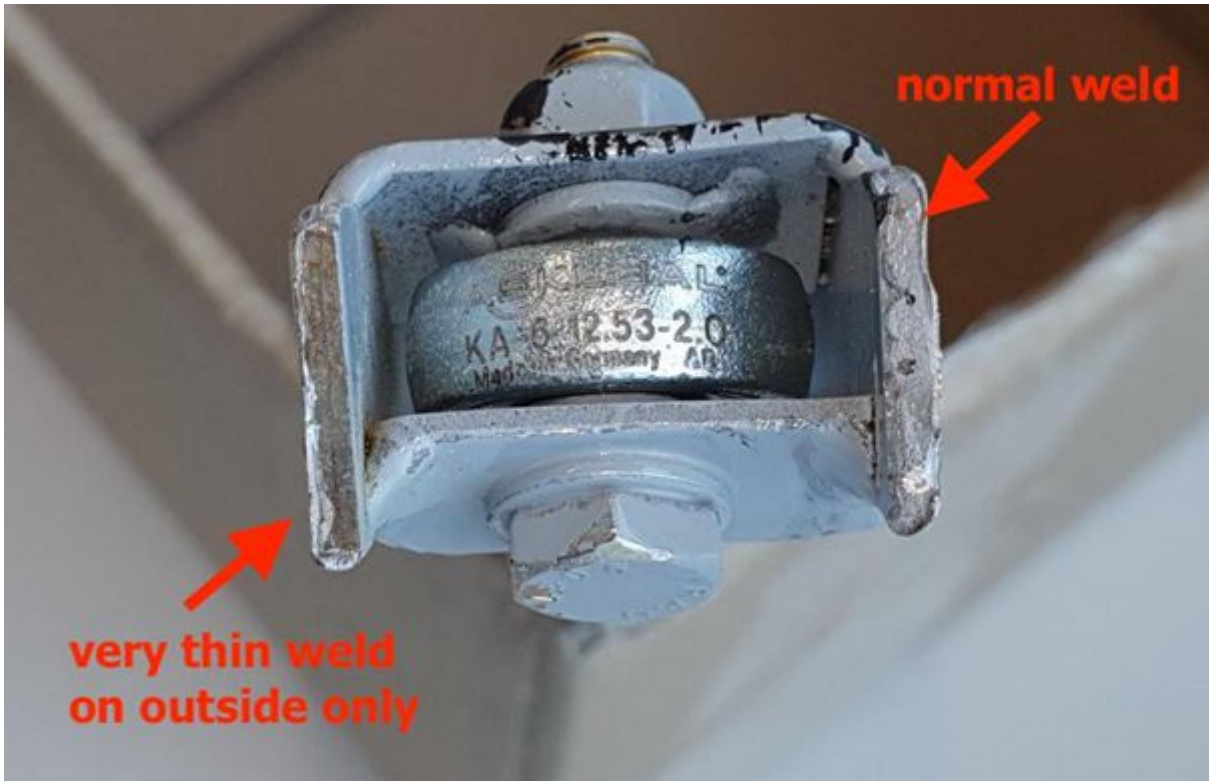
Initial inspection revealed a broken pushrod of the gear mechanism.

A part of the broken pushrod had also ruptured the fuel line at the fuel shut-off valve, causing a fuel leakage into the fuselage.

The insurance expertise also involved an inspection of the broken pushrod. This inspection revealed a weak welding connection.

- Before this incident SH has received 2 other notifications on similar cases. These are undocumented.
- SH is not convinced that the weak welding connection was the primary cause of this incident. Insufficient maintenance and /or hard landing(s) could be a contributing factor according to SH.
- In 2013 SH drafted a special welding protocol to prevent reoccurrence.

Maybe small cracks in the construction are already visible before failure of the welding connection?

Should inspection be recommended?

When the wings are removed the area can easily be inspected by mirror or camera via the opening for the wing spar on the right hand side of the fuselage.
