Schlussbericht Nr. 2148 der Schweizerischen Unfalluntersuchungsstelle SUST

über die möglichen Gefährdungen von
Rettungs- und Untersuchungsorganen
durch ballistische Fallschirmrettungssys-
teme (*Ballistic Parachute Systems – BPS*)
in Flugzeugen

Thermal behavior of BRS 440 and BRS 601 rockets

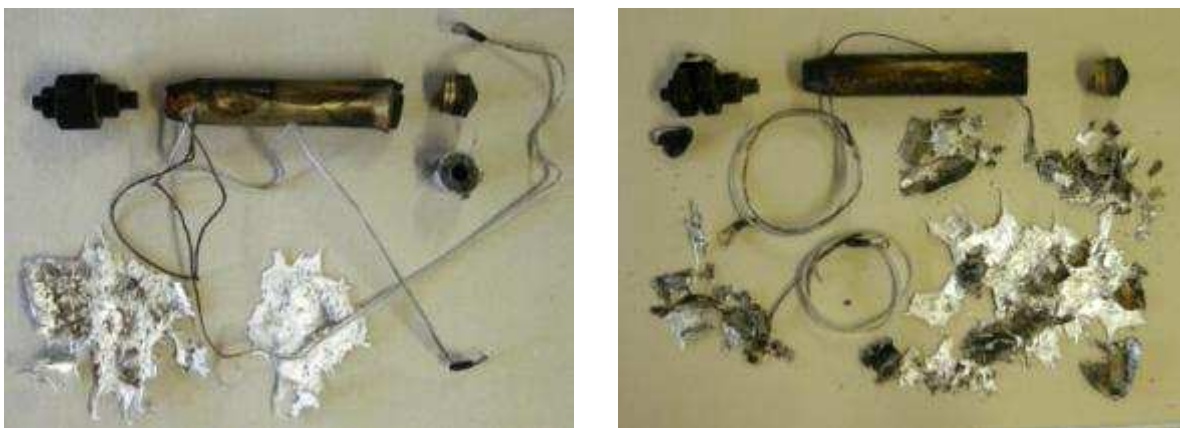
Test Nr. / Rocket	Mean Temp. [°C]	Time to Reaction [s]	Type of Reaction ¹	Remarks
V01/ BRS 440 Nr. 2	1045	145	Type V-IV Fast burning towards deflagration	End cap was axially ejected out of the rocket casing with high velocity. The main part of HTPB cylinder of the rocket motor did not react. Both percussion cups of the Igniter did not react.
V03/ BRS 440 Nr. 3	1085	129	Type V-IV Fast burning towards deflagration	The end cap was axially ejected out of the rocket casing with high velocity. One wire cut and the second wire almost cut. No unreacted rocket motor parts left. Igniter including primary booster remained unreacted.
V02/ BRS 601 Nr. 1	1050	43	Type V-IV Fast burning towards deflagration	The rocket was axially ejected apart from the fixation and penetrated the 2 mm thick aluminum witness plate (see Fig. 7). The outer casing of the rocket was ejected to the opposite witness plate which resulted in a crack into the plate. All parts of the rocket motor and igniter did react.

Fig. 6: FCO results for the BRS 440 respectively for test V01 (left) and test V03 (right).

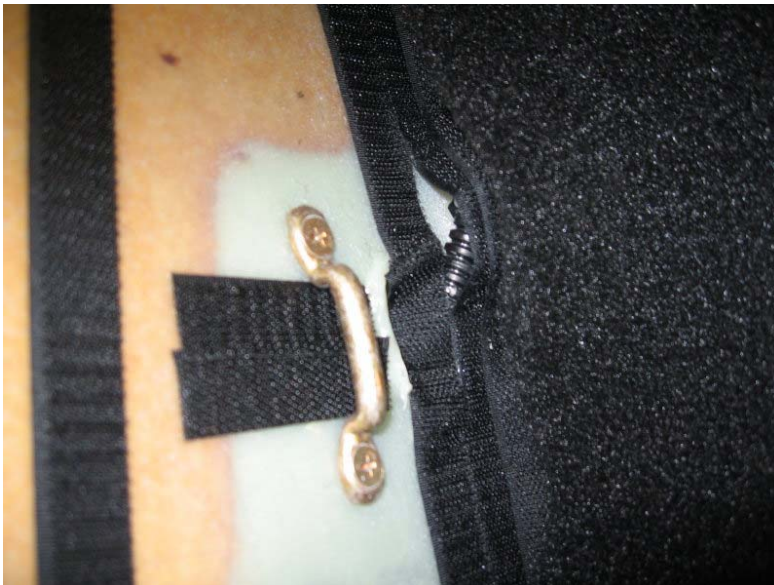
Kabelzug hier durchtrennen
