Aviation Division

Final report No. 2148 by the Swiss Accident Investigation Board SAIB

On potential risks of ballistic para-
chute systems (BPS) in aircraft to
rescue and investigation crews

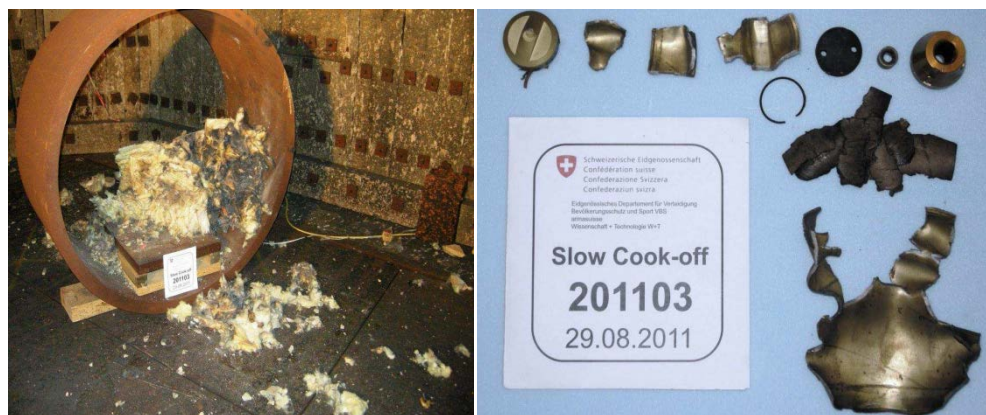
Fig. 12: Test results and fragments

Both the BRS 440 rockets tested reacted violently after 129 and 145 sec. respectively, in that the rocket motors burned off fast and exploded. The primer mixture and the primary booster material in one rocket, failed to respond. Both rockets mounted on the test bench shot the rocket motor end caps off at high velocity. With one of the rockets tested, large quantities of unreacted rocket fuel were left behind.

Both the BRS 601 rockets tested reacted violently after 43 and 69 sec. respectively, by burning off fast and exploding. All the explosives in the igniter unit and rocket motor reacted completely. The force of the reaction tore the rocket motor being tested off its mountings, and it penetrated 2 mm thick aluminium target plate 2 m away.

This reaction was an explosion, which burst the aluminium rocket motor casing into a number of flying fragments.

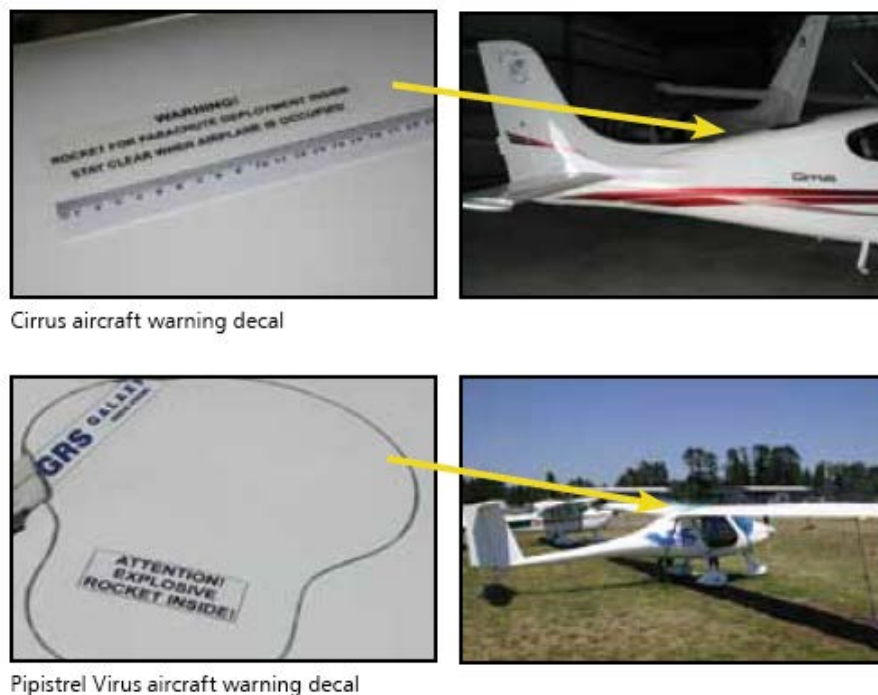
Fig. 13: Current BPS aircraft IDs

BPS aircraft are currently identified by a small triangular decal about 40 mm long on a side. This decal warns of the risks a BPS can involve, and tells emergency rescue crews to call the telephone number in the USA printed on the decal before starting rescue work on the wreckage.

Above all, BPS aircraft should be clearly and uniquely identifiable as such. The aircraft must be marked by a large triangular hazard warning decal approx. 40 cm on a side on the fuselage. This decal warns in prominent colours that the aircraft has a BPS installed in or on it which may put rescue workers at risk, and that, before starting rescue work, they must call REGA's telephone number printed on the decal which will tell them how to proceed. Other precautions required are:

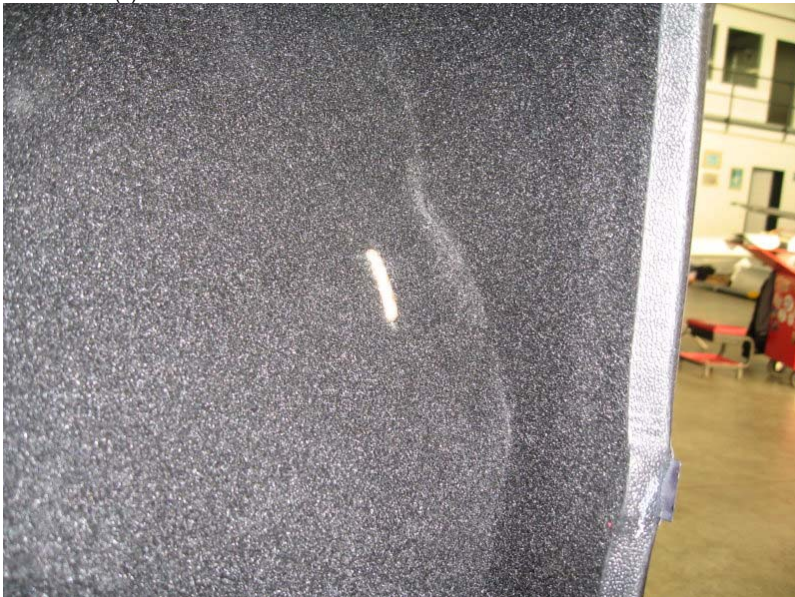
Beule in Gepäckraum,
Abdeckung entfernen

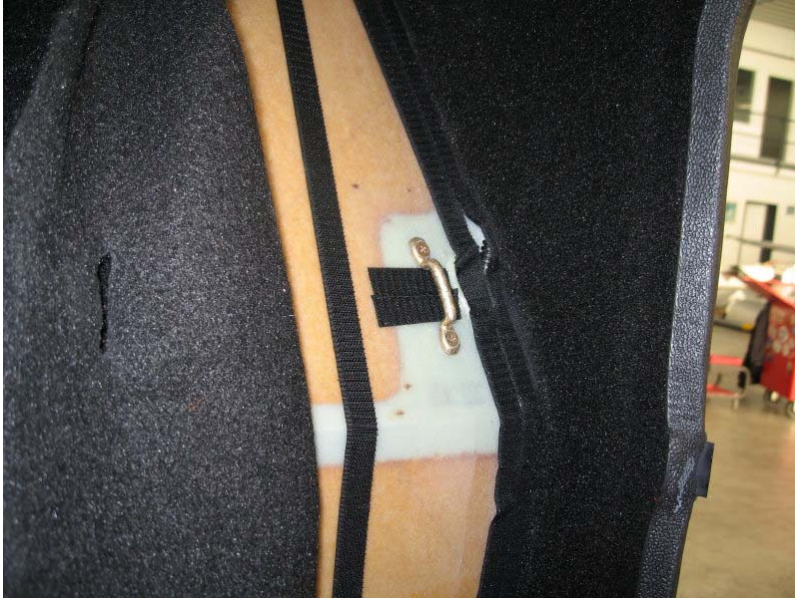
Kabelzug sichtbar
