Service Bulletin No: 28-014

ATA Chapter: 28

**FUEL - DISTRIBUTION  
REPLACE THE FUEL TRANSFER EJECTOR****1. Planning Information****A. Effectivity**

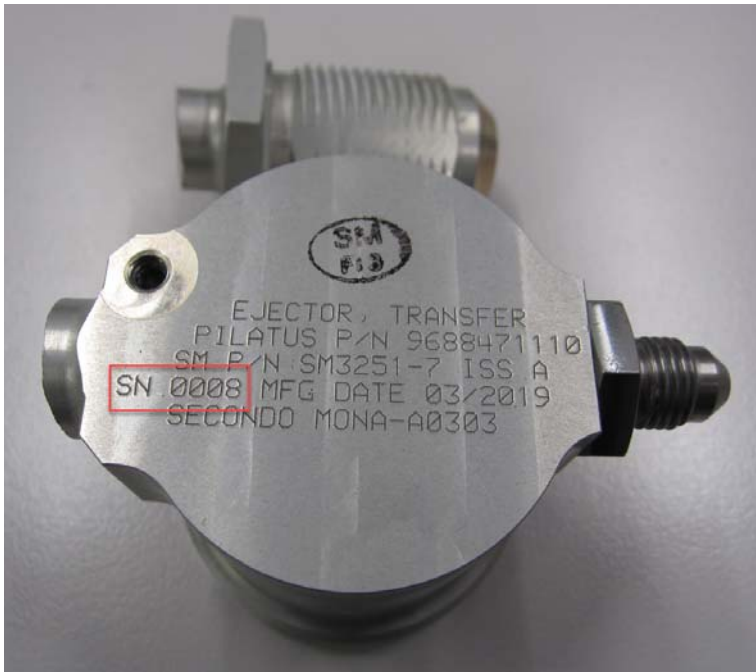
- (1) Remove the affected left and/or right fuel transfer ejector and install a replacement, refer to AMM 12-C-28-20-05-00A-920A-A.
- (2) Destroy the fuel transfer ejector by cutting off the fuel pipe connection to make the fuel transfer ejector unserviceable. Take a photograph of the destroyed fuel transfer ejector to show the serial number and add it to the warranty claim (see example photograph below).

- The work is accomplished during the next Scheduled Inspection by an authorized Service Center within the compliance time given in Para 1.E. of this Service Bulletin.
- The returned feedback sheet has a picture of the destroyed fuel transfer ejector.
