### **SERVICE BULLETIN**

SERVICE BULLETIN NO: 32-003 REF NO: 58

### LANDING GEAR - MAIN GEAR AND DOORS REPLACEMENT OF THE MAIN-GEAR SUPPORT STRUT

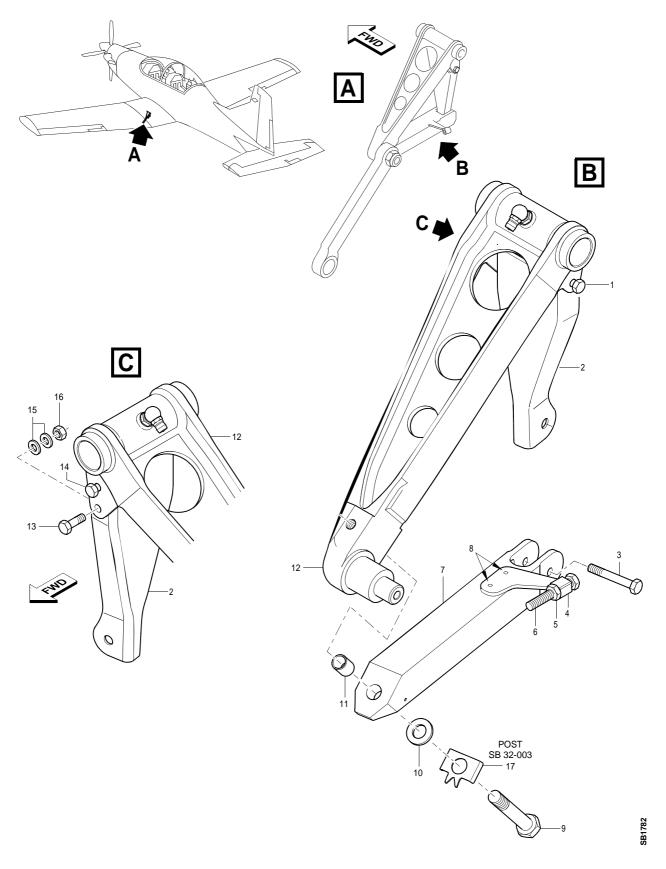
Support Strut Removal/Installation Figure 1

Cracks have occurred in the main-gear support struts on some aircraft. All the main-gear support struts that had cracks were made from material AA2024-T351. This material has a lower resistance to stress corrosion cracking.

The cause of the cracks is stress corrosion.

Replace the main-gear support strut with a new item made from the material with an increased resistance to stress corrosion cracking.

#### B. Remove the Main-Gear Support Strut (Ref. Fig. 1)

- (1) Remove and discard the lockwire from the bolt (9).
- (2) Remove and discard the bolt (9), the washer (10) and the bush (11) that attach the maingear support strut (7) to the upper folding strut (12).
- (3) Loosen, but do not remove, the bolts (1) and (14).
- (4) Remove the nut (16), the washers (15) and the bolt (13).
- (5) Move the folding strut lever (2) away from the main-gear support strut (7).

- (6) Remove the main-gear support strut (7). If the main-gear support strut (7) is difficult to remove, apply heat to the area.
- (7) Use the applicable size drill and remove the two rivets (8) that attach the support assembly (4) to the main-gear support strut (7). Keep the support assembly (4).
- (8) Discard the main-gear support strut (7).

#### C. Install the New Main-Gear Support Strut (Ref. Fig. 1)

- (1) Attach the support assembly (4) to the main-gear support strut (7) (P/N 532.10.09.128):
  - (a) Use a 4.1 mm (0.16 in.) diameter drill to make one of the rivet holes in the maingear support strut (7) (P/N 532.10.09.128).
  - (b) Temporarily attach the support assembly (4) to the main-gear support strut (7) (P/N 532.10.09.128) with a gripper pin.

- (d) Temporarily install, but do not fully tighten, the bolt (9) (P/N 932.35.14.227), the lock washer (17) (P/N 532.10.09.133) and the washer (10) (P/N 938.75.11.311) to attach the main-gear support strut (7) (P/N 532.10.09.128) to the upper folding strut (12).

- (k) Temporarily install the bolt (3).
- (I) Torque the bolt (9) (P/N 932.35.14.227) to between 7,0 and 9,5 Nm (60 and 85 lb. in.).
- (m) Safety the bolt (9) (P/N 932.35.14.227) with the lock washer (17) (P/N 532.10.09.133).

- (o) Install the bolt (13), the washers (15) and the new nut (16) (P/N 938.07.68.305).
- (p) Tighten the nuts on the bolts (1) and (14) and the new nut (16) (P/N 938.07.68.305) to between 3,4 and 4,5 Nm (30 and 40 lb. in.).
