FOCA AD
HB-2020-001

Pilatus – P3

Subject: **Fuselage – Fuselage to Horizontal Tail Fittings – Identification, Repetitive Inspections**

Applicability: Model P3-03 and P3-05 aircraft, all Serial Numbers (S/N).

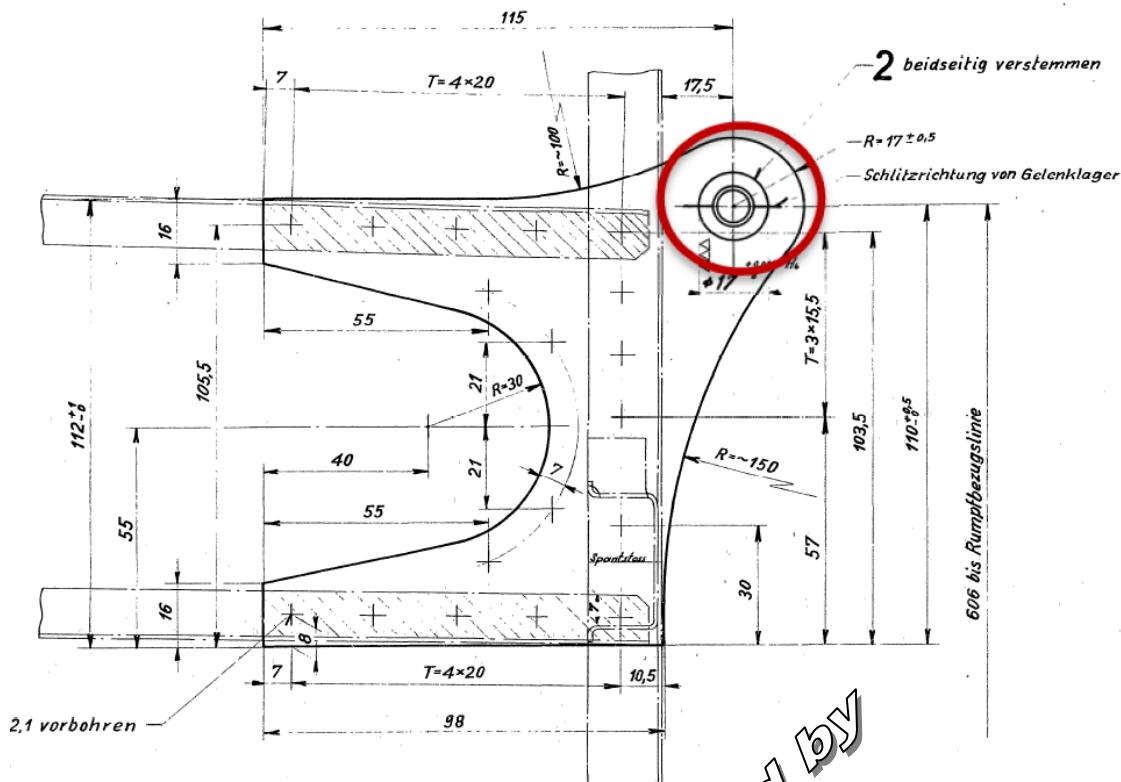
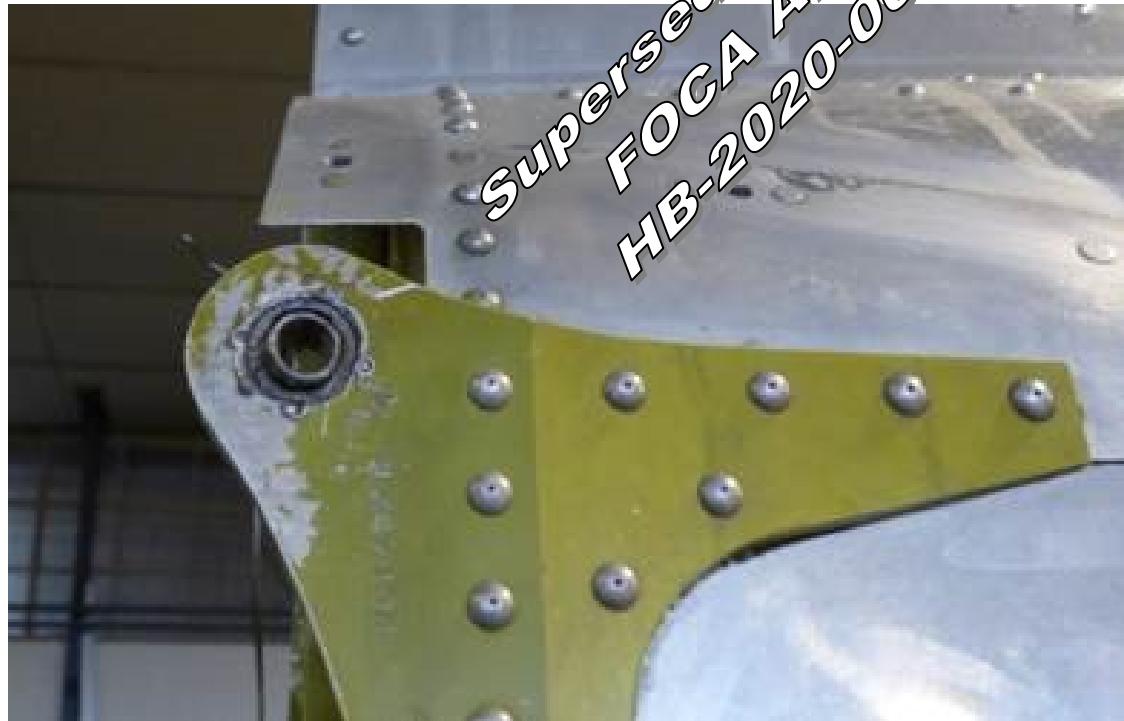
Reason: This Airworthiness Directive (AD) is prompted due to a report of a damaged fuselage to horizontal tail fitting. It's assumed that the signs of damage of the fuselage to horizontal tail fitting was occurred during maintenance work by using a centre punch tool.

Such a condition, if left uncorrected, could lead to stress corrosion cracking on the affected fuselage to horizontal tail fittings and will prejudice the structural integrity of the aircraft.

Fuselage to horizontal tail fitting: damage caused by using a centre punch tool during maintenance

- (1) Perform a visual inspection for damage caused by using a centre punch tool. No signs of damage caused by using a centre punch tool are permitted.
- (2) If during the inspection required by paragraph (1) of this AD any fuselage to horizontal tail fittings with no signs of damage caused by using a centre punch tool are found, no further action is necessary.

- (3) If during the inspection required by paragraph (1) of this AD any fuselage to horizontal tail fittings with signs of damage caused by using a centre punch tool are found, before next flight, perform an eddy current inspection of the fuselage to horizontal tail fittings for cracks.
- (4) If during the eddy current inspection required by paragraph (3) of this AD any fuselage to horizontal tail fittings with cracks are found, replace the fitting in accordance with an approved repair solution.
- (5) If during the eddy current inspection required by paragraph (3) of this AD any fuselage to horizontal tail fittings with no cracks are found, within the next 200 FH repeat the eddy current inspection for signs of cracks.
