Service Bulletin No: 71-009

ATA Chapter: 71

**POWER PLANT - ENGINE MOUNTING FRAME
ULTRASONIC INSPECTION OF SWAGED TUBE ENDS****1. Planning Information****A. Effectivity**

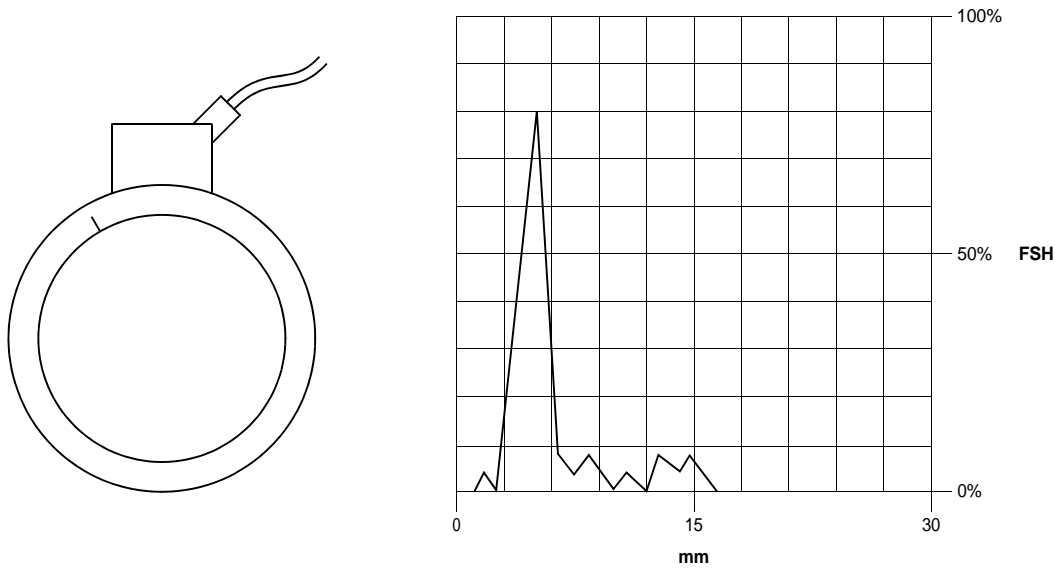
NOTE: The inspection reference pieces can have one or more natural material separations.

- 4 Set the echo of the material separation to 80% full-screen height (FSH).
- 5 Record the device gain (dB).

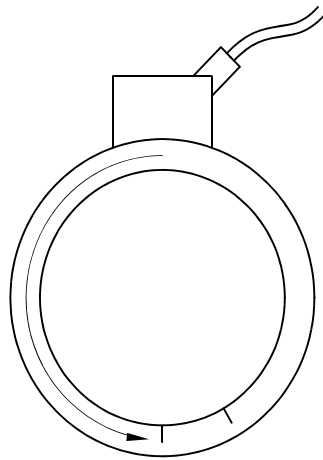
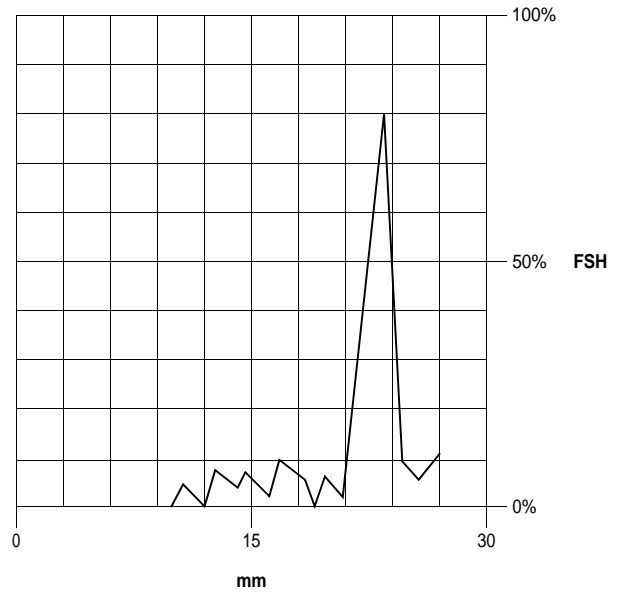
INSPECTION
EXAMPLE

(c) Additional calibration for Multiple Transverse Scan required in case of limited accessibility:
