Service Bulletin No: 27-026

**FLIGHT CONTROLS - FLAP DRIVE SYSTEM - INSPECTION OF THE INBOARD FLAP FAIRINGS AFT AND THE FRONT INBOARD TENSION RODS****1. Planning Information****A. Effectivity**

PC-12/47E aircraft MSN 1819 thru 1843 and 1845 thru 1854 only.

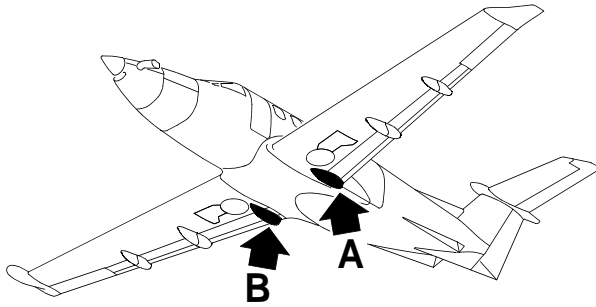
Correct Contours - Inboard Flap Fairing Aft  
Figure 2

- (1) Do an inspection of the left and right IFFA to determine if the contour is the correct shape:
  - Figure 2 shows the correct (non symmetrical) contours of the left and right IFFA
  - Figure 3 shows the incorrect (symmetrical) contours of the left and right IFFA.
- (2) If the left and right IFFAs each have the correct contours as shown in Figure 2, do step 3.D.Close Up.
- (3) If the left or the right IFFA has incorrect contours as shown in Figure 3, do step 3.C.Modification.

CORRECT CONTOUR  
RIGHT IFFA

CORRECT CONTOUR  
LEFT IFFA

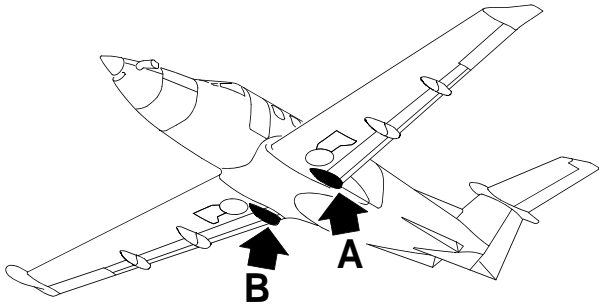
Incorrect Contours - Inboard Flap Fairing Aft  
Figure 3

Chafing can occur between the left or right Inboard Flap Fairing Aft (IFFA) (P/N 557.52.12.223 and 557.52.12.224) and the left or right front inboard tension rod (P/N 527.52.12.135).

For the affected aircraft, IFFAs with an incorrect contour were possibly installed on new production aircraft. This could cause interference between the IFFAs and the tension rods due to incorrect clearance. No affected IFFAs were supplied to operators as spares.

INCORRECT CONTOUR  
RIGHT IFFA

INCORRECT CONTOUR  
LEFT IFFA

Do an inspection of the shape of the left and right IFFA contours and modify them if necessary. Examine the tension rods and replace them if there is chafing damage.
