Service Bulletin No: 53-019

ATA Chapter: 53

FUSELAGE - MAIN FRAMES**DO A CHECK OF THE MATERIAL SPECIFICATION OF THE FRAME 11 FITTINGS AND, IF NECESSARY, DO A CHECK FOR CRACKS****1. Planning Information****A. Effectivity**

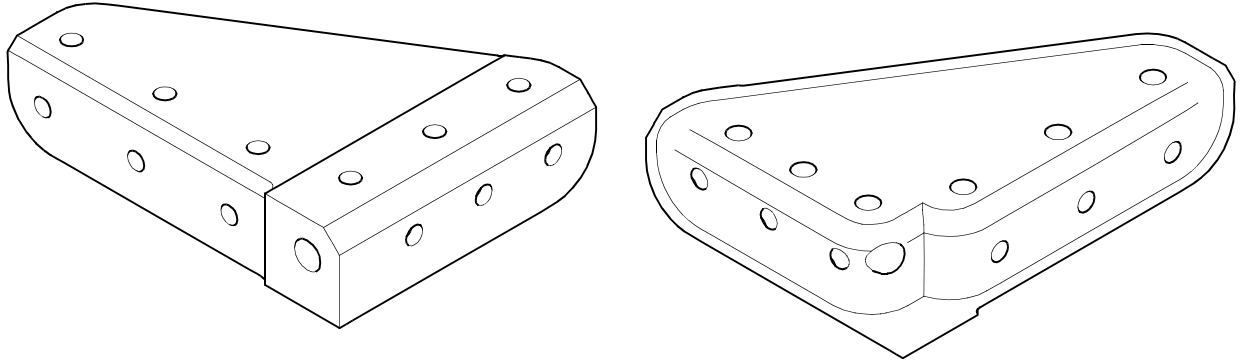
Fittings - Crack Inspection (If Necessary)
Figure 3

(1) Obey the manufacturer's instructions and use a borescope to examine the fitting from inside FR11 (looking AFT) for cracks (Ref. Fig. 3).

- (2) If you find cracks, you must replace the fitting before the next flight (Ref. Service Bulletin 53-020). Make a copy of the Inspection Report Form (Ref. Fig. 4).
- (3) If you do not find cracks in the area examined in Step 3.C.(1):
 - (a) Remove the horizontal stabilizer (Ref. AMM, 55-10-00, Page Block 401).
