Service Bulletin No: 51-001

ATA Chapter: 51

AIRCRAFT STRUCTURE - GENERAL**DO A CHECK OF THE MATERIAL SPECIFICATION USED DURING MANUFACTURE AND, IF NECESSARY, DO A CHECK FOR CRACKS OR REPLACE THE PART****1. Planning Information****A. Effectivity**

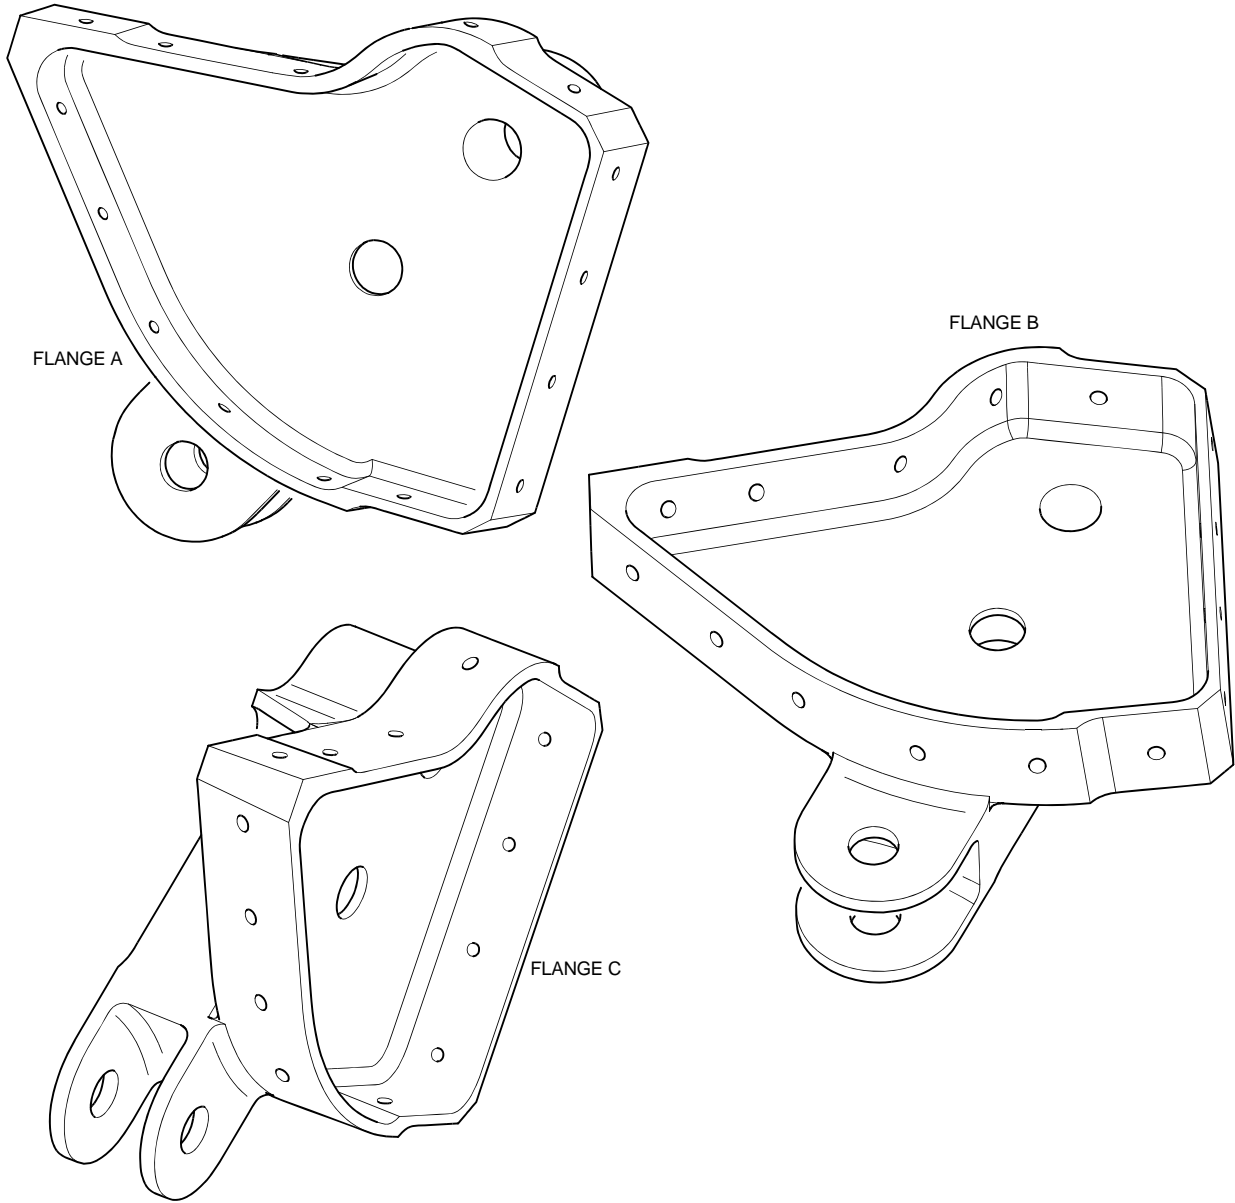
Nose Rib 1 - Inspection Form
 Figure 4, Sheet 1 of 2

LEFTAILERON NOSE RIB 1

- 1 Make a copy of the Inspection Report Form(s) (Ref. Fig. 4).
- 2 Complete the Inspection Report Form:
 - Give the date of the inspection.
 - Give the aircraft details.
 - Show the location(s) and dimensions of the crack(s) found (if applicable).
 - Add any necessary comments.

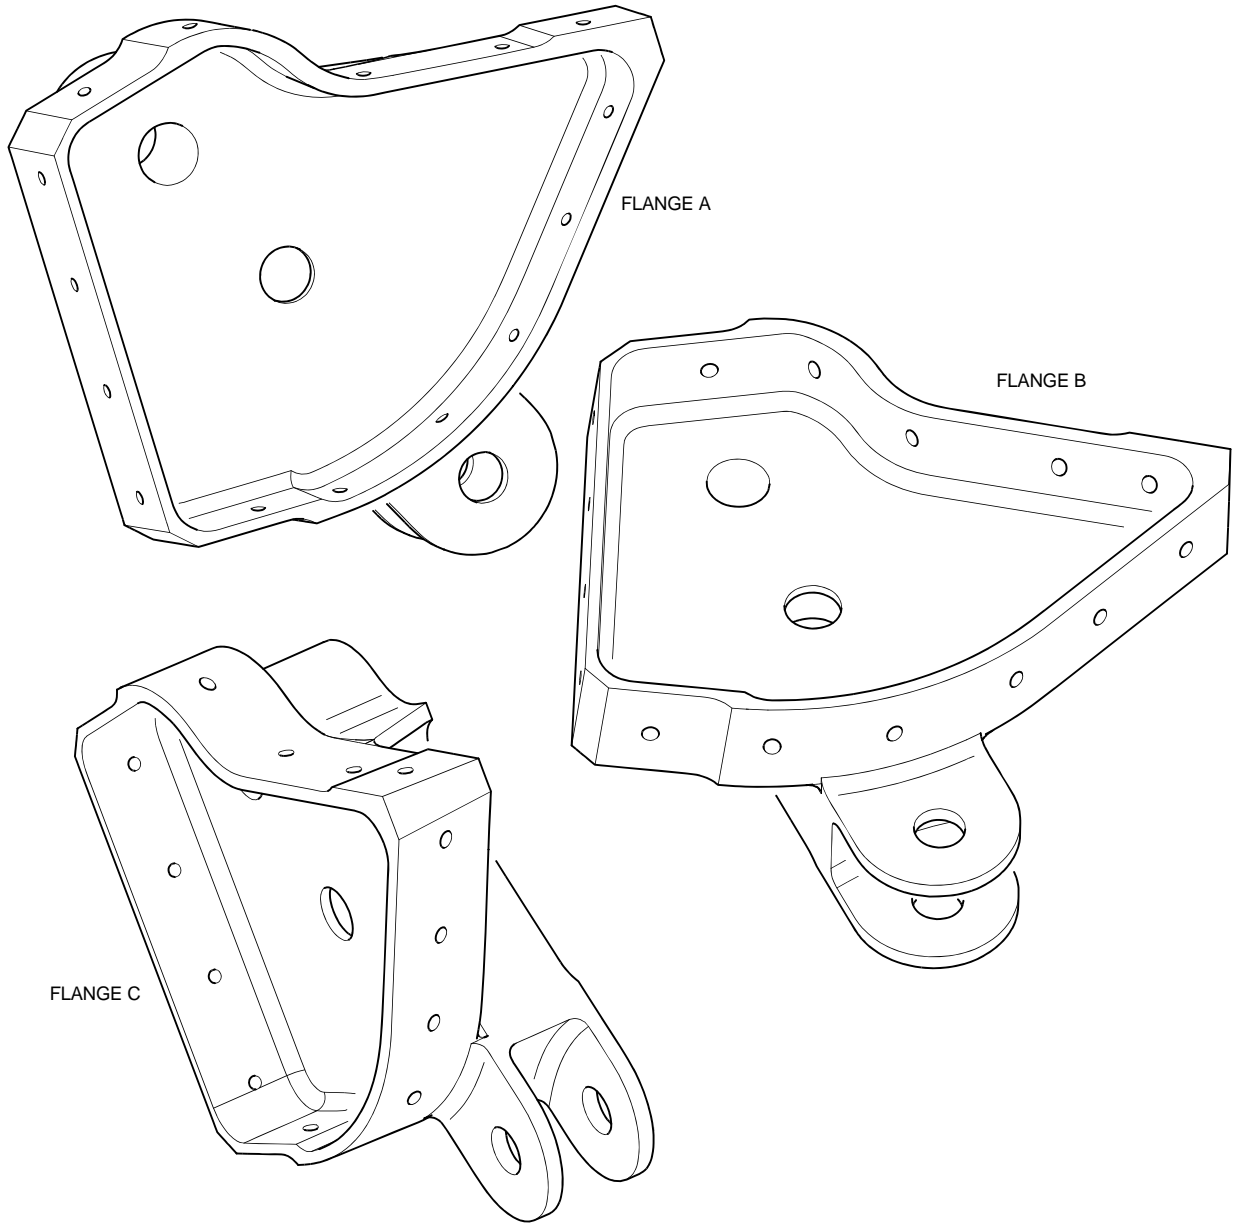
Nose Rib 1 - Inspection Form
 Figure 4, Sheet 2 of 2

RIGHTAILERON NOSE RIB 1

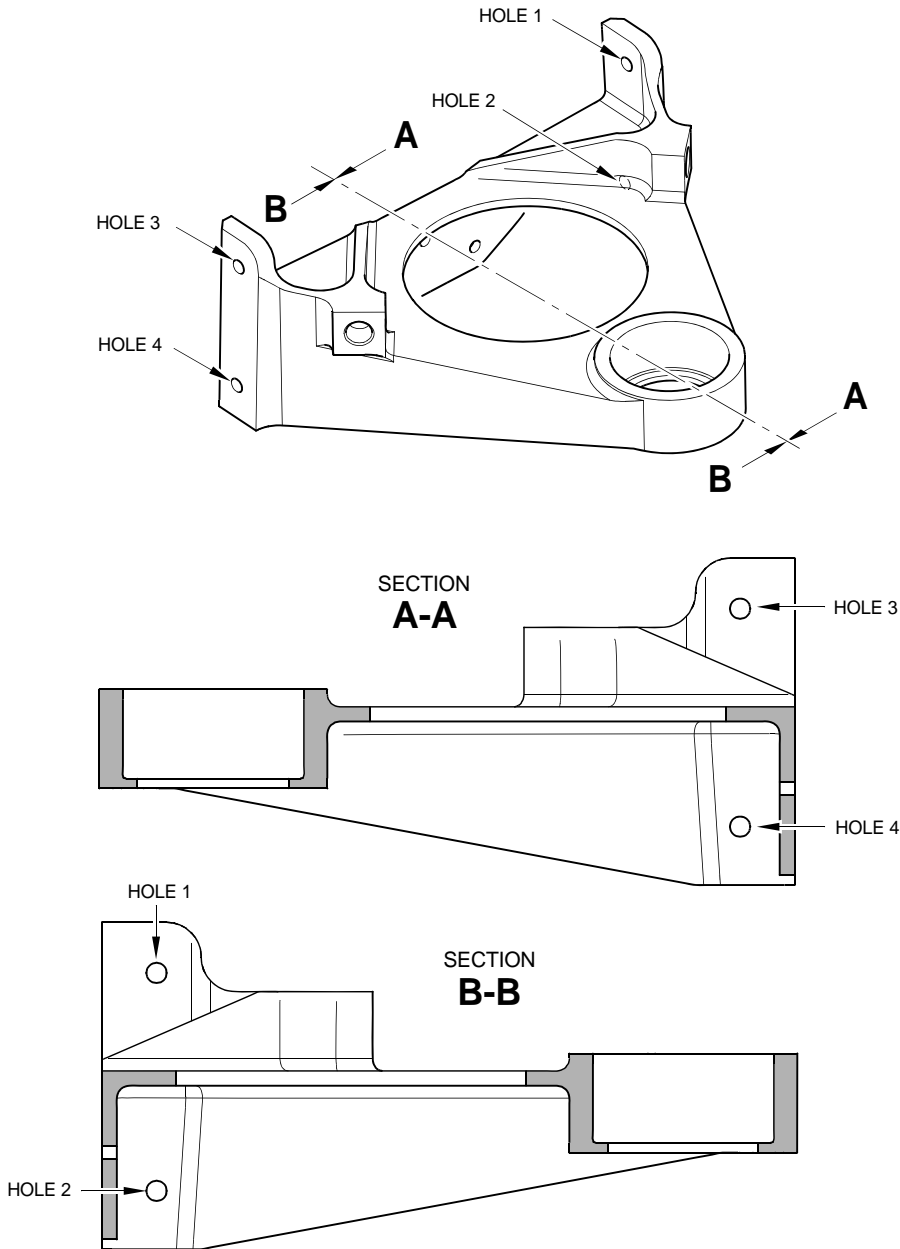
DATE:	AIRCRAFT MSN:	FLYING HOURS:	LANDINGS:
HOLE 1 CRACK LENGTH	ADDITIONAL COMMENTS		
mm			
HOLE 2 CRACK LENGTH			
mm			
HOLE 3 CRACK LENGTH			
mm			
HOLE 4 CRACK LENGTH			
mm

- 1 Make a copy of the Inspection Report Form (Ref. Fig. 6).
- 2 Complete the Inspection Report Form:
 - Give the date of the inspection.
 - Give the aircraft details.
 - Show the location(s) and dimensions of the crack(s) found (if applicable).
 - Add any necessary comments.

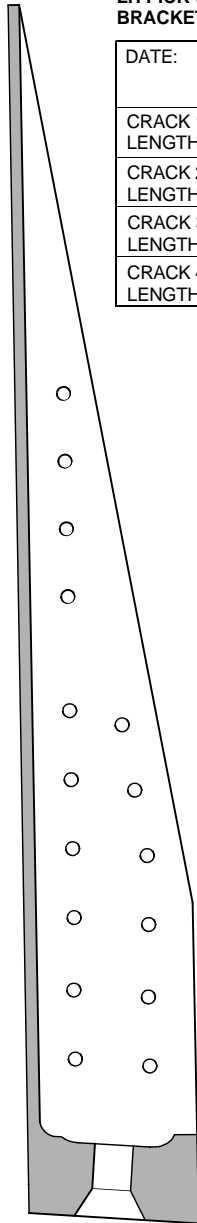
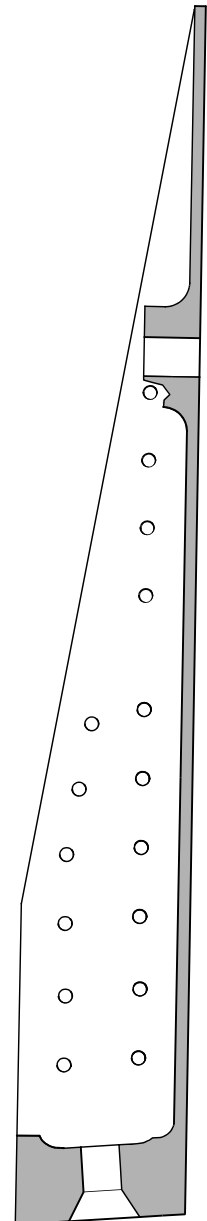
Frame 3 Pick-Up Brackets - Inspection Form
 Figure 8

LH PICK UP BRACKET

RH PICK UP BRACKET

1 Make a copy of the Inspection Report Form(s) (Ref. Fig. 8).

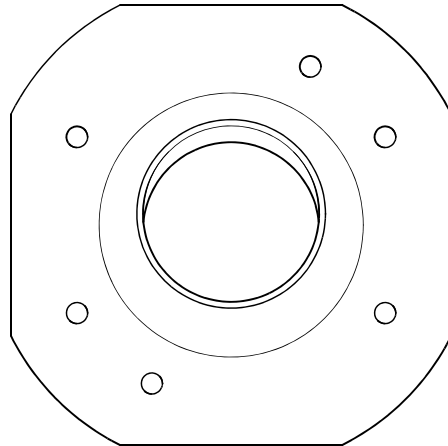
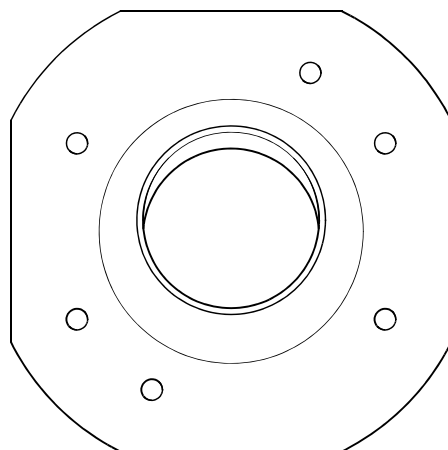
Front and Rear Rudder-Pedal Outboard-Bearings (P/N 553.20.09.062) - Inspection Form
 Figure 18, Sheet 1 of 4

FWD LH SUPPORT BRACKET

FWD RH SUPPORT BRACKET

- 1 Make a copy of the Inspection Report Form(s) (Ref. Fig. 18).

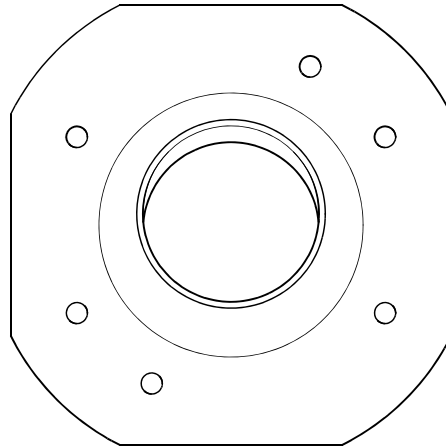
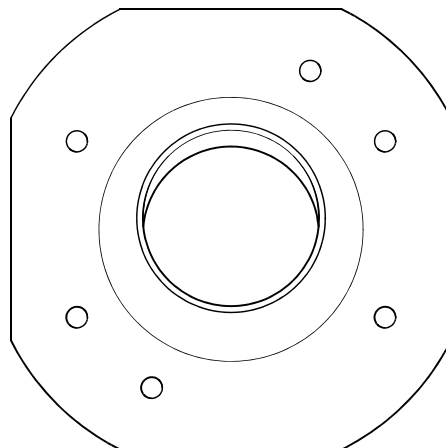
Front and Rear Rudder-Pedal Outboard-Bearings (P/N 553.20.09.062) - Inspection Form
 Figure 18, Sheet 2 of 4

REAR LH SUPPORT BRACKET

REAR RH SUPPORT BRACKET

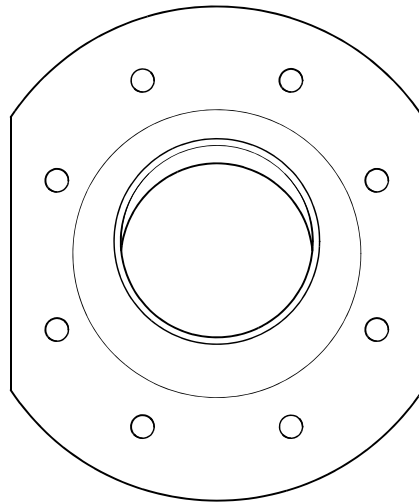
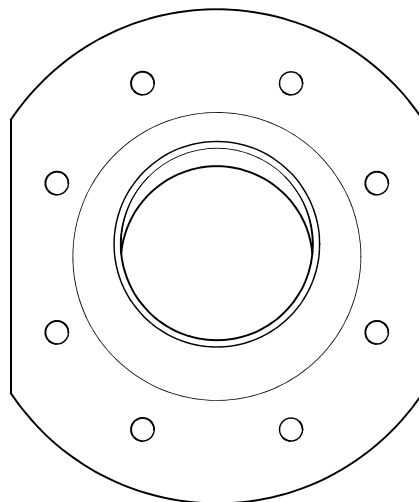
Front and Rear Rudder-Pedal Outboard-Bearings (P/N 553.20.09.235) - Inspection Form
Figure 18, Sheet 3 of 4

FWD LH SUPPORT BRACKET

FWD RH SUPPORT BRACKET

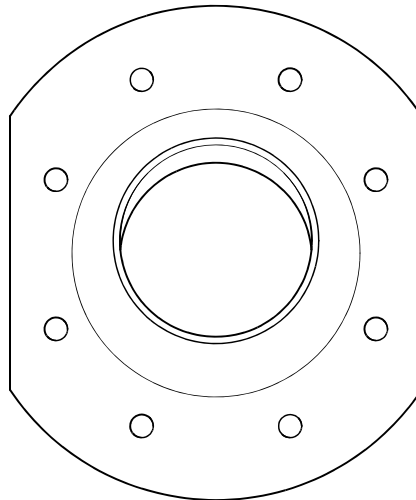
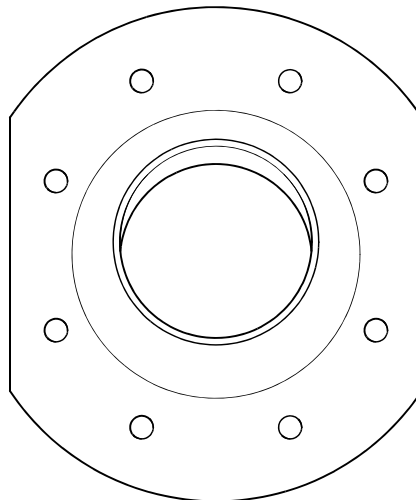
Front and Rear Rudder-Pedal Outboard-Bearings (P/N 553.20.09.235) - Inspection Form
Figure 18, Sheet 4 of 4

REAR LH SUPPORT BRACKET

REAR RH SUPPORT BRACKET

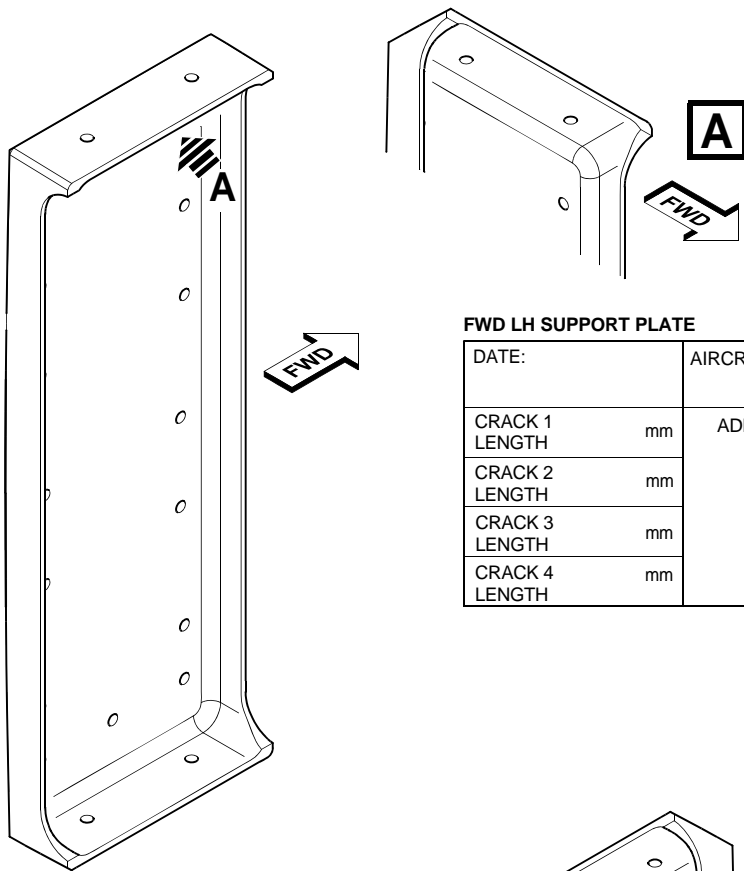
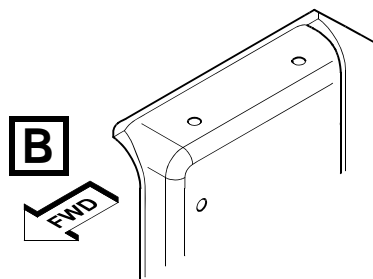
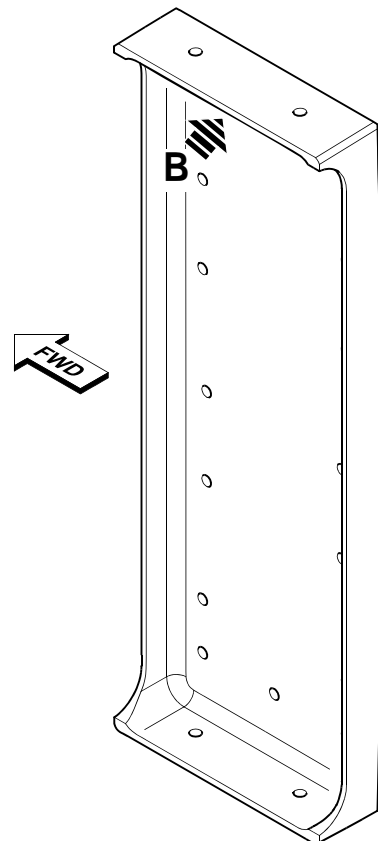
Front and Rear Rudder-Pedal Outboard-Bearing-Support Plates (P/N 553.20.09.229) - Inspection Form
Figure 20, Sheet 1 of 2

FWD LH SUPPORT PLATE

FWD RH SUPPORT PLATE

1 Make a copy of the Inspection Report Form(s) (Ref. Fig. 20).

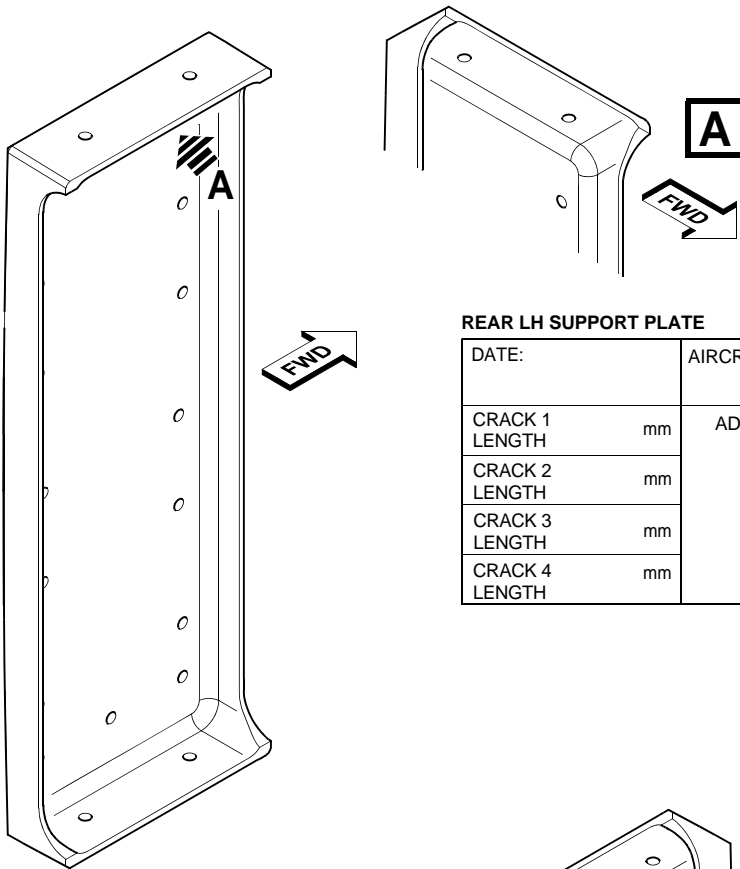
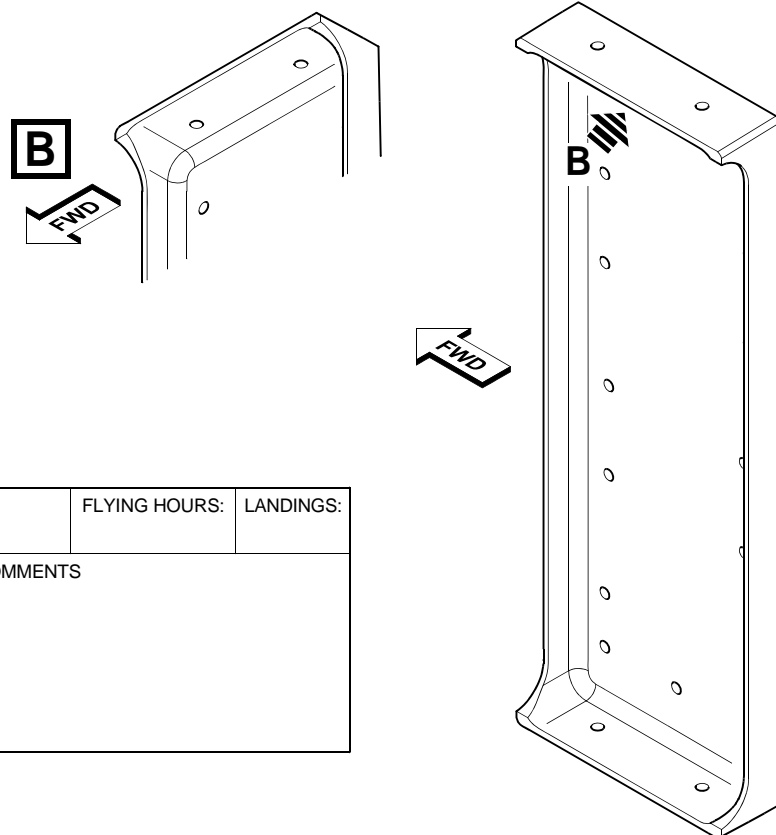
Front and Rear Rudder-Pedal Outboard-Bearing-Support Plates (P/N 553.20.09.229) - Inspection Form
Figure 20, Sheet 2 of 2

REAR LH SUPPORT PLATE

REAR RH SUPPORT PLATE
