Service Bulletin No: 57-011

ATA Chapter: 57

**WINGS - OUTER WING
INSPECTION OF THE LEFT AND RIGHT OUTBOARD AILERON BEARING-BRACKETS****1. Planning Information****A. Effectivity**

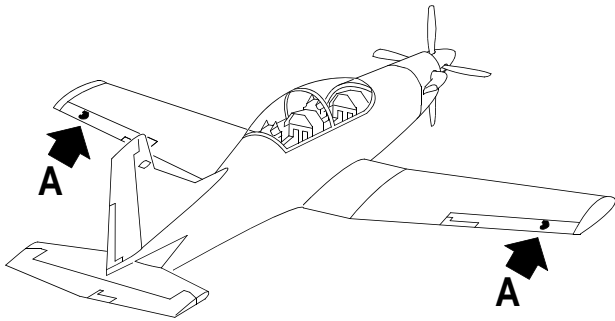
LEFT HAND SHOWN
RIGHT HAND SIMILAR

An Operator has found cracks in the outboard aileron bearing-bracket (bracket), P/N 557.22.09.281 (LH) and P/N 557.22.09.282 (RH) installed on some of his aircraft. If the rivets in the affected location come out, they could cause the aileron to become jammed or lost in flight.

The cause of the cracks is stress corrosion.

It is possible for stress corrosion cracks to occur in brackets, P/N 557.22.09.281 (LH) and P/N 557.22.09.282 (RH) made of aluminium alloy 2024-T351. These cracks would occur in the areas around the attachment fasteners.

- (1) Obey the manufacturer's operating instructions and calibrate the eddy-current conductivity measurement equipment.
- (2) For the left-aileron outboard bearing-bracket, P/N 557.22.09.281 (Ref. Fig. 1):
 - (a) Remove the dirt and grease from the test area with the absorbent paper (Material No. P02-031) made moist with the solvent (Material No. P01-010).
