SERVICE BULLETIN

SERVICE BULLETIN NO: 57-006

WINGS - CENTER WING - INSPECTION AND MODIFICATION OF THE MAIN-SPAR DIHEDRAL FITTINGS

PILATUS
PC-7
SERVICE BULLETIN

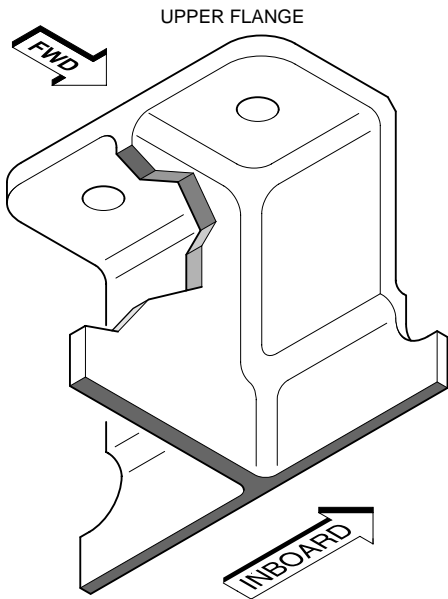
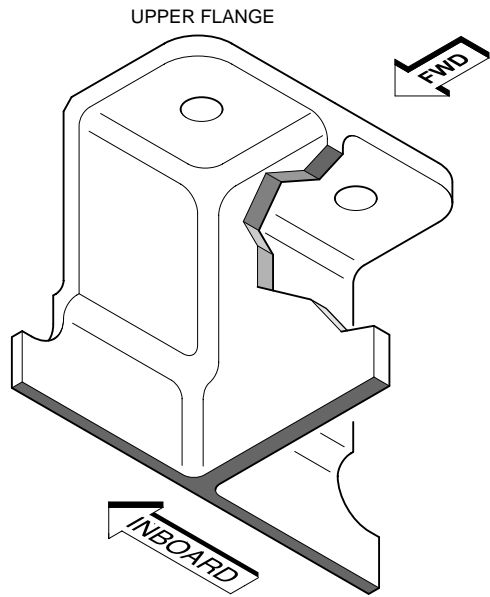
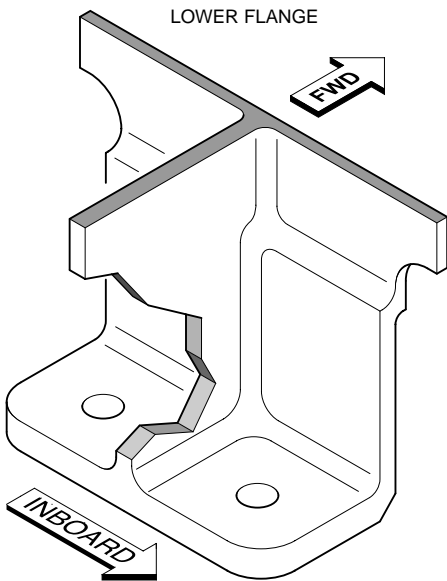
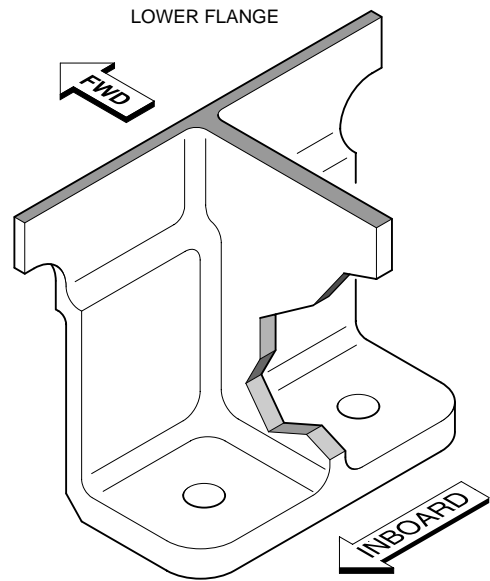
Aft Dihedral Fittings - Inspection Report Form (Eddy Current)
Figure 3

- (1) Use the Inspection Report Form (Figure 3) to tell the result of the inspection to PILATUS (Ref. Para. I).
- (2) Fittings with a defect indication that can be repeated:
- Do not fly the aircraft until PILATUS has made an analysis of the results. PILATUS will make a decision on the repair, replacement or inspection frequency necessary for each aircraft.

- (1) Use a **photocopy** of the Inspection Report Forms (Fig. 3 and Fig. 4) to show the location and length of cracks if found. If an aircraft has a fitting with no crack indication, use the Inspection Report Form to tell Pilatus the aircraft details. Give as many of the aircraft details as are known and send or fax the completed form(s), to

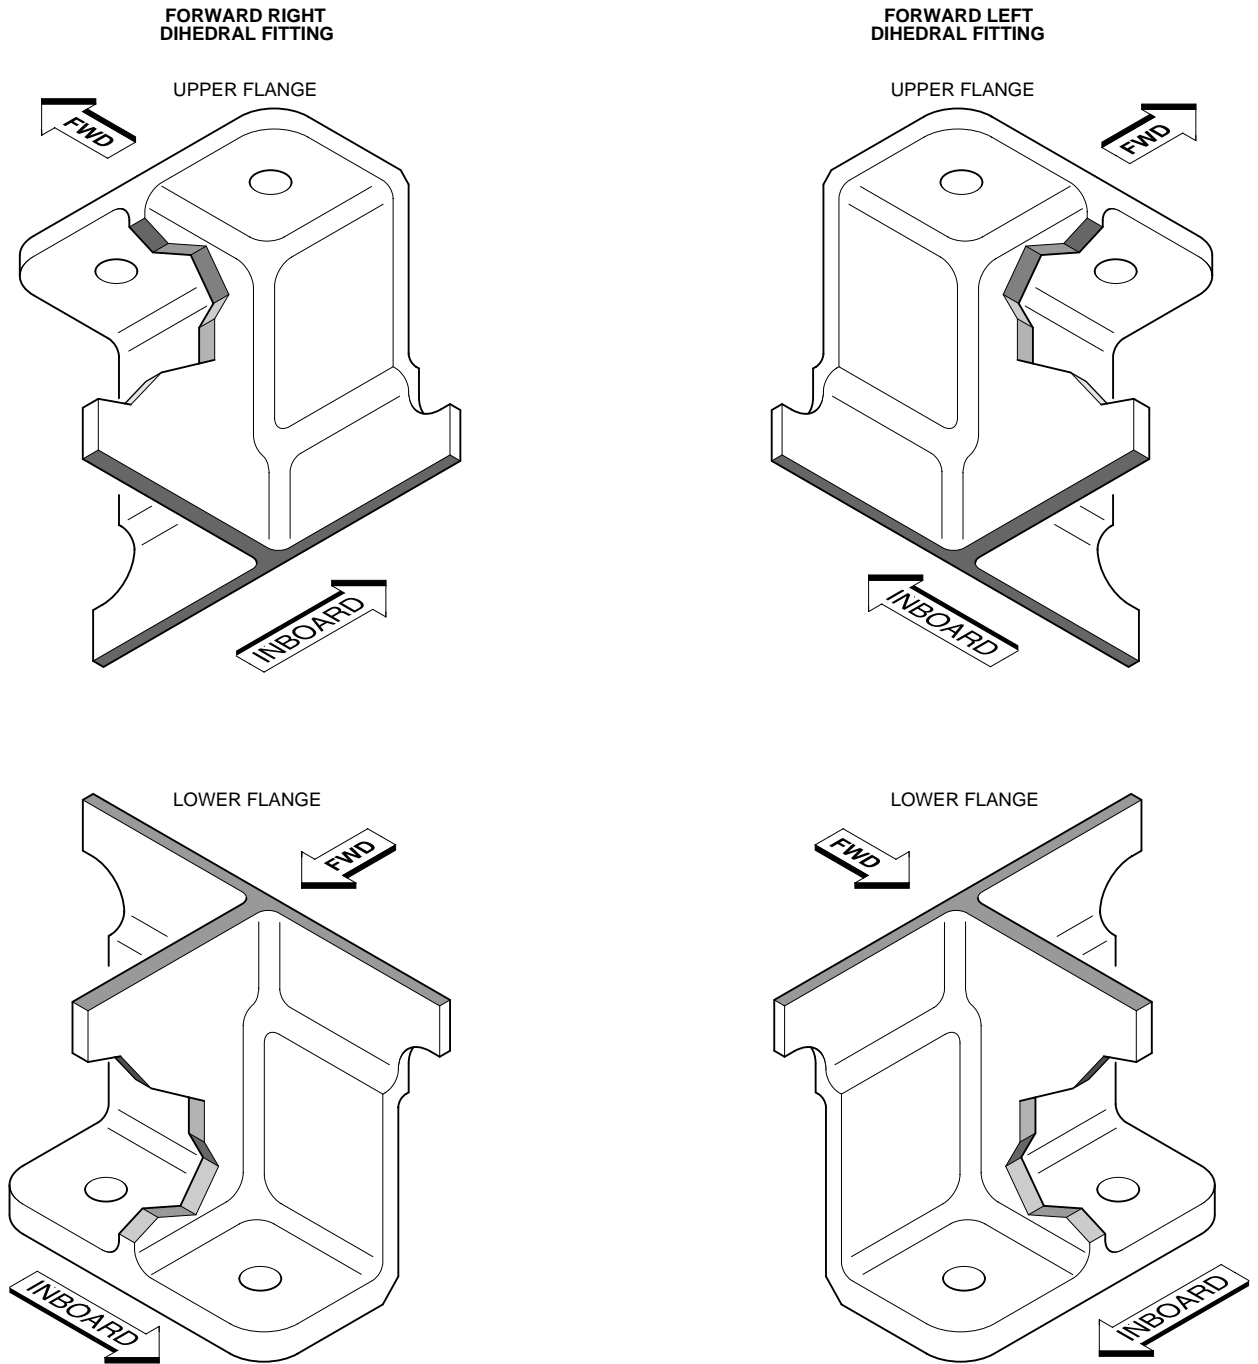
Forward Dihedral Fittings - Inspection Report Form (Radiographic)
Figure 4

- (1) Use the Inspection Report Form (Fig. 4) to tell the result of the inspection to PILATUS (Ref. Para. I).
- (2) All dihedral fittings with a crack indication

- Reject fittings with a crack indication.
- Do not fly the aircraft until PILATUS has made an analysis of the results. PILATUS will make a decision on the repair, replacement or inspection frequency necessary for each aircraft.
