Service Bulletin No: 51-001

ATA Chapter: 51

AIRCRAFT STRUCTURE - GENERAL**DO A CHECK OF THE MATERIAL SPECIFICATION USED DURING MANUFACTURE AND, IF NECESSARY, DO A CHECK FOR CRACKS OR REPLACE THE PART****1. Planning Information****A. Effectivity**

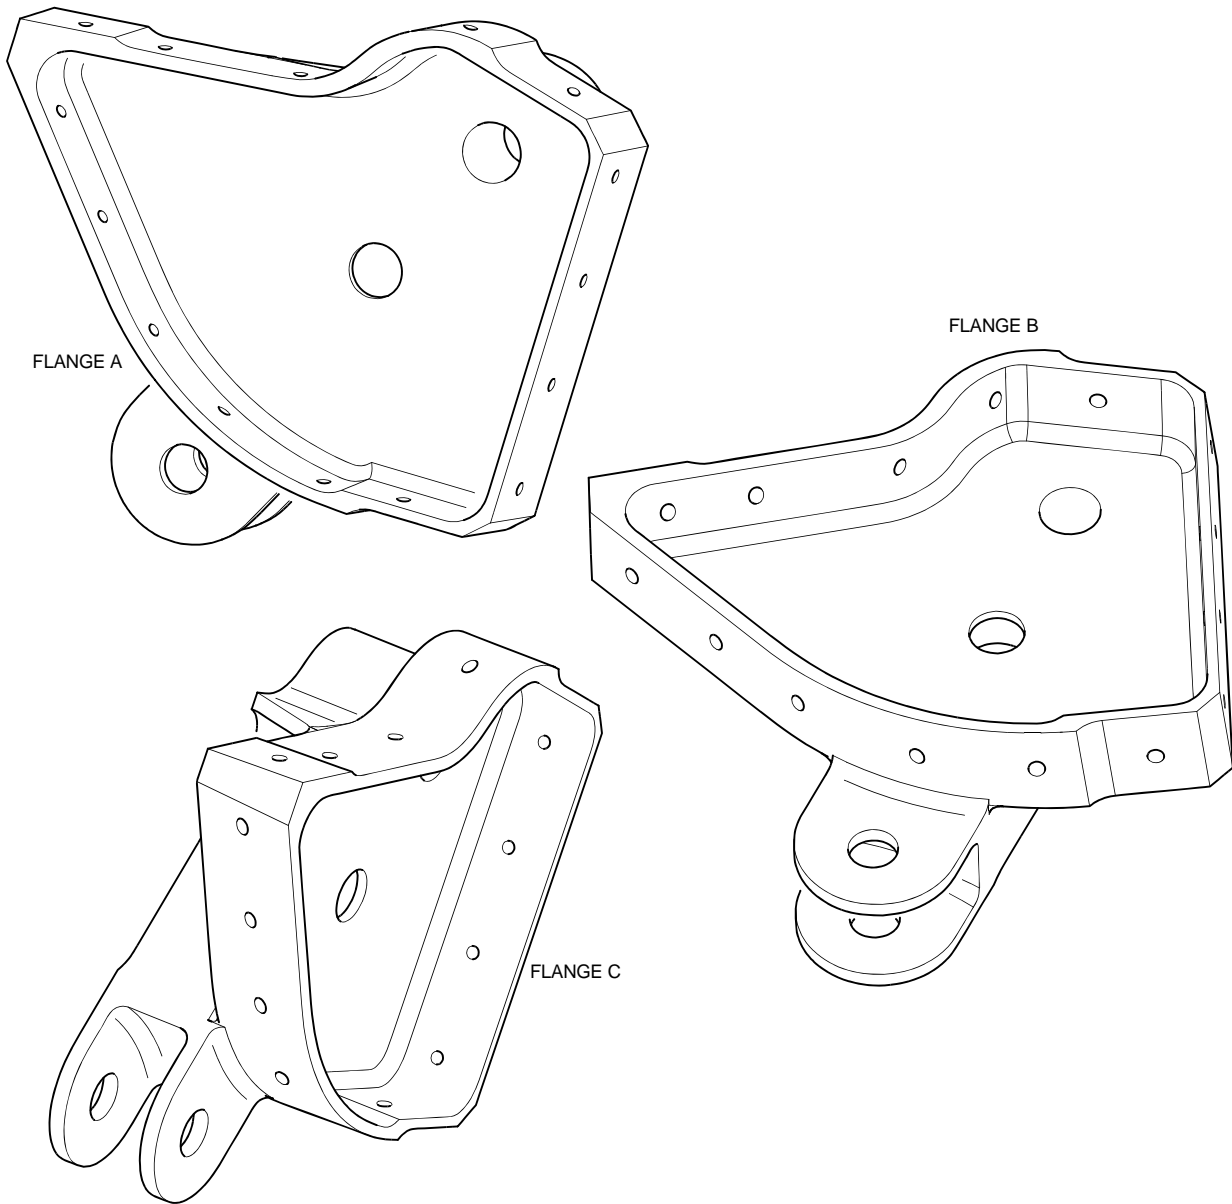
Nose Rib 1 - Inspection (If Necessary)
Figure 3

- 7 Write the type of material that the left-aileron nose-rib 1 is made from on the Status of Parts Form (Ref. Fig. 29).
- 8 Do Step 3.B.(1)(a)1 thru 7 again on the right-aileron nose-rib 1 (P/N 557.51.09.014).
- (b) If you find an aileron nose rib made from AA2024-T351, continue this Service Bulletin from Step 3.B.(1)(d).
- (c) If the aileron nose ribs are made from AA2124-T851, re-identify them (Ref. Para. 2.D.) and continue this Service Bulletin from Step 3.B.(2).
- (d) Do an inspection for cracks (Ref. Fig. 3):

- 2 Use a bright light source and a mirror to examine the inspection areas of the left-aileron nose-rib 1 for cracks.

- 3 If you find cracks:

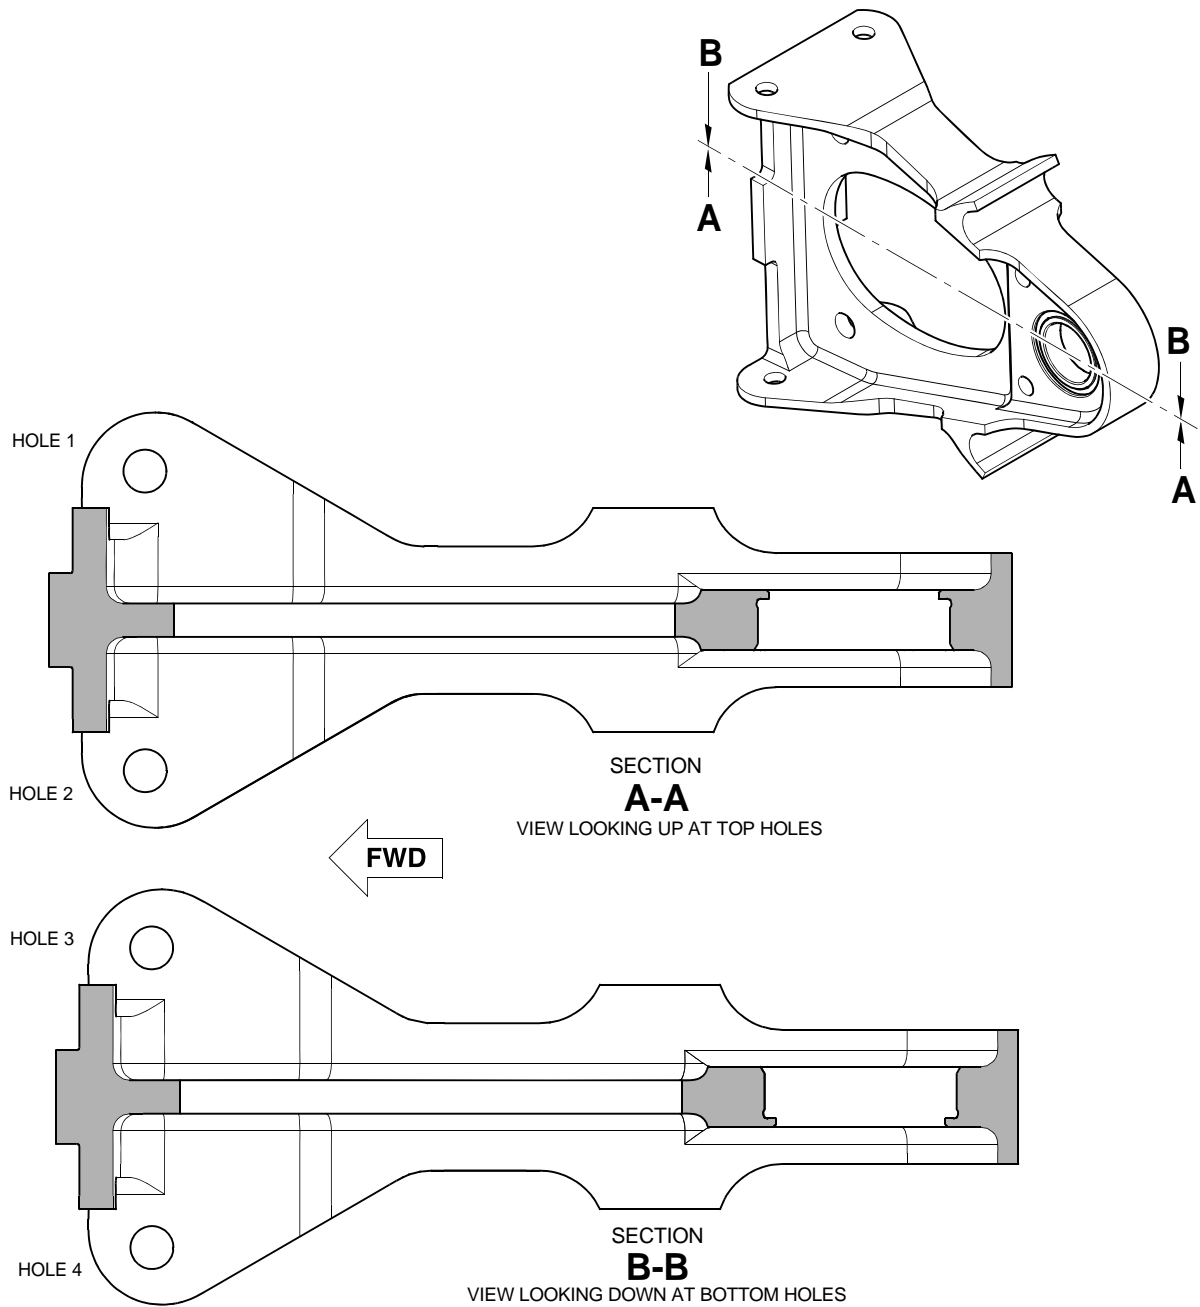
Elevator Center-Attachment Bearing-Bracket - Inspection (If Necessary)
Figure 5

- 7 Write the type of material that the elevator center-attachment bearing-bracket is made from on the Status of Parts Form (Ref. Fig. 29).
- (b) If you find an elevator center-attachment bearing-bracket made from AA2024-T351, it is P/N 555.10.09.060. Continue this Service Bulletin from Step 3.B.(2)(d).
- (c) If you find an elevator center-attachment bearing-bracket made from AA2124-T851, it is P/N 555.10.09.143. Re-identify it (Ref. Para. 2.D.) and continue this Service Bulletin from Step 3.B.(3).
- (d) Do an eddy-current Non-Destructive-Inspection (NDI) for cracks (Ref. Fig. 5):

- 5 Obey the manufacturer's instructions and move the probe of the eddy-current NDI equipment over the inspection areas shown in Fig. 5.
- 6 Apply a layer of the corrosion preventative (Material No. P04-039) to the shank of the bolt (1).

- 7 Install the bolt (1), the washer (2), the washer (3) and the nut (4).
- 8 Do Steps 3.B (2)(d)2 thru 7 again for the other 3 holes.
- 9 If you find cracks:

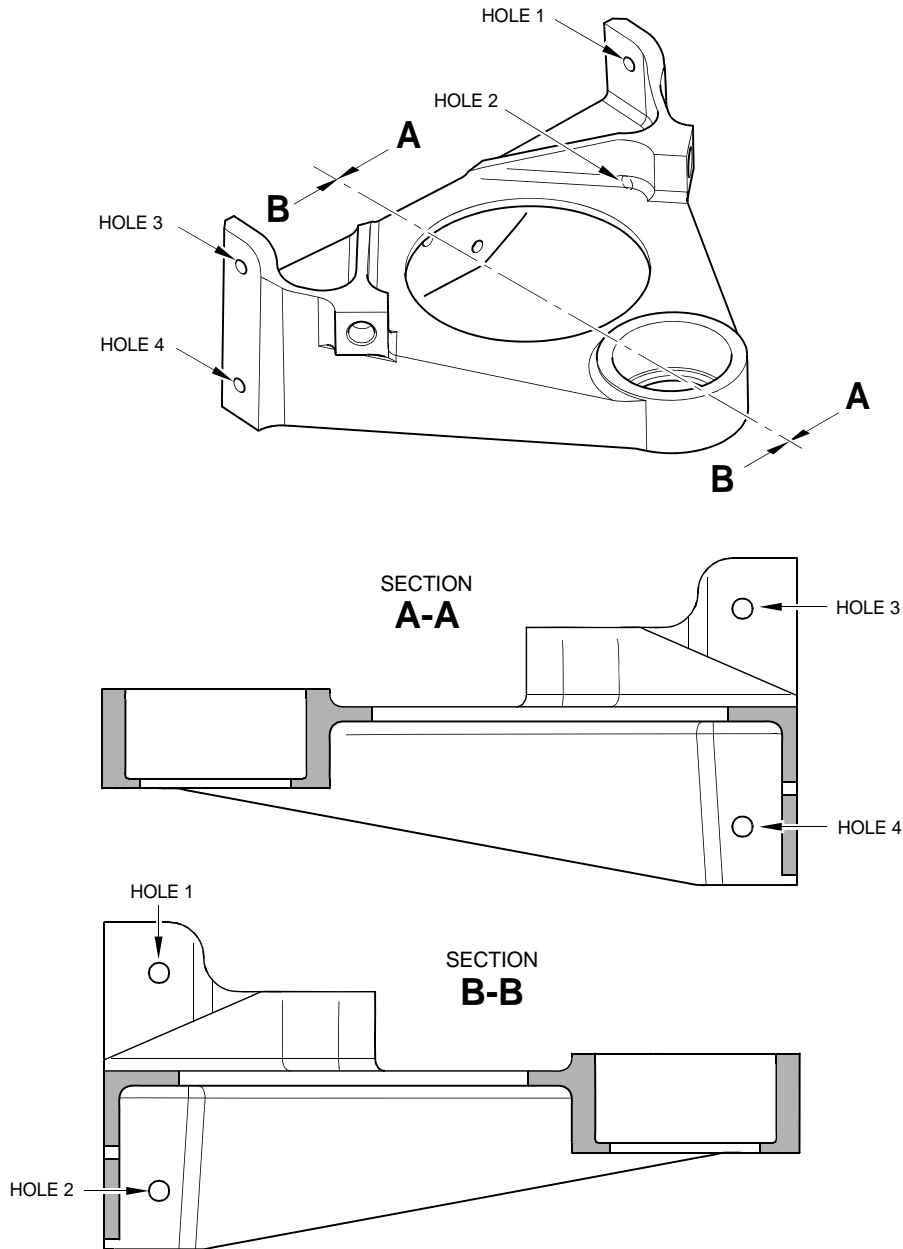
Lower Rudder Bracket - Inspection (If Necessary)
Figure 7

- (d) Do an eddy-current Non-Destructive-Inspection (NDI) for cracks (Ref. Fig. 7):

- 5 Obey the manufacturer's instructions and move the probe of the eddy-current NDI equipment over the inspection areas shown in Fig. 7:

- 6 Apply a layer of the corrosion preventative (Material No. P04-039) to the shank of the bolts (1).

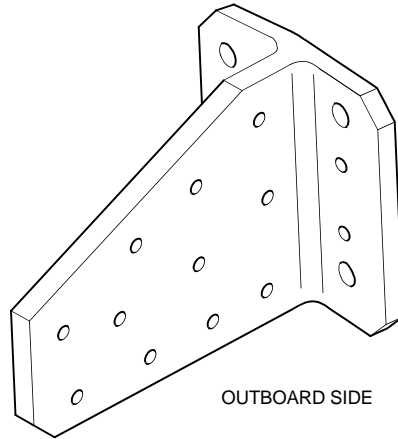
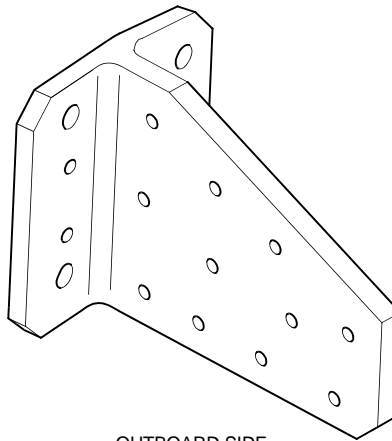
Left and Right Flap Bearing Support-Bracket - Inspection (If Necessary)
Figure 11

- (a) Do the conductivity test to find the material of the left flap bearing support-bracket (P/N 111.34.07.329) and the right flap bearing support-bracket (P/N 111.34.07.330) (Ref. Fig. 11).

(d) Do an inspection for cracks (Ref. Fig. 11):

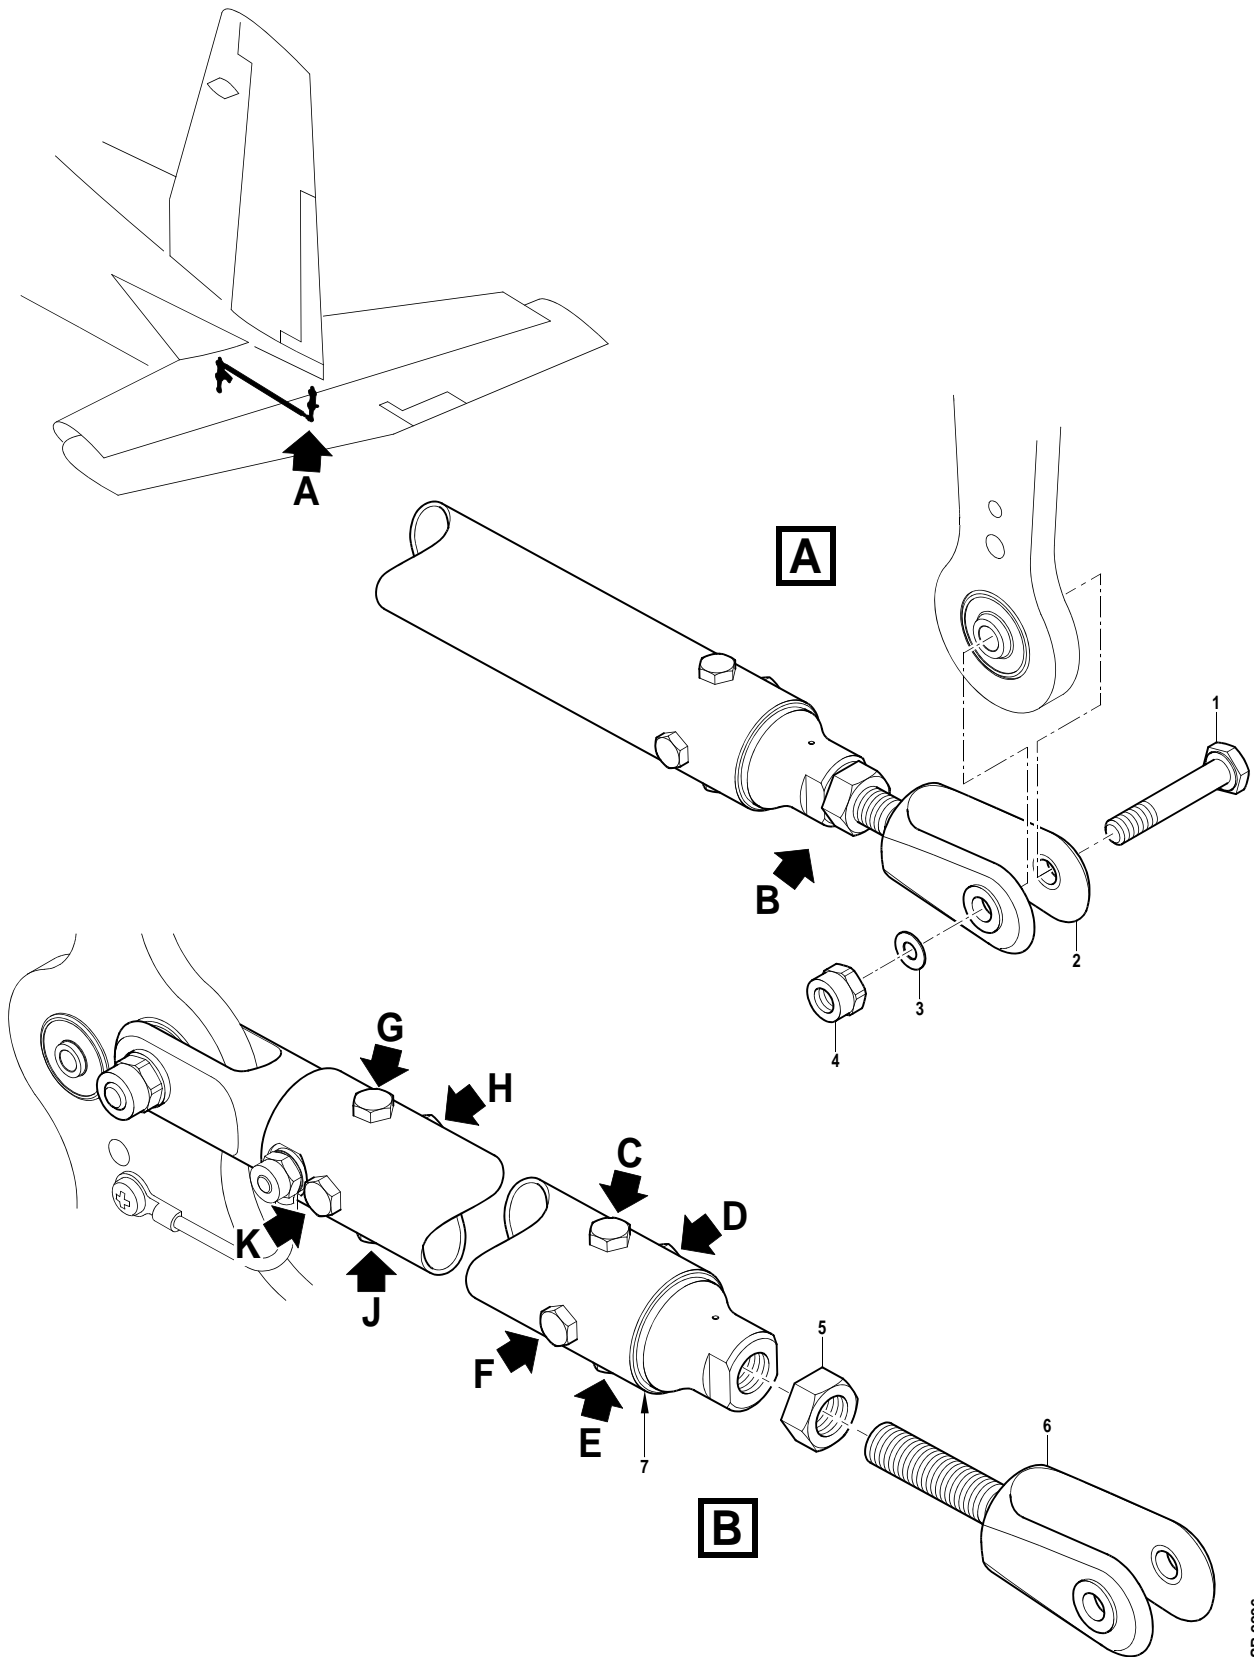
Elevator Rear Control-Rod - Inspection (If Necessary)
Figure 18

(b) Disconnect the elevator rear control-rod (P/N 527.30.09.016) (Ref. Fig. 18):

(c) Do an inspection for cracks (Ref. Fig. 18):

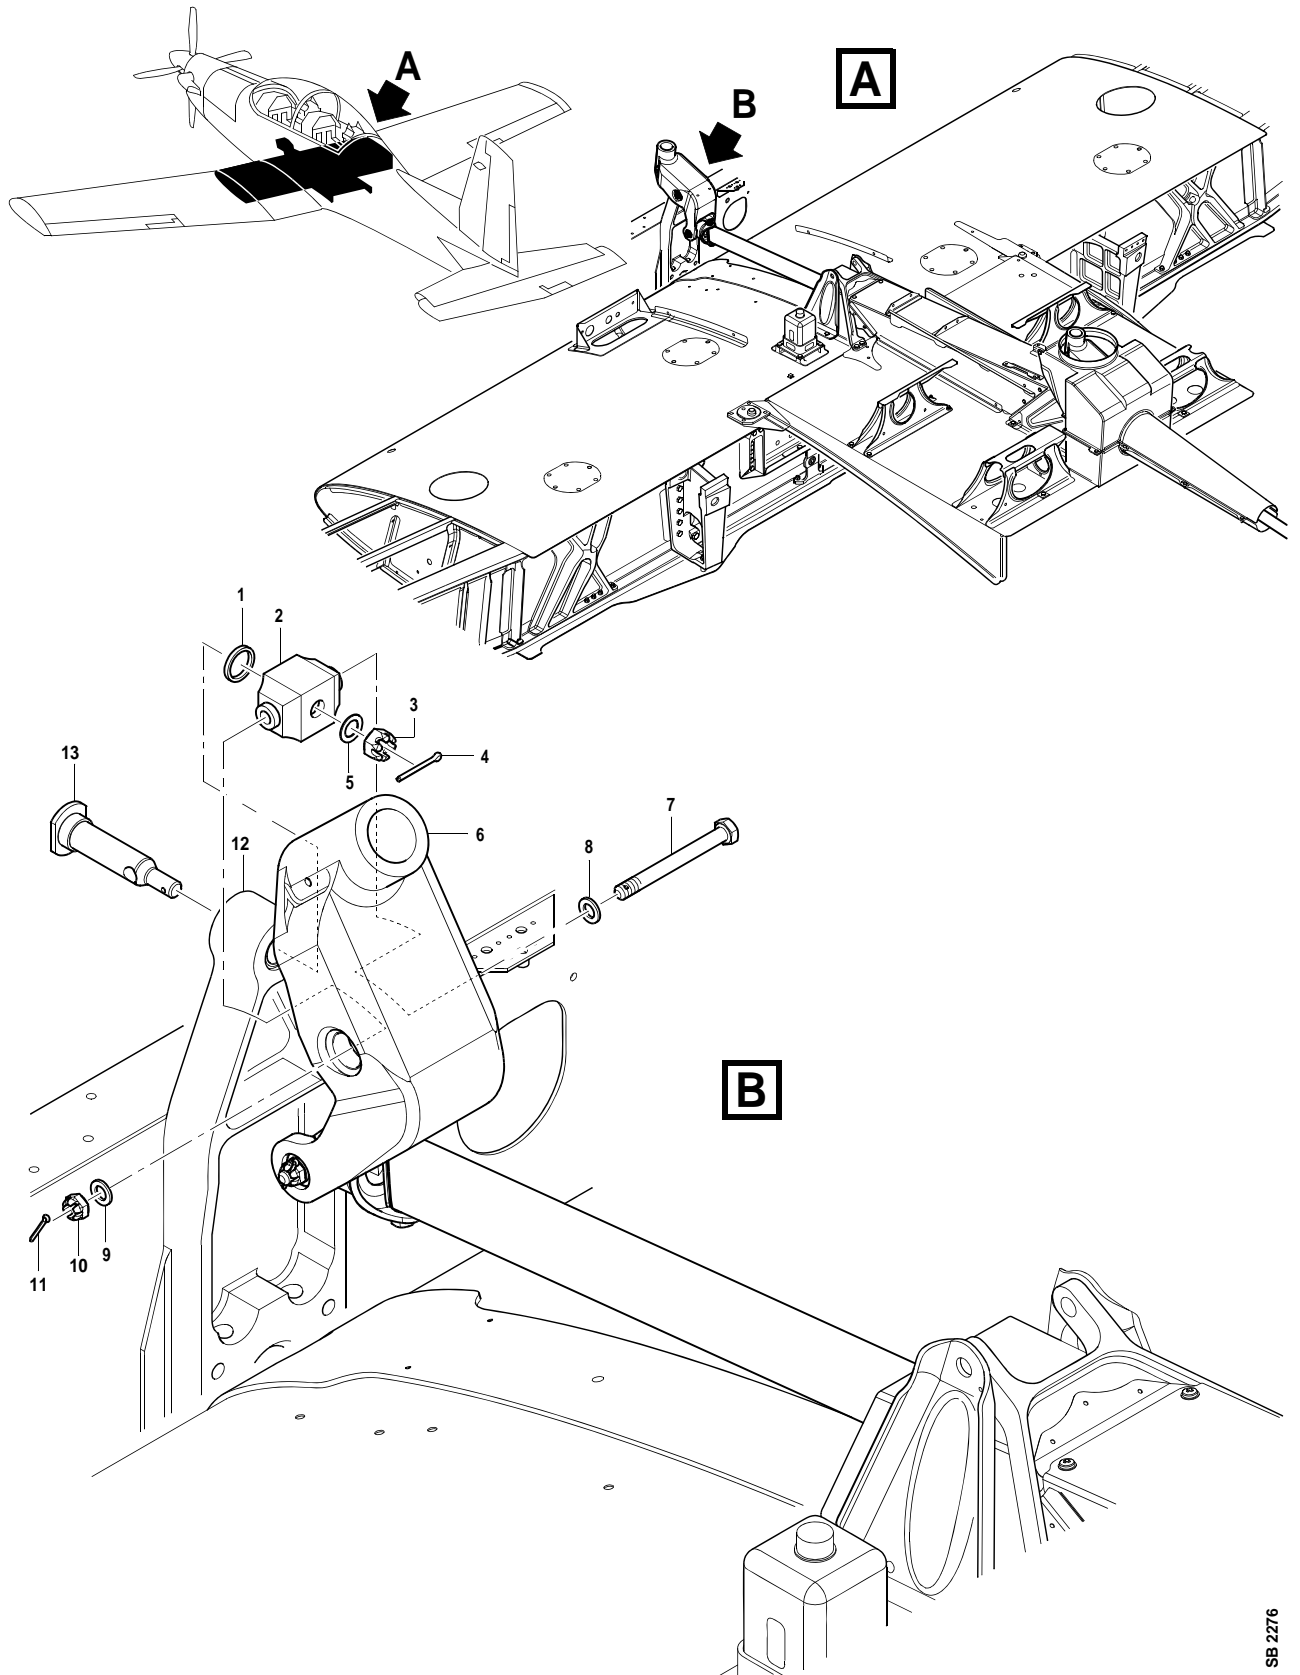
Replacement of the Bearing on the Forward Control Column
Figure 20

(10) Inspection and, if Necessary, Replacement of the Bearing in the Forward Control-Column (Ref. Fig. 20)

(a) Do the conductivity test to find the material of the bearing (Ref. Fig. 20) on the fwd control-column (Ref. IPC, 27-10-01).

(d) Replace the bearing assembly (Ref. Fig. 20):

- 14 Install the bolt (7), the washer (8) (if removed), the washer (9) and the nut (10).
- 15 Torque the nut (10) to between 7 and 8 Nm (60 and 70 lb in).

- 16 Install the new cotter pin (11) (P/N 940.17.02.340).

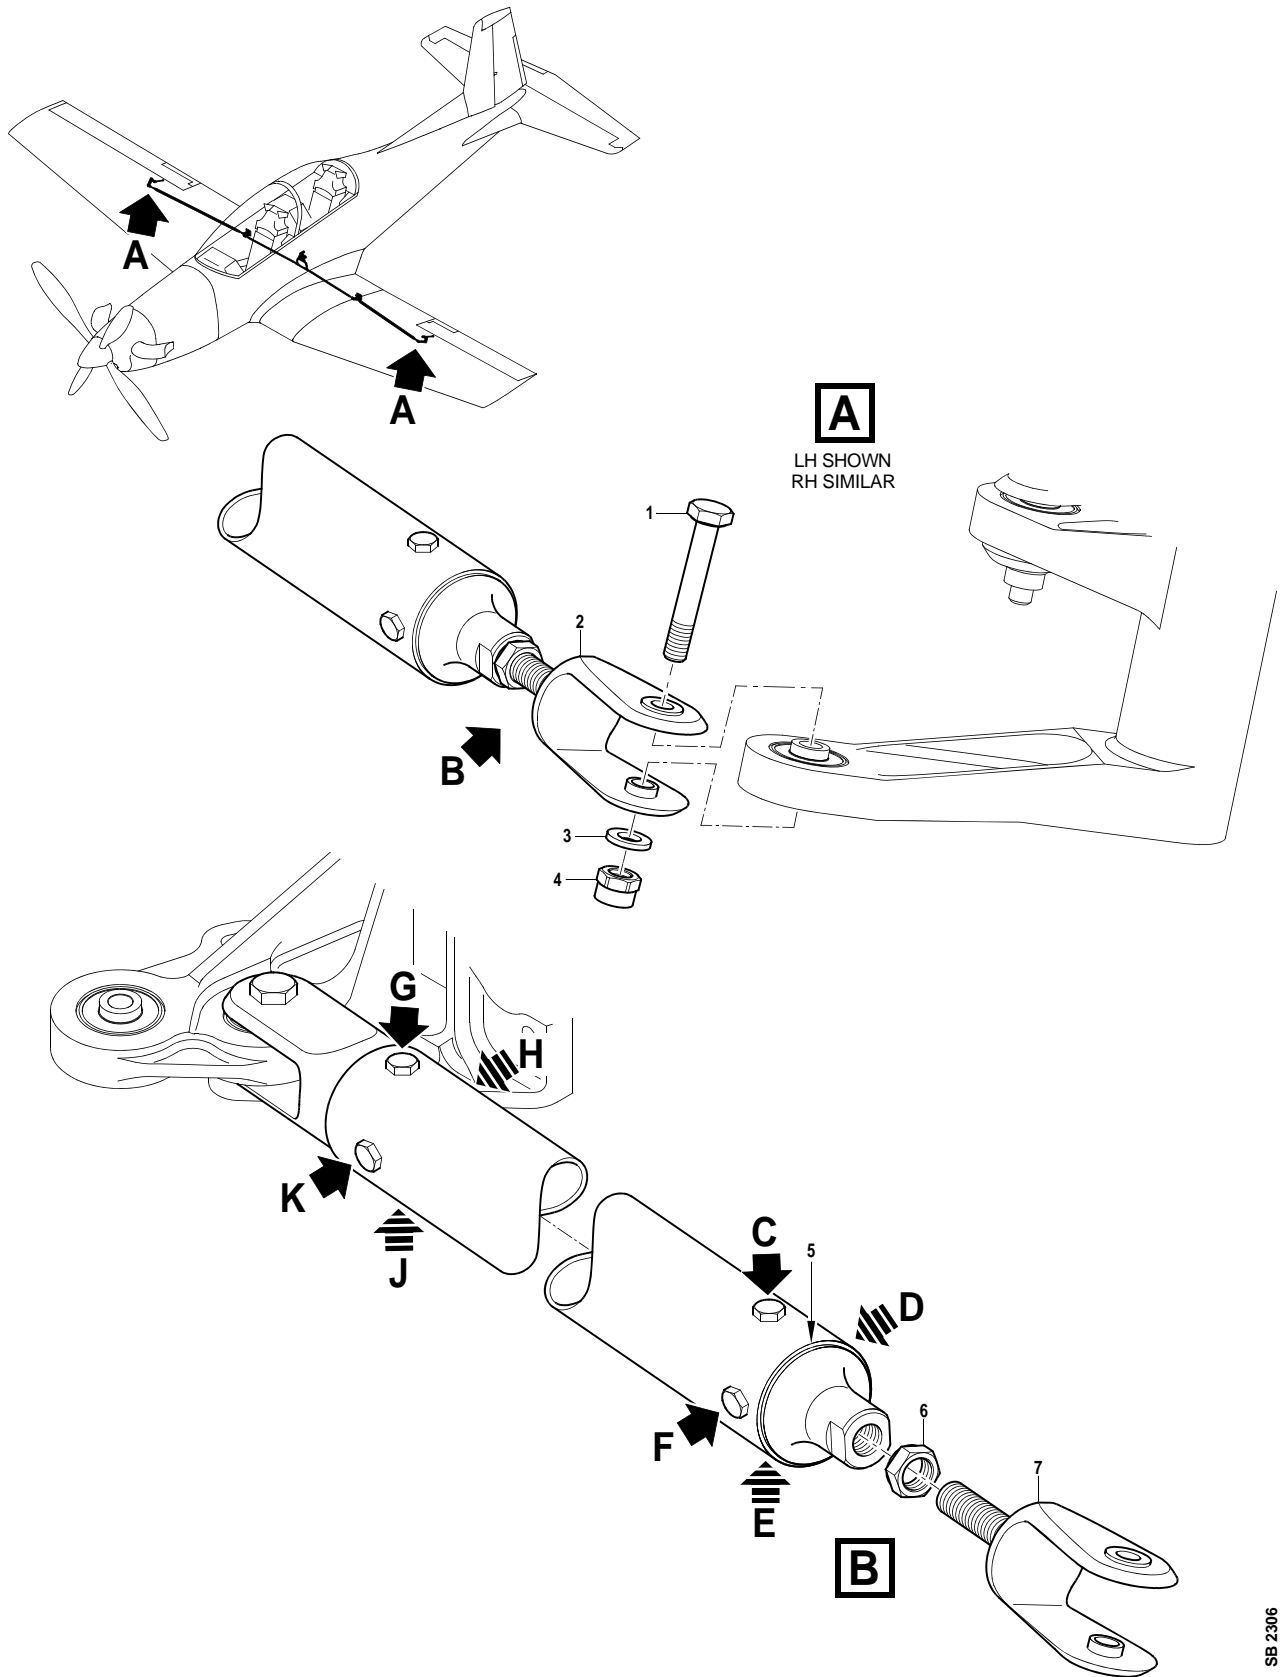
Aileron Outer Control-Rod - Inspection (If Necessary)
Figure 23

(b) Disconnect the left-aileron outer control-rod (P/N 527.10.09.021) (Ref. Fig. 23):

(c) Do an inspection for cracks (Ref. Fig. 23):

- (h) Connect the left-aileron outer control-rod:
- 1 Install the end fitting (7).
 - 2 Adjust the end fitting (7) until the distance between:
 - The center of the hole for the attachment bolt (1)
 - The outboard end of the tube (5) on the control rod (2)is the same as noted in Step 3.B.(12)(b)3.
 - 3 Tighten the lock nut (6).

- 4 Put the left-aileron outer control-rod (2) in position.
- 5 Install the bolt (1), the washer (3) and the nut (4).
- (i) Do Step 3.B.(12)(h) again for the right aileron outer control-rod (P/N 527.10.09.021).
- (j) Do the adjustment / test of the aileron controls (Ref. AMM, 27-10-00, Page Block 501).

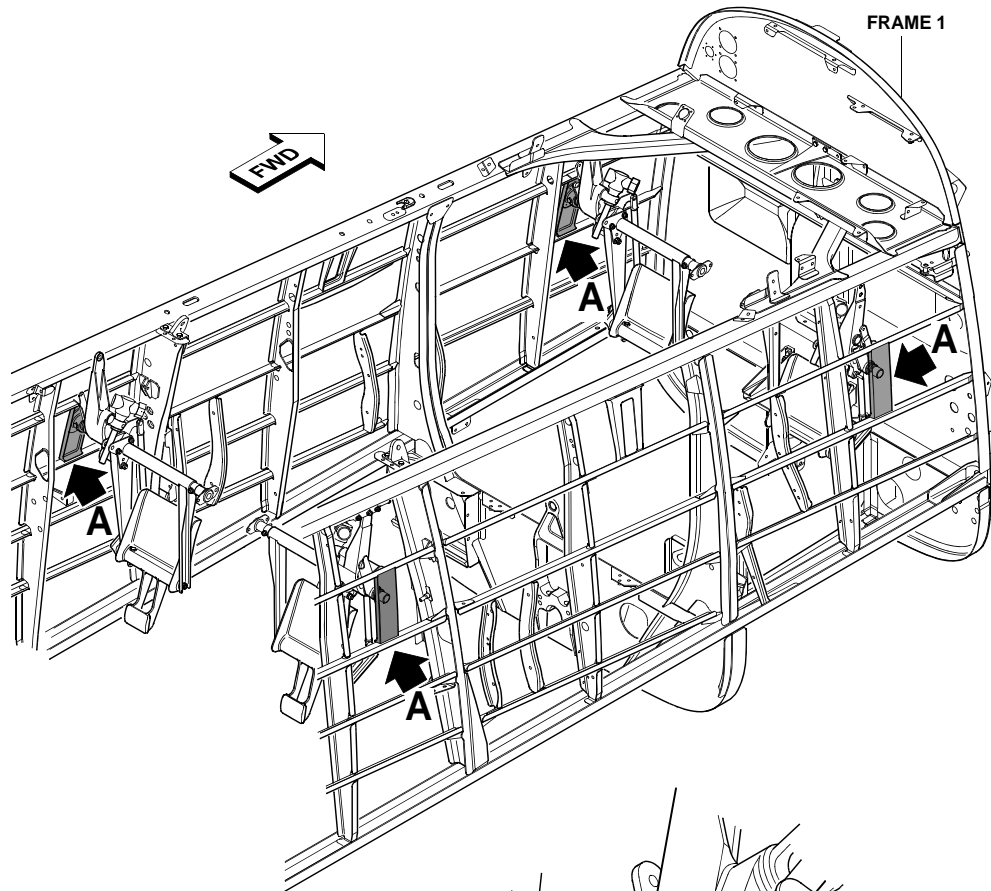
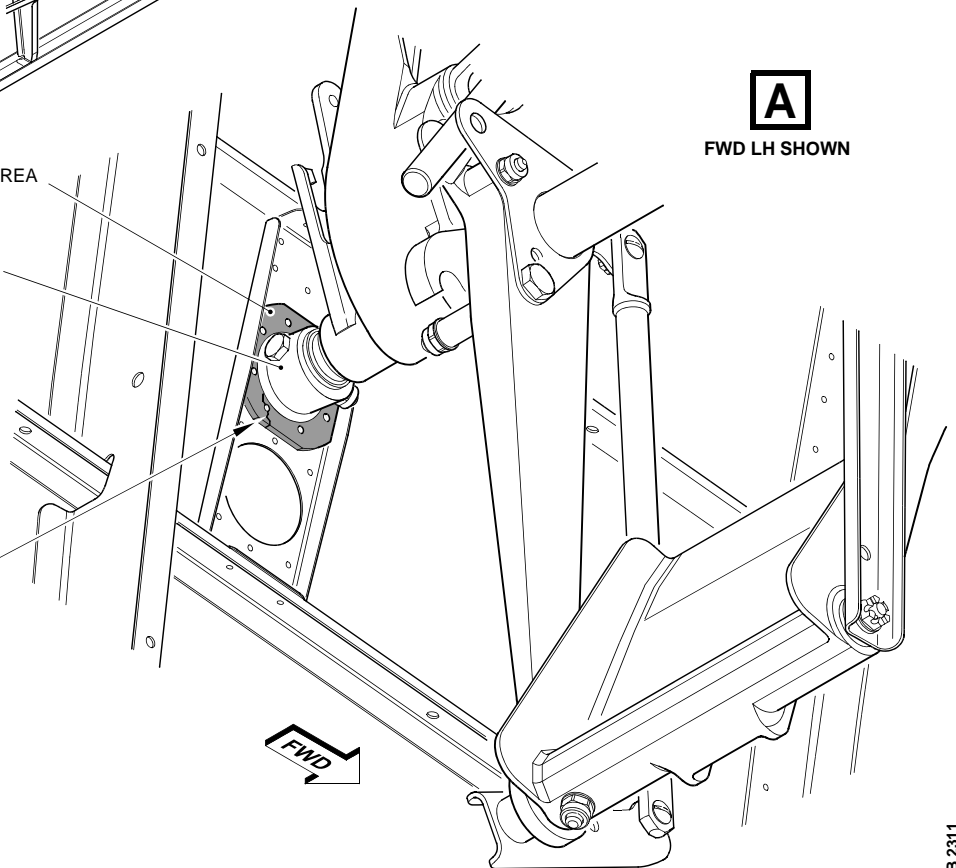
Front and Rear Rudder-Pedal Outboard-Bearings (P/N 553.20.09.062 / 231) - Inspection (If Necessary)
Figure 25, Sheet 1 of 2

1 If the outboard bearings looks the same as the one shown in sheet 1 of Fig. 25, it's part number is 553.20.09.062 or 553.20.09.231 and it is made from AA2024-T351, continue the Service Bulletin from Step 3.B.(13)(e).

- (f) Do an inspection for cracks of the outboard bearings (Ref. Fig. 25):

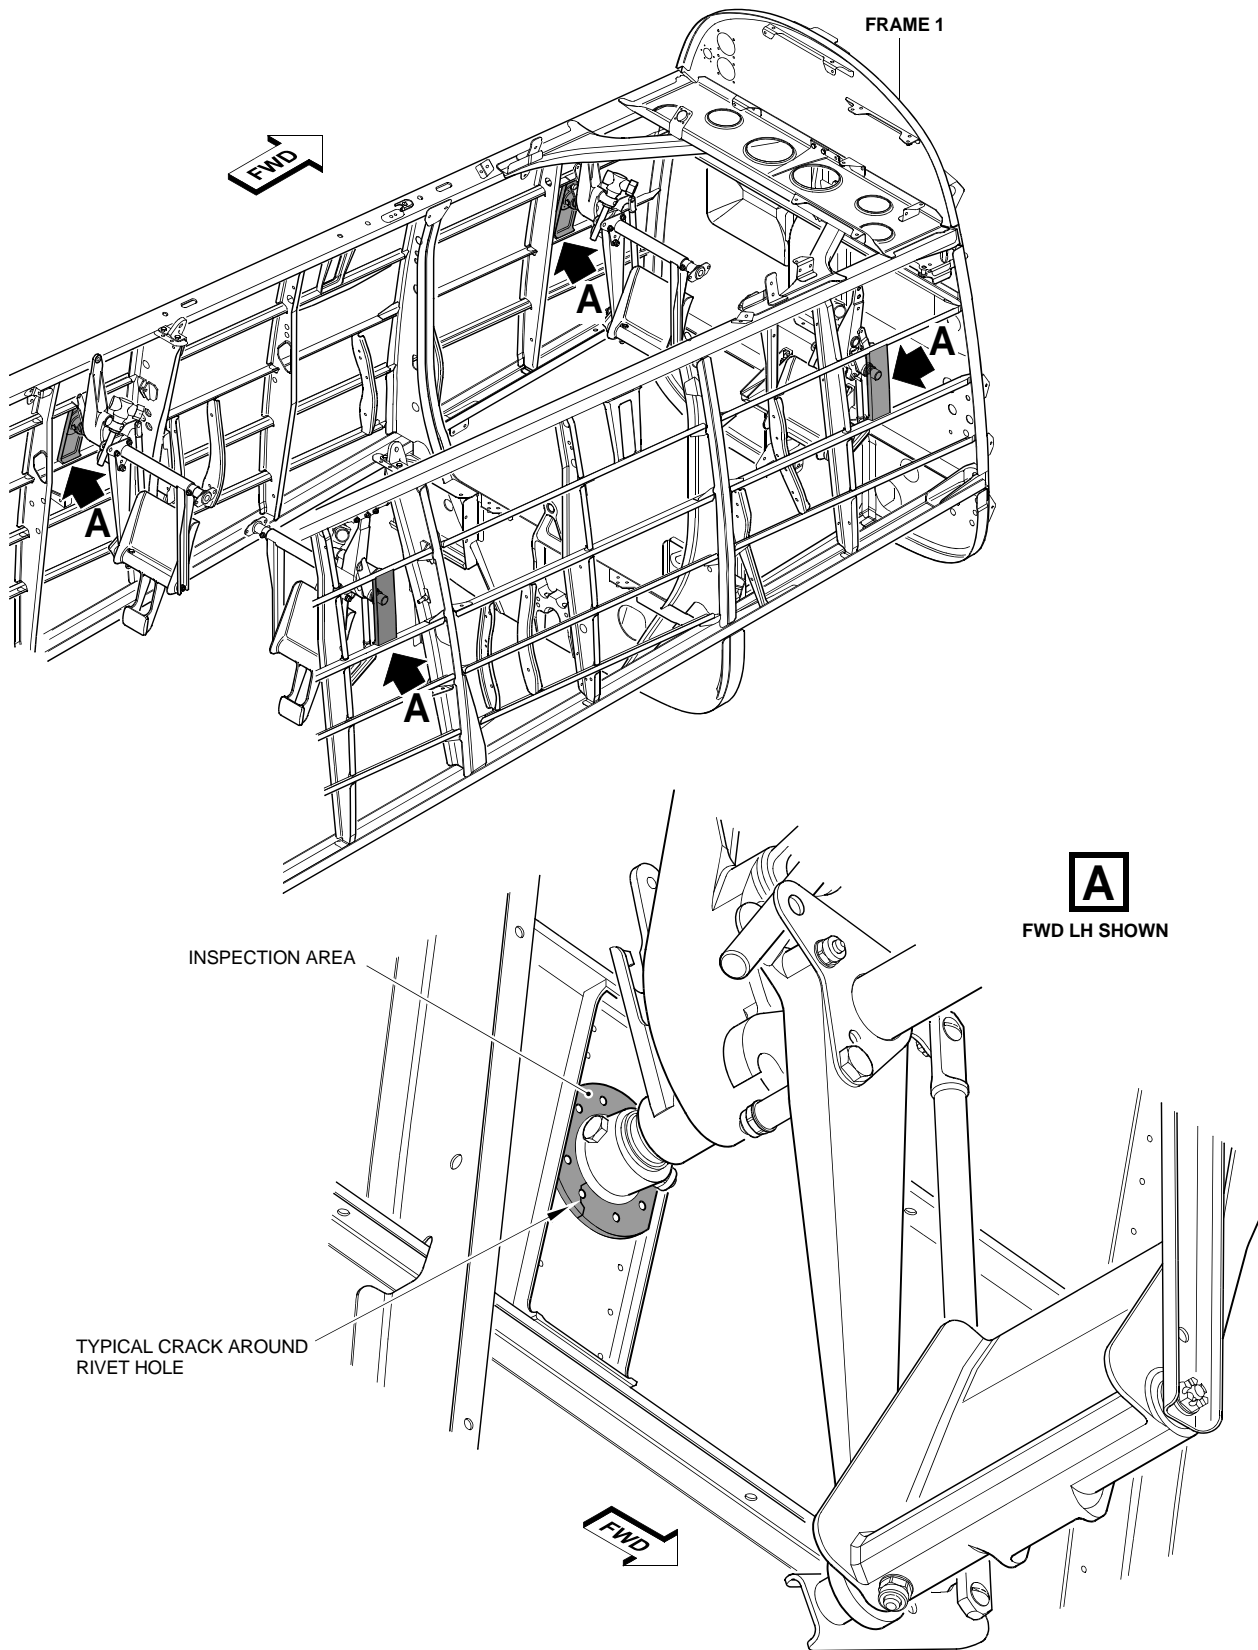
Front and Rear Rudder-Pedal Outboard-Bearings (P/N 553.20.09.235) - Inspection (If Necessary)
Figure 25, Sheet 2 of 2

2 If the outboard bearings looks the same as the one shown in sheet 2 of Fig. 25, it's P/N 553.20.09.235 and can be made from AA2024-T351 or AA2124-T851, continue the Service Bulletin from Step 3.B.(13)(b).

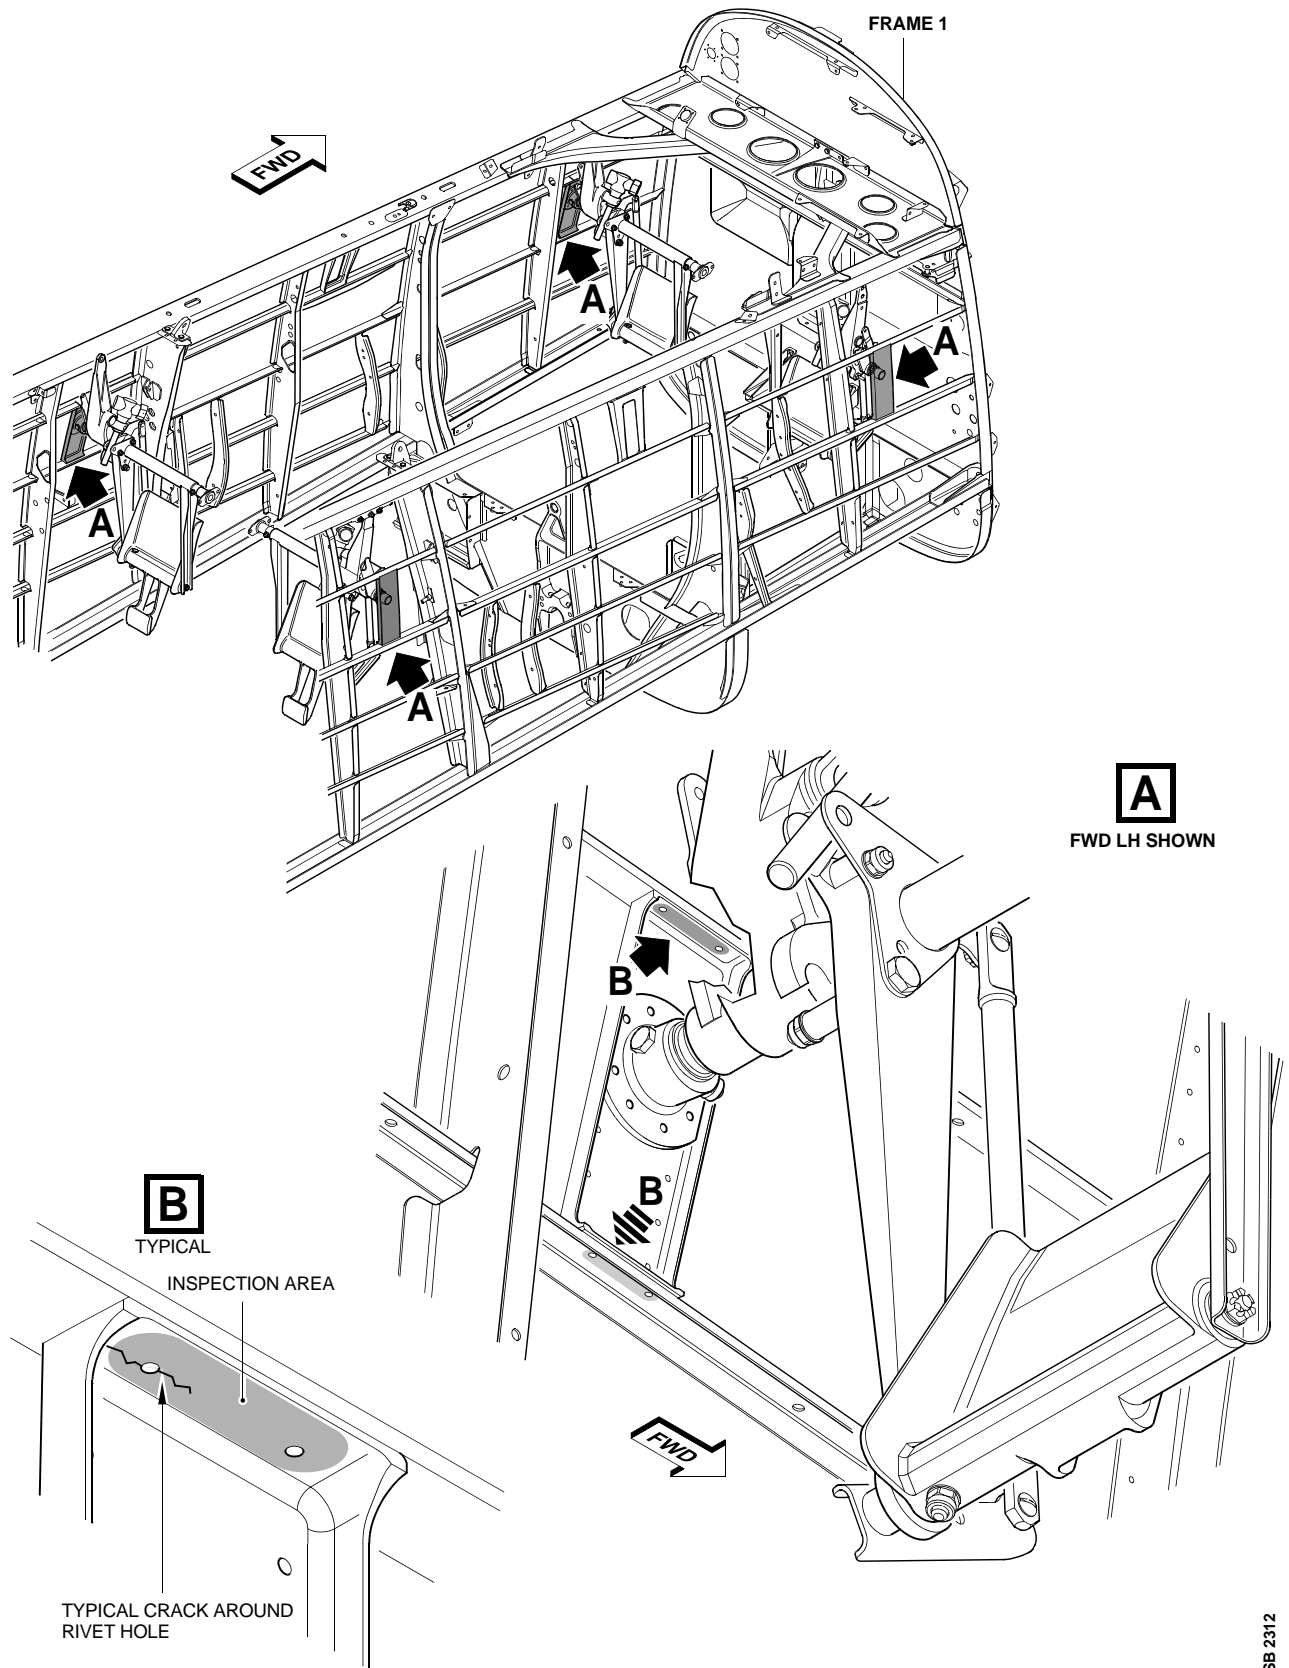
Front and Rear Rudder-Pedal Outboard-Bearing-Support Plates (P/N 553.20.09.229) - Inspection
Figure 27

(i) Do an inspection for cracks of the support plates (Ref. Fig. 27):
