Schlussbericht Nr. 2148 der Schweizerischen Unfalluntersuchungsstelle SUST

über die möglichen Gefährdungen von
Rettungs- und Untersuchungsorganen
durch ballistische Fallschirmrettungssys-
teme (*Ballistic Parachute Systems – BPS*)
in Flugzeugen

Thermal behavior of BRS 440 and BRS 601 rockets

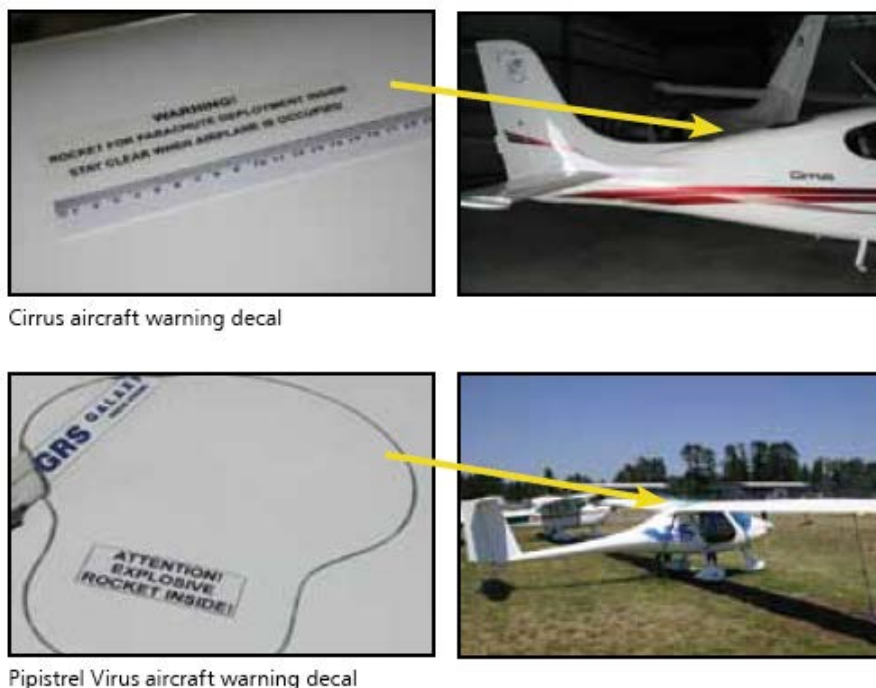
Abbildung 13: Zurzeit gültige Identifikationen von BPS-Flugzeugen

Zurzeit sind BPS-Flugzeuge mit einem kleinen dreieckförmigen Kleber mit einer Seitenlänge von ca. 40 mm versehen. Der Kleber warnt vor den Gefahren, welche von einem BPS ausgehen und gibt der Rettungsmannschaft den Hinweis, vor Aufnahme der Rettungsarbeiten am Wrack die auf dem Kleber aufgedruckte Telefonnummer in den USA anzurufen.

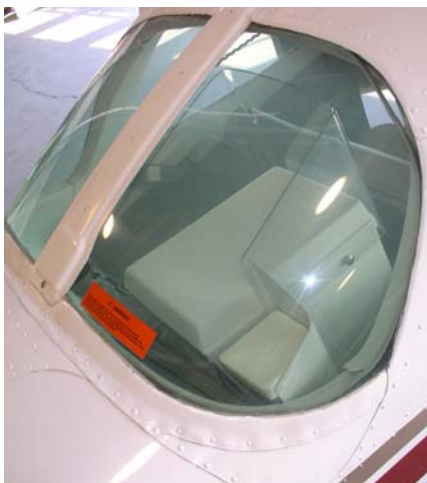
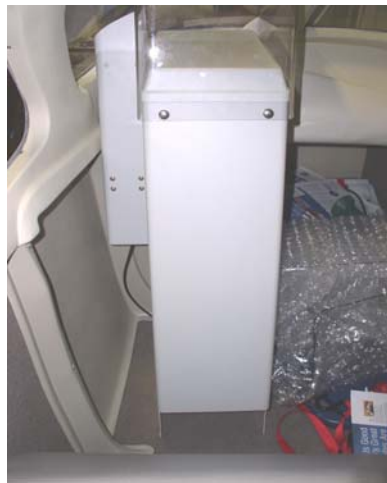
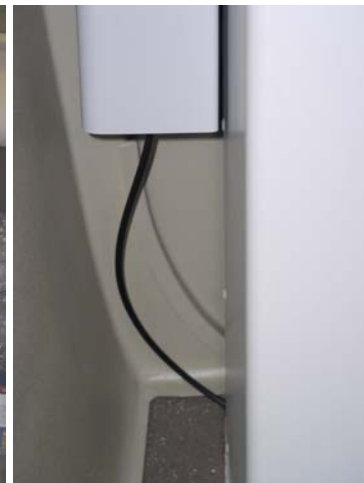
Cessna 172

The above three photos show the location of the parachute canister and rocket in the **Cessna 172**. The aluminum parachute canister (large box) is in the left rear of the

baggage area, as viewed from the front seats. The rocket is on the left of the parachute canister; the activation cable runs down to the floorboard, under a cover, then forward to the activation handle, located near the fuel selector.
