Aviation Division

Final report No. 2148 by the Swiss Accident Investigation Board SAIB

On potential risks of ballistic para-
chute systems (BPS) in aircraft to
rescue and investigation crews

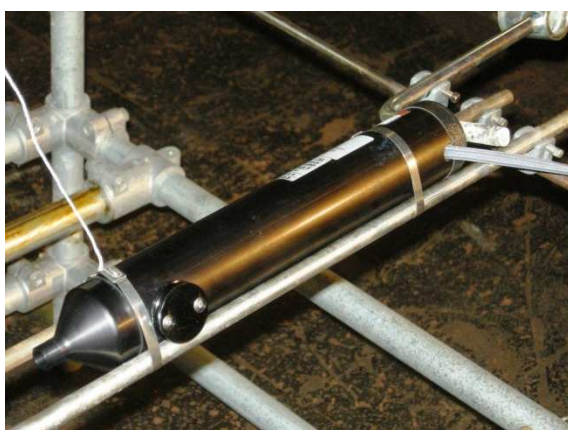
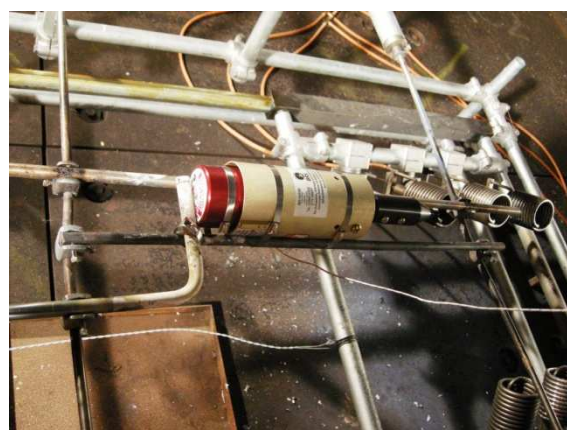
Fig. 3: FCO set-up; respectively for the BRS 440 (left) and the BRS 601 (right).

Test Nr. / Rocket	Mean Temp. [°C]	Time to Reaction [s]	Type of Reaction ¹	Remarks
V01/ BRS 440 Nr. 2	1045	145	Type V-IV Fast burning towards deflagration	End cap was axially ejected out of the rocket casing with high velocity. The main part of HTPB cylinder of the rocket motor did not react. Both percussion cups of the Igniter did not react.
V03/ BRS 440 Nr. 3	1085	129	Type V-IV Fast burning towards deflagration	The end cap was axially ejected out of the rocket casing with high velocity. One wire cut and the second wire almost cut. No unreacted rocket motor parts left. Igniter including primary booster remained unreacted.
V02/ BRS 601 Nr. 1	1050	43	Type V-IV Fast burning towards deflagration	The rocket was axially ejected apart from the fixation and penetrated the 2 mm thick aluminum witness plate (see Fig. 7). The outer casing of the rocket was ejected to the opposite witness plate which resulted in a crack into the plate. All parts of the rocket motor and igniter did react.

V04/ BRS 601 Nr. 2	1065	69	Type V-IV Fast burning towards deflagration	The rocket remained onto the support but shifted the whole test equipment about 1.5 m in the direction of the base of the rocket. All parts of the rocket motor and igniter did react.

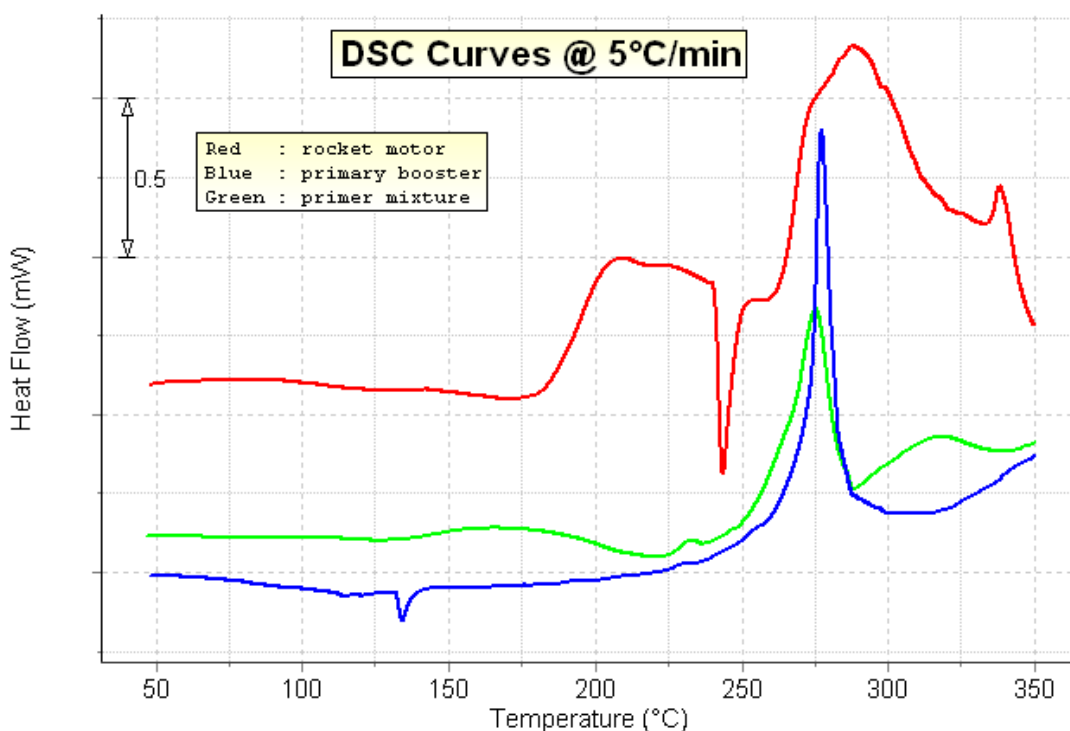
Fig. 11: DSC curves of the rocket motor, the primary booster and the primer mixture with a heating rate of 5°C per minute.

The DSC experiments have shown that for a heating rate of 5°C per minute, the rocket motor is the sample which shows first an exothermic reaction at 180°C (cf. fig. 11). In comparison the primary booster and the primer mixture seem to be thermodynamically more stable.

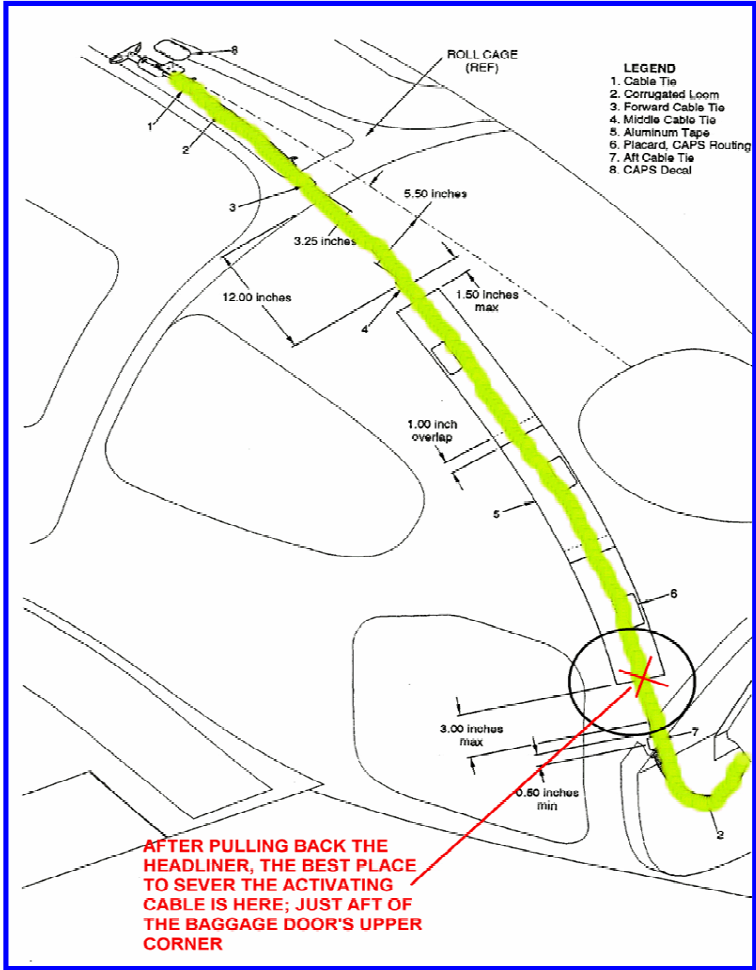
CIRRUS

This illustration shows the routing of the activation cable in a Cirrus SR20 or SR22 aircraft, which is covered entirely by headliner panels. The best place to expose the cable is just aft of the baggage door, near the upper right corner.

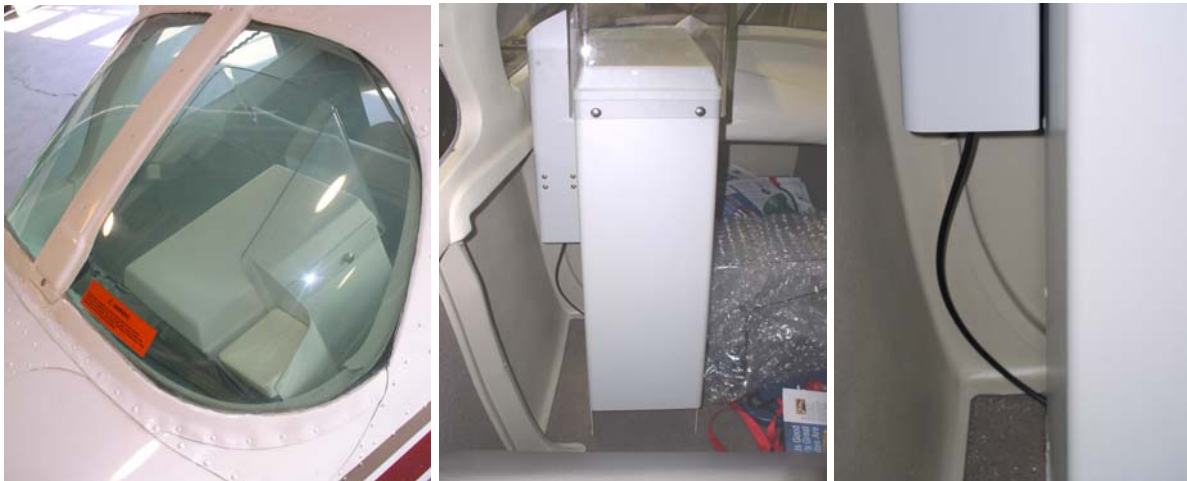
Cessna 172

The above three photos show the location of the parachute canister and rocket in the **Cessna 172**. The aluminum parachute canister (large box) is in the left rear of the

baggage area, as viewed from the front seats. The rocket is on the left of the parachute canister; the activation cable runs down to the floorboard, under a cover, then forward to the activation handle, located near the fuel selector.
